Improving the Foundation Layers for Concrete Pavements

Field Assessment of Jointed Portland Cement Concrete Pavement with Premature Distresses – Iowa US 34 Field Study

February 2016

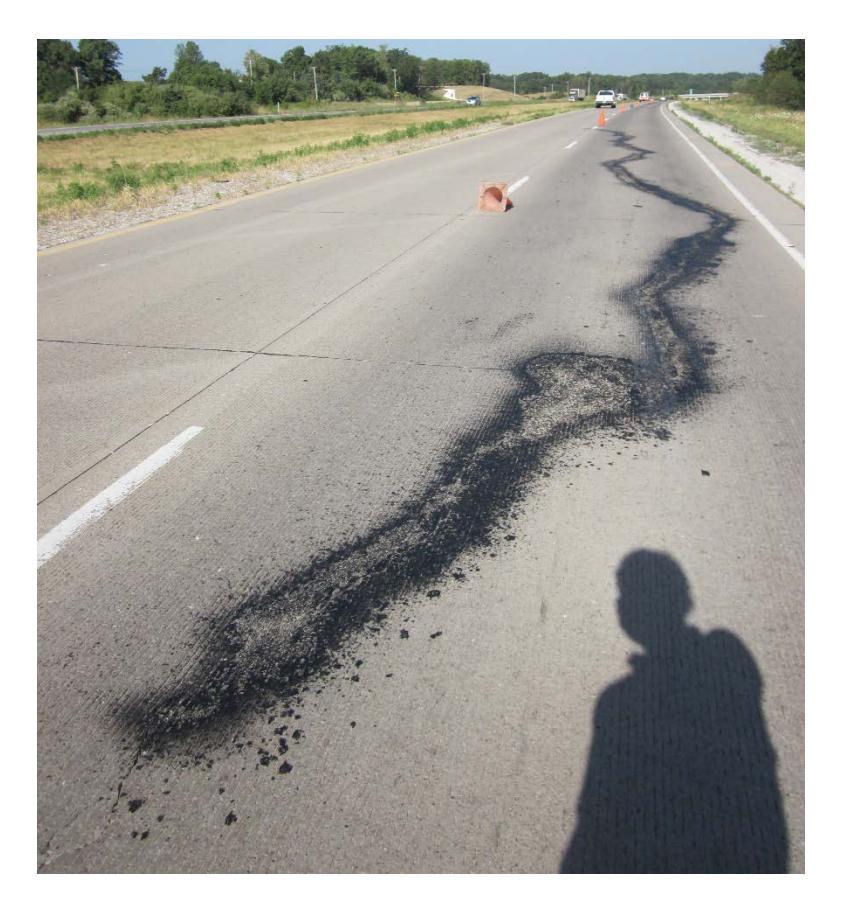
Figure 4. Longitudinal cracking near Sta. 350+00 (7/27/12)

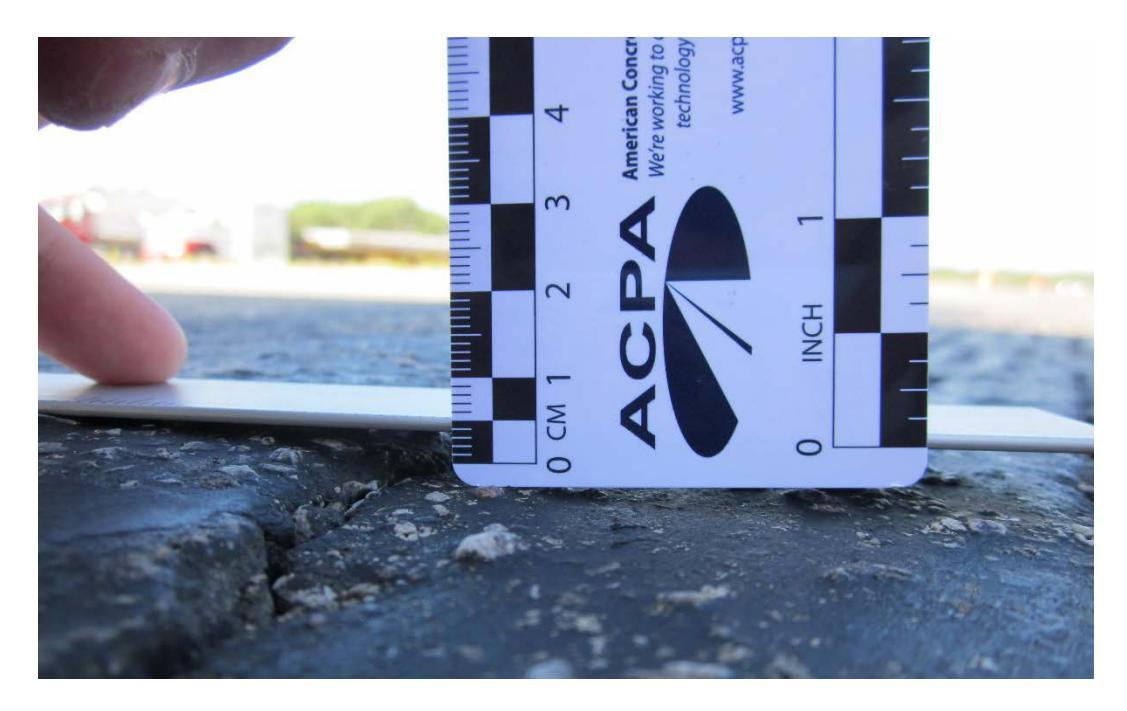
Figure 5. Faulting measured along longitudinal crack near Sta. 350+00 (7/27/12)

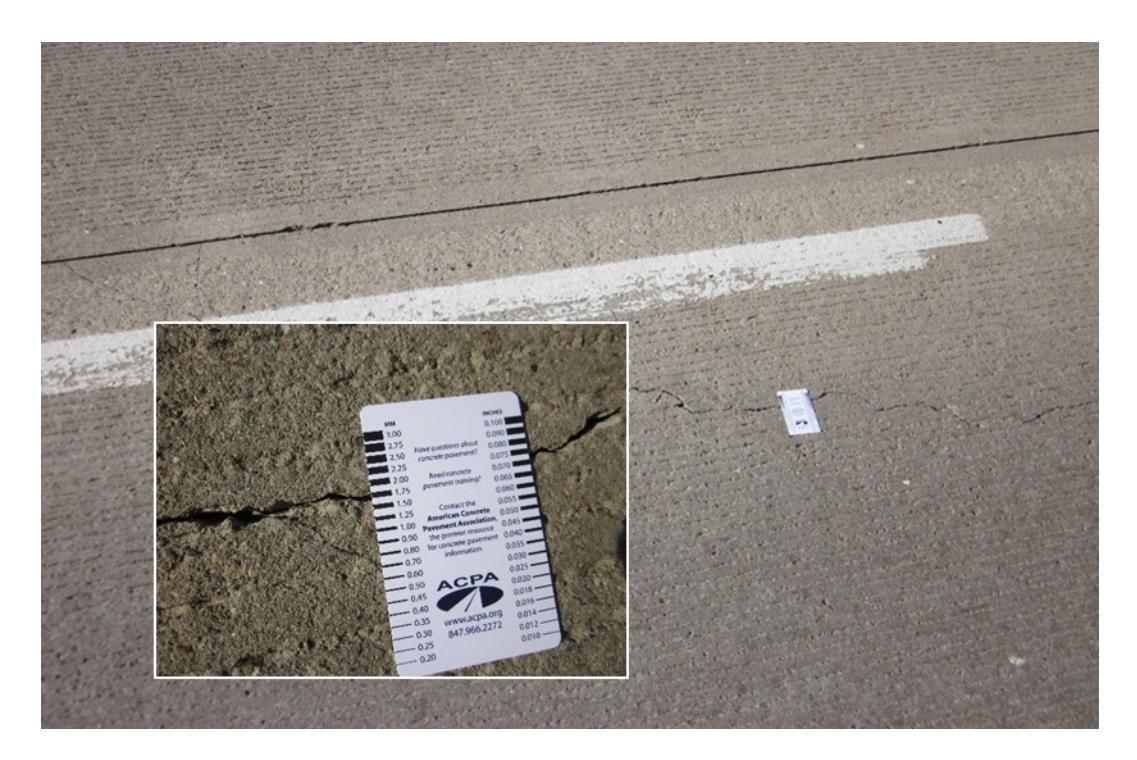
Figure 6. Corner cracking observed near Sta. 350+25 (7/27/12)

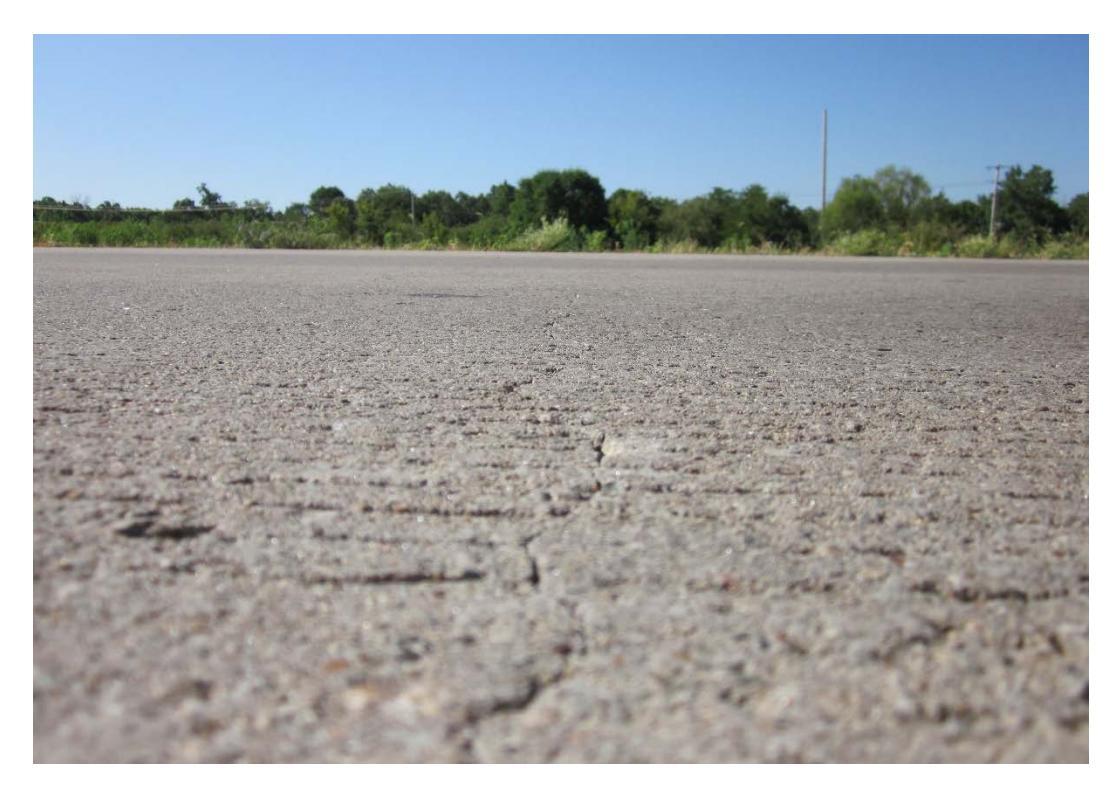
Figure 7. Mid panel cracking observed near Sta. 349 (7/27/12)

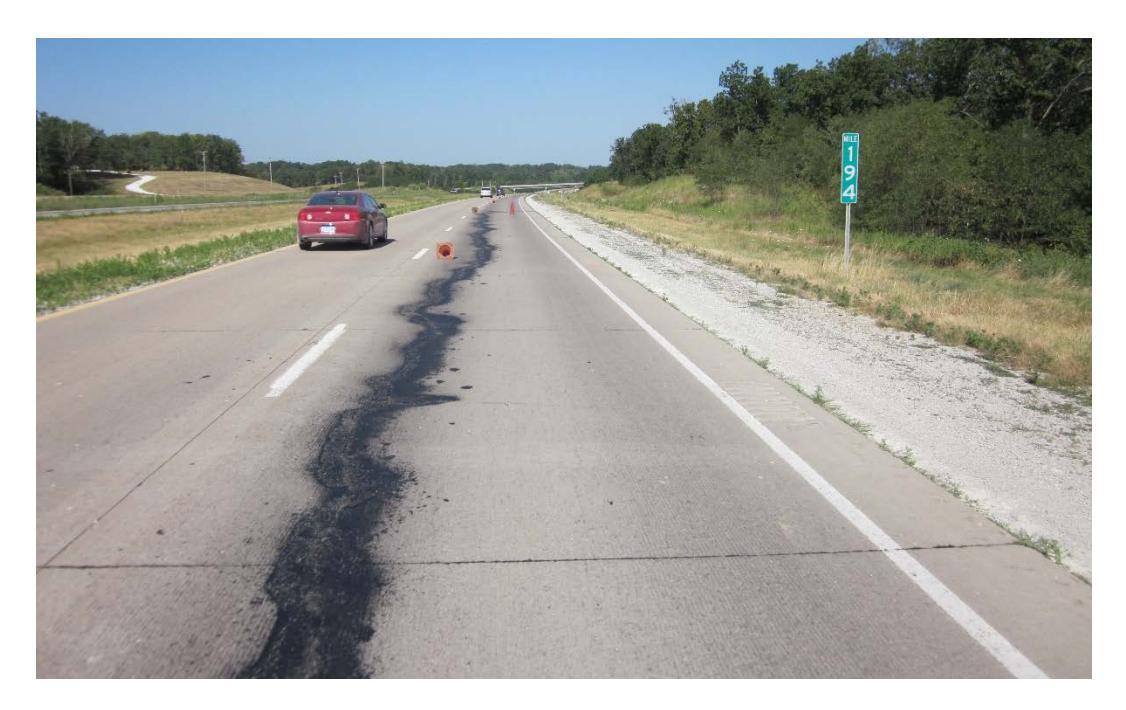
Figure 8. Longitudinal cracking near Sta. 348+50 near mile post 194 (7/27/12)

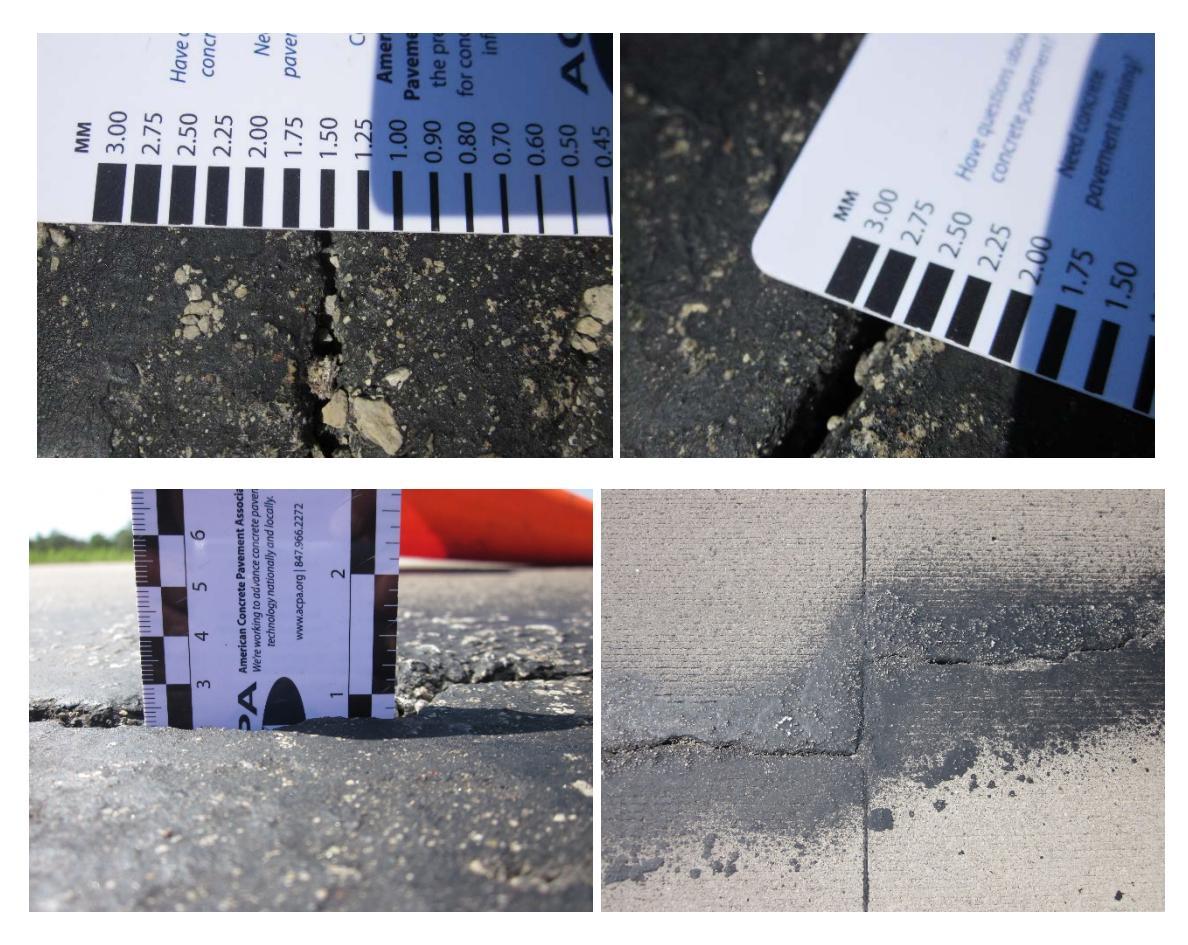
Figure 9. Close-up views of the cracks near mile post 194 (7/27/12)

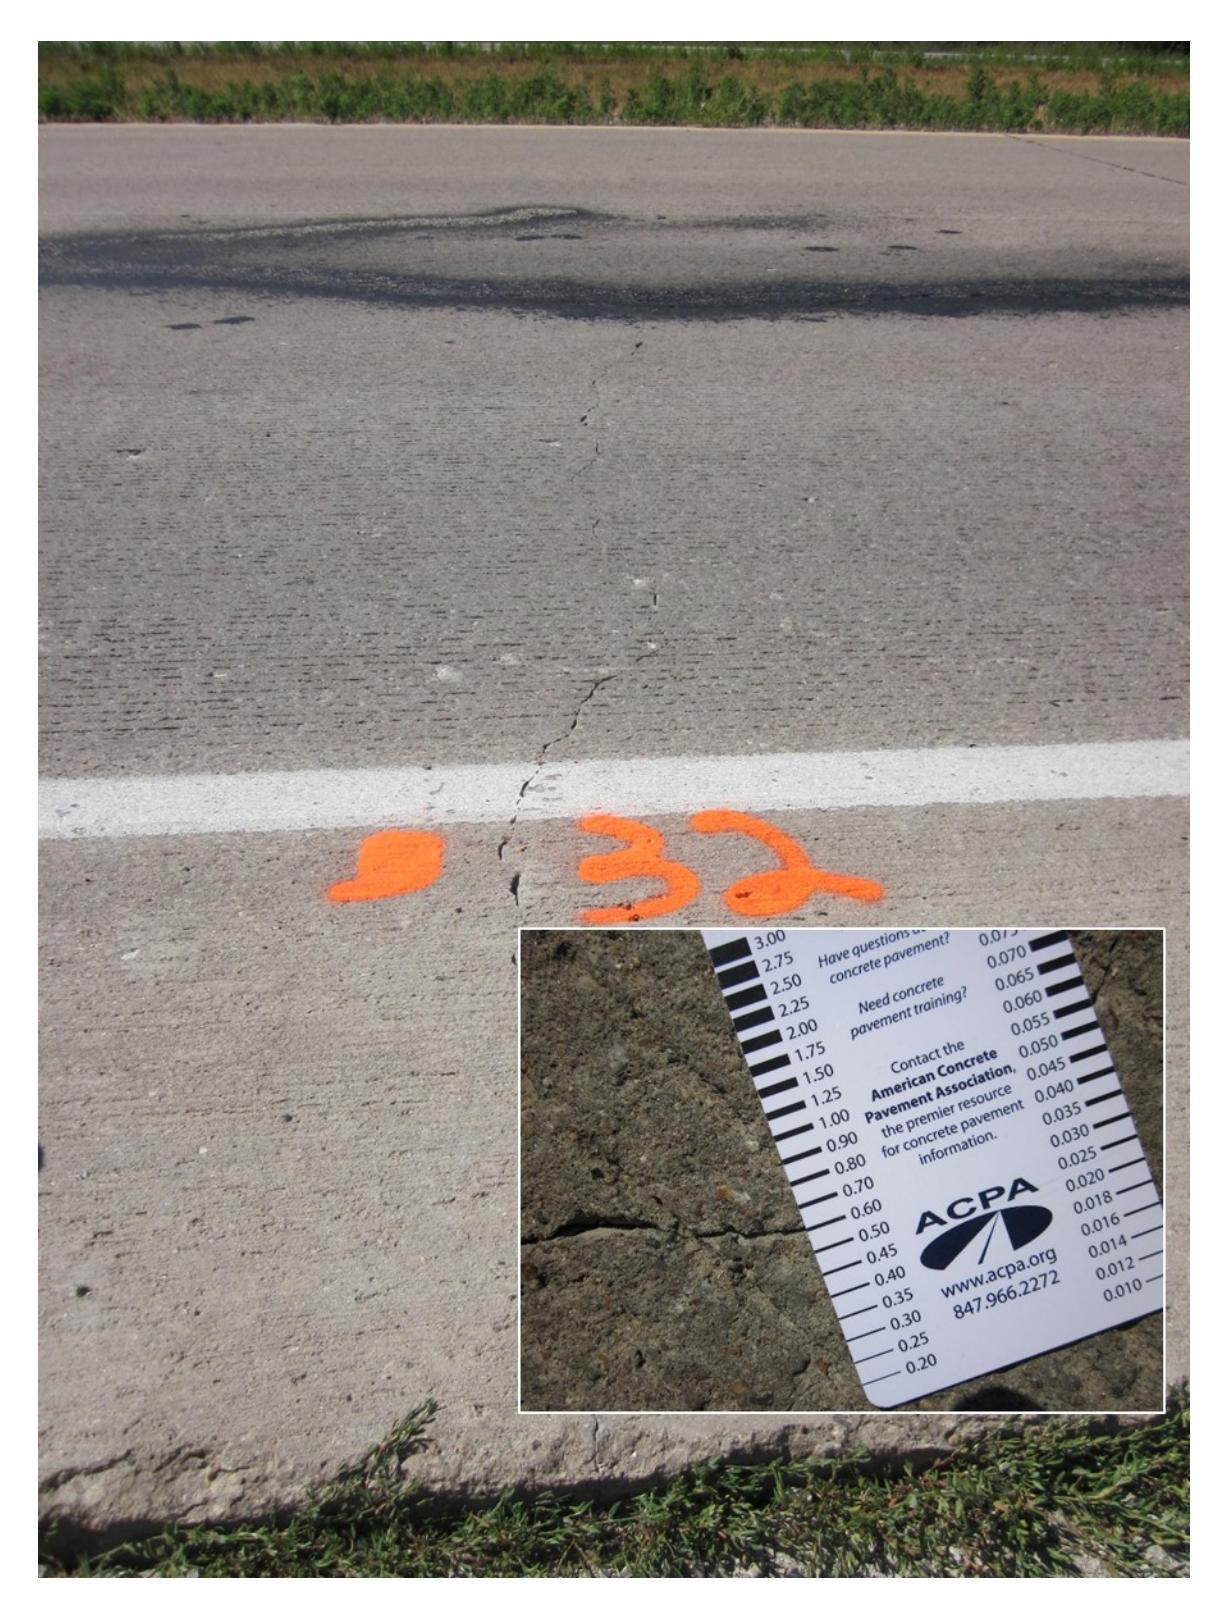
Figure 10. Midpanel cracking near on panel 32 near mile post 194 (7/27/12)

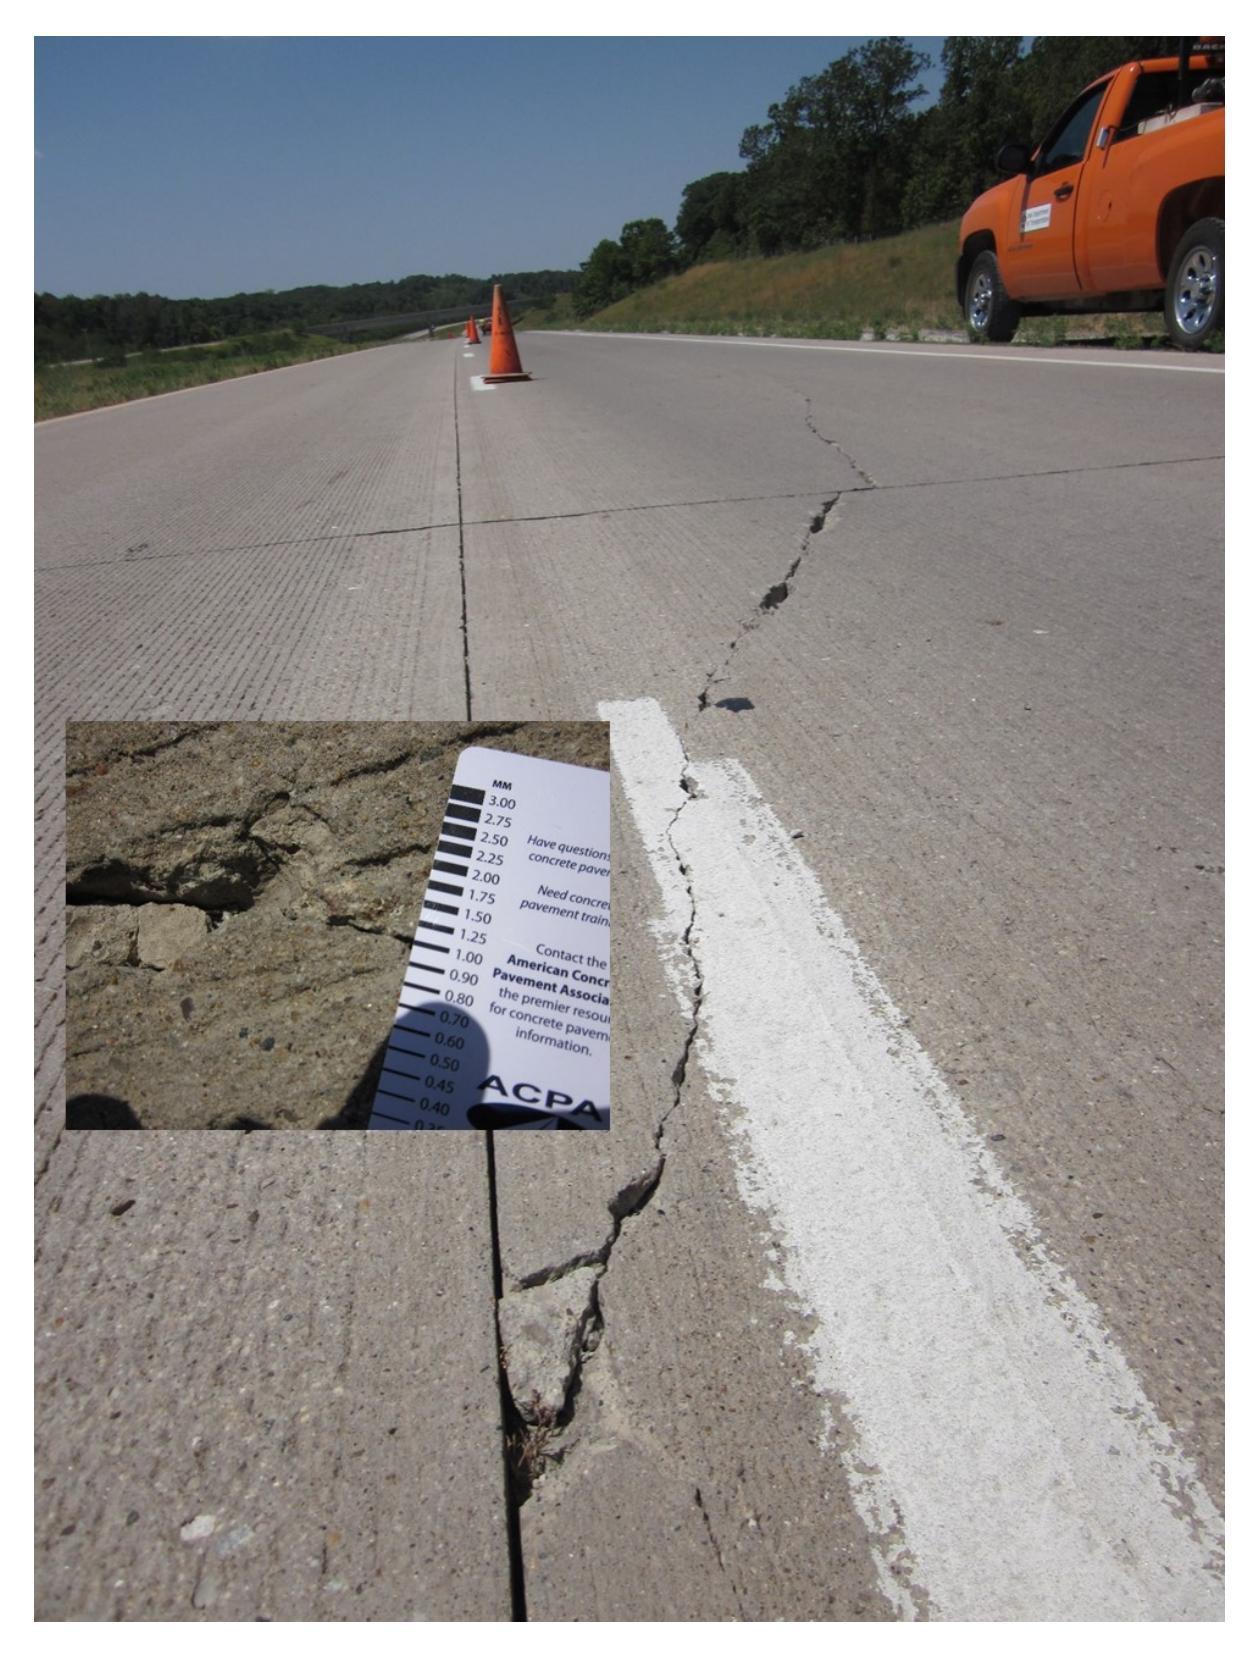
Figure 11. Corner cracking on panel 84 (7/27/12)

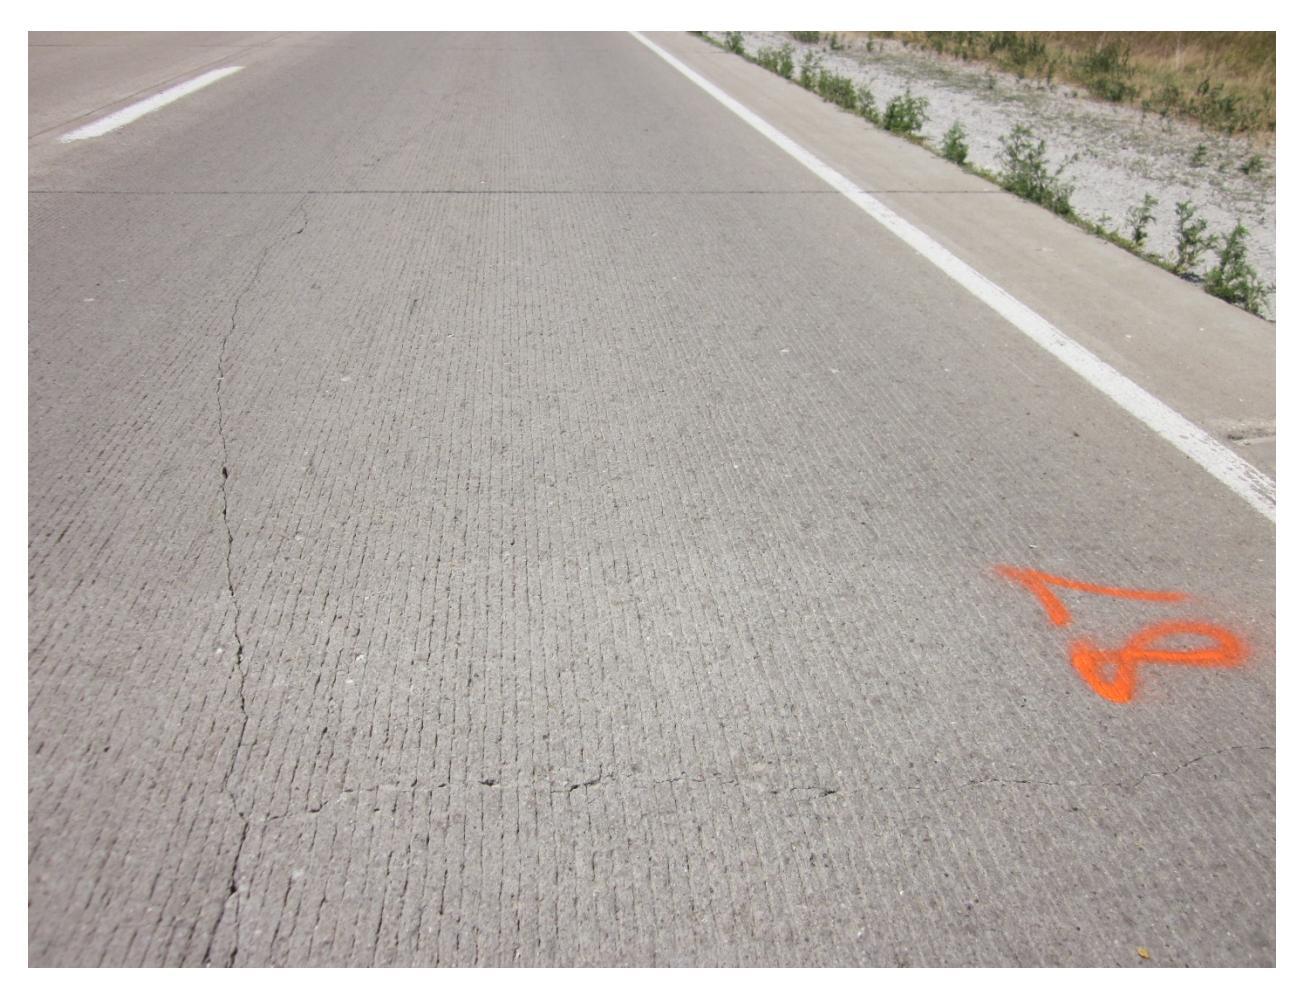
Figure 12. Longitudinal and mid-panel cracking on panel 87 (7/27/12)

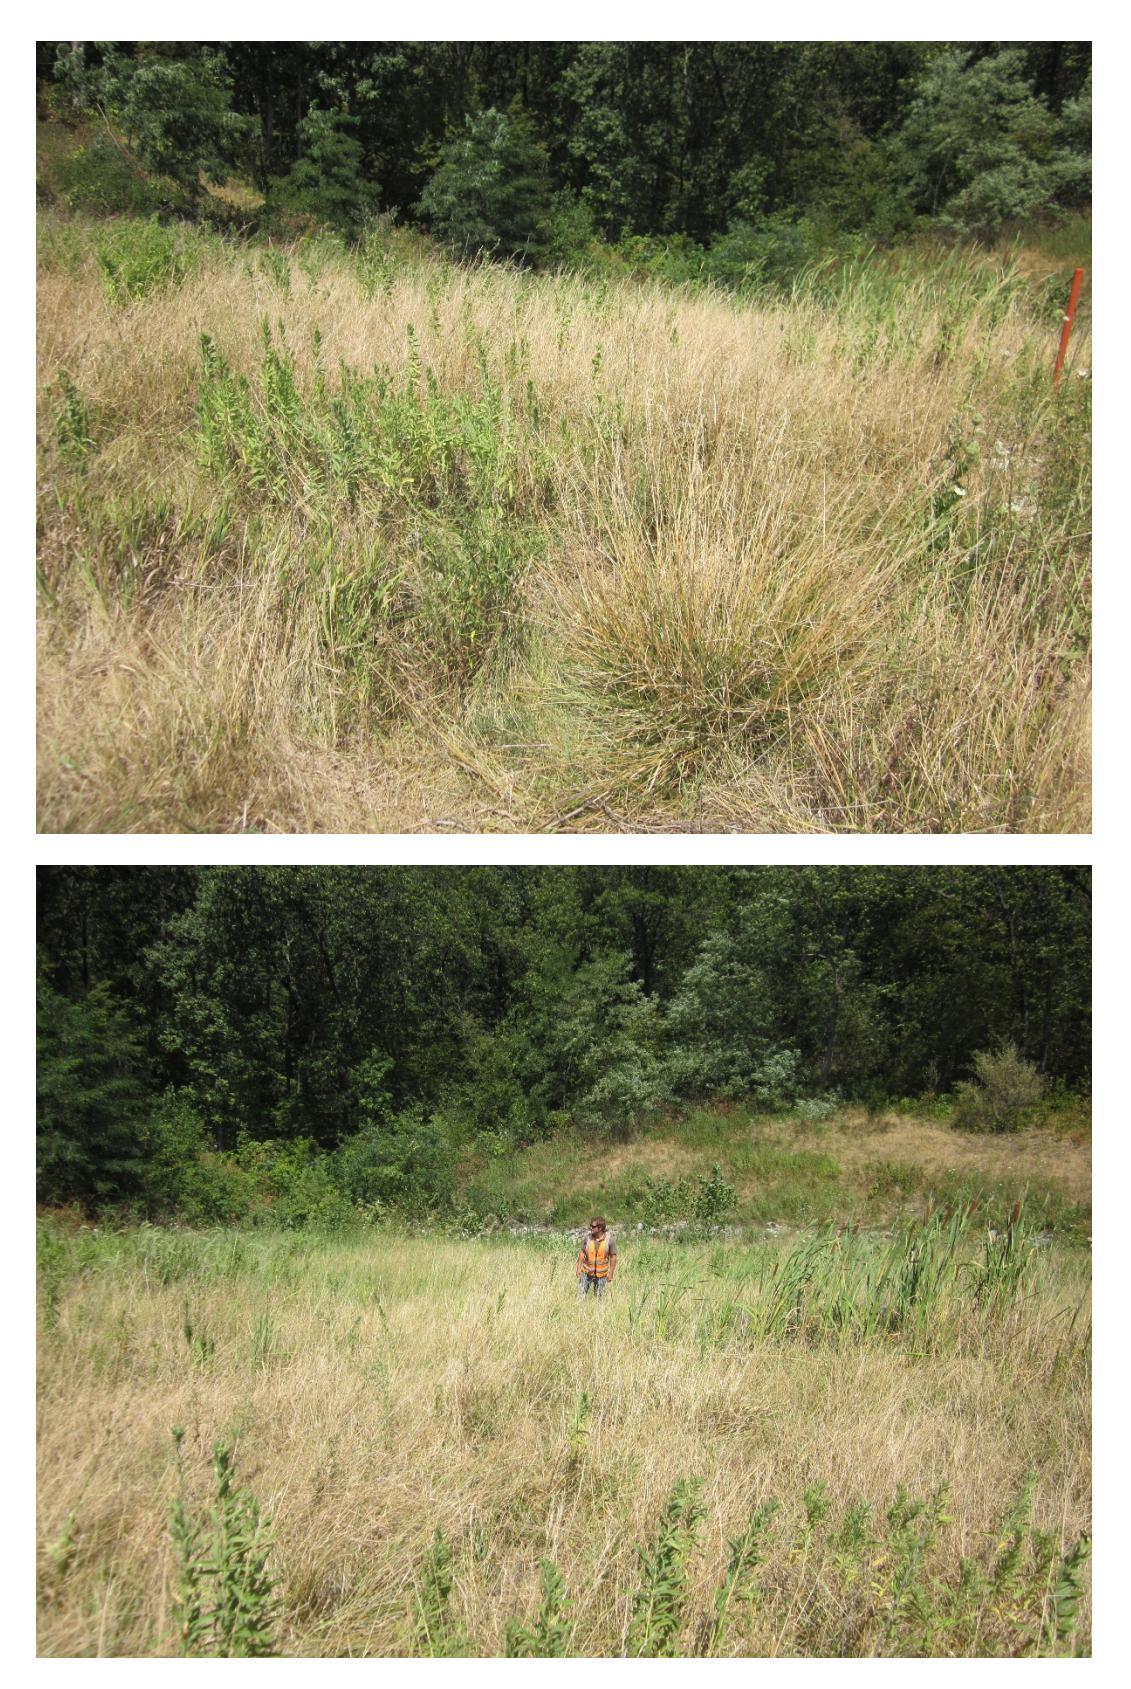
Figure 13 and Figure 14 show pictures of embankment slope on the north side of US34 near Sta. 347+00 that was built up with about 10 m thick embankment fill material. Tension cracks were observed on the slope as shown in Figure 14, which suggests the possibility of slope movements.

Figure 13. Looking down the creek valley near Sta. 347+00 (7/27/12).

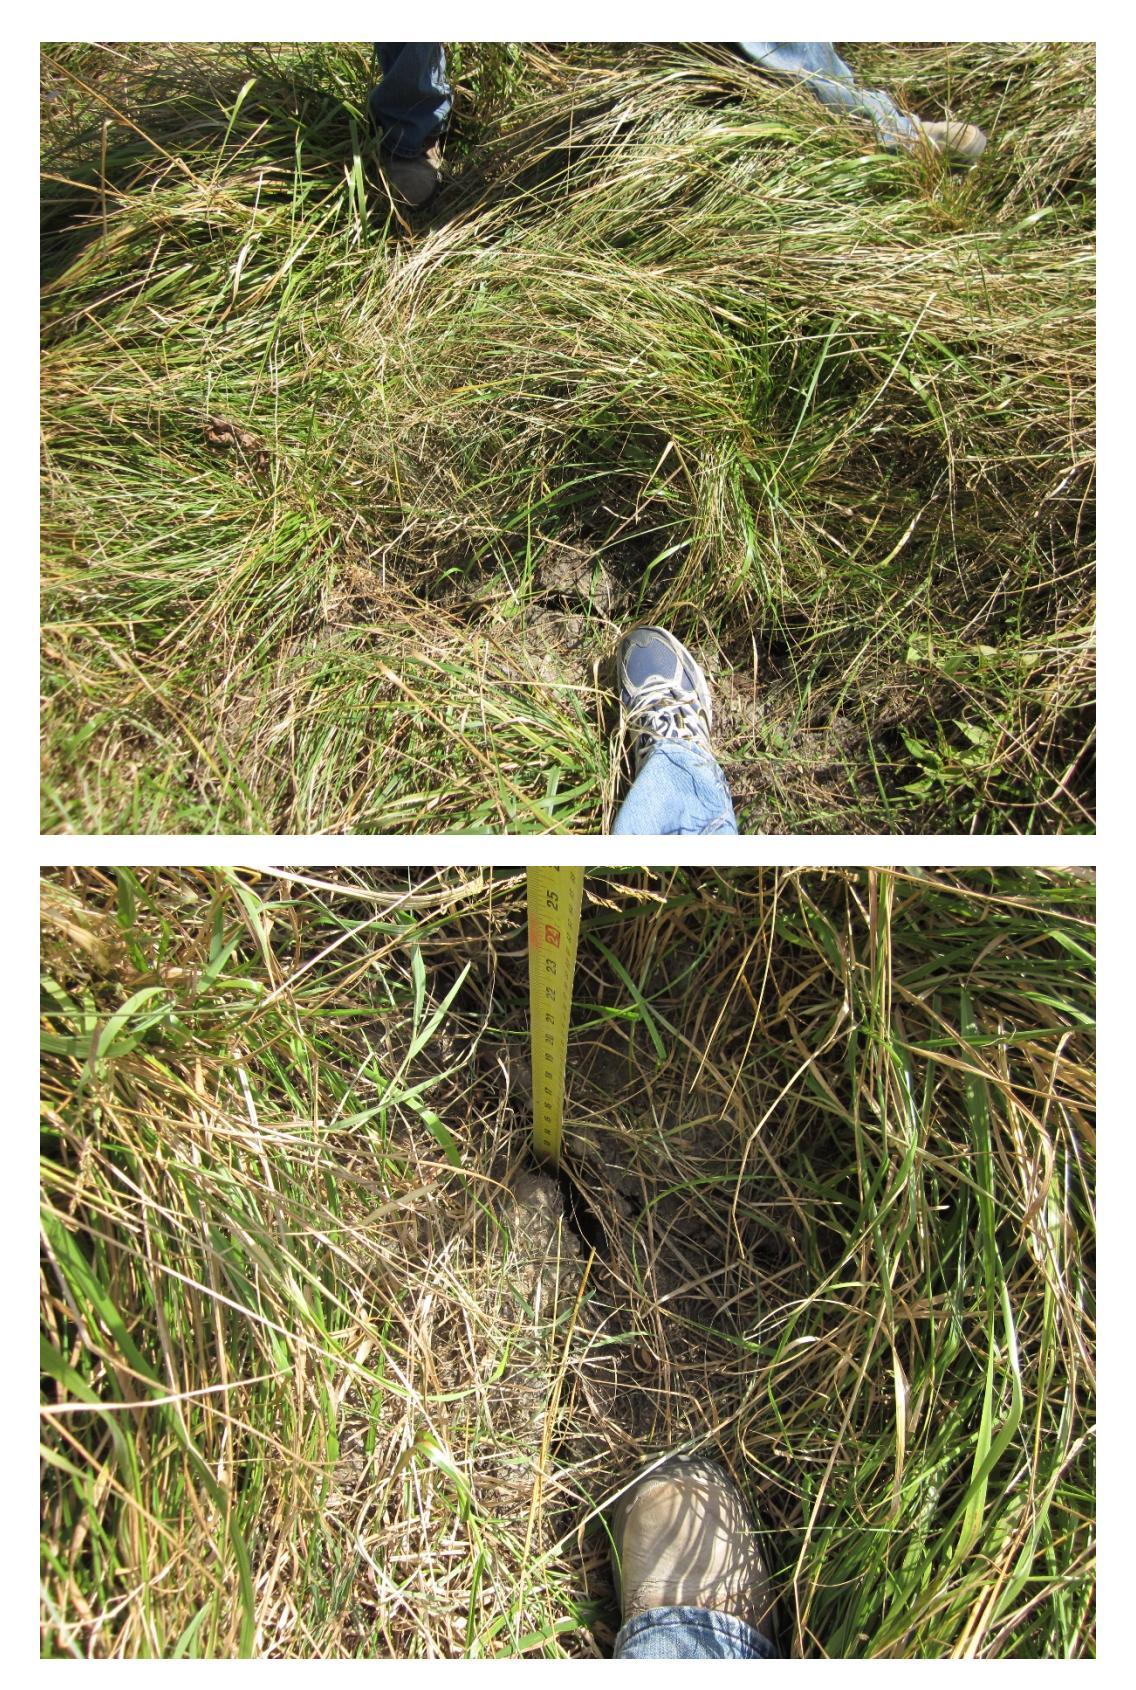
Figure 14. Cracks observed on embankment fill slope near Sta. 347+00 (7/27/12)
