Improving the Foundation Layers for Concrete Pavements

Field Evaluation of Premature Pavement Joint Deterioration – Iowa Urbandale Drive Field Study

December 2015

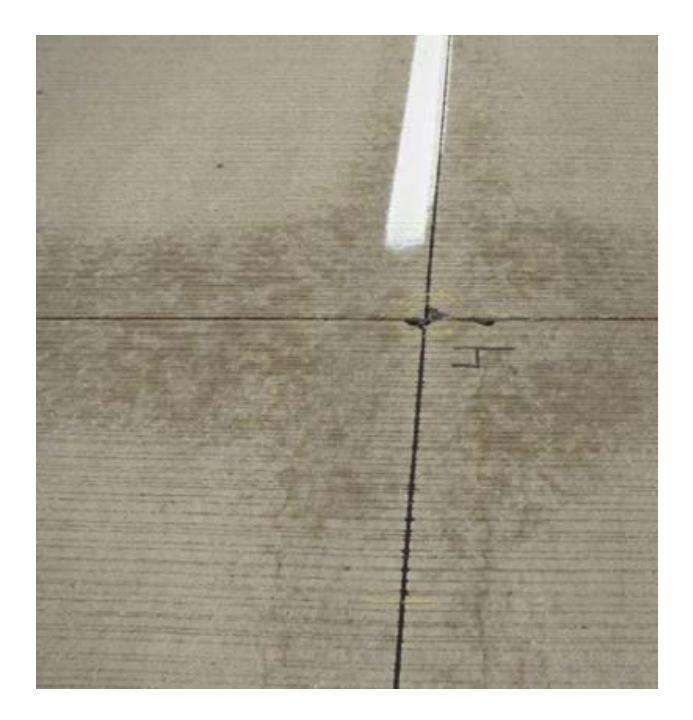
Figure 1. Shadowing microcracking near joints (Taylor 2011)

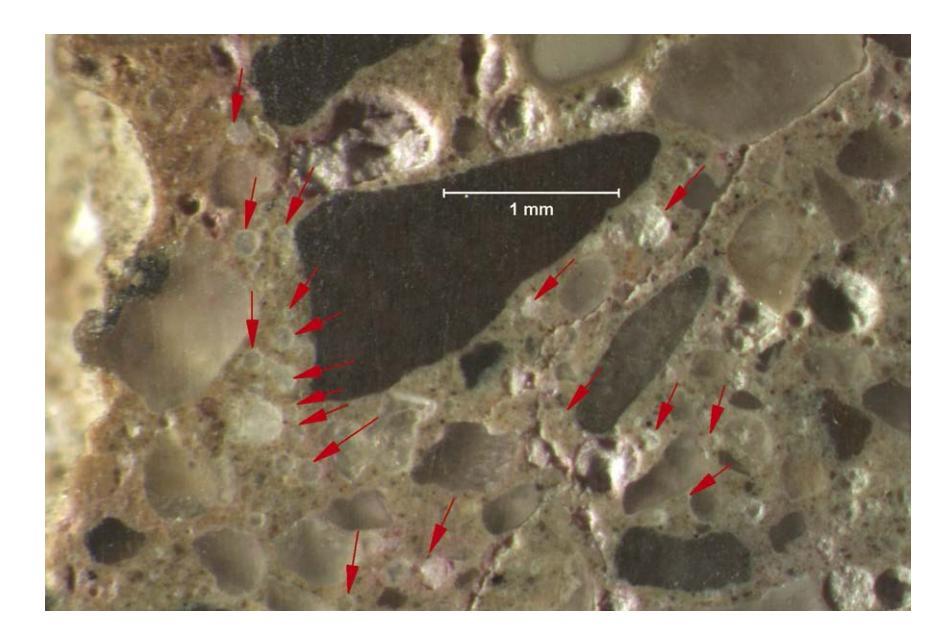
Figure 2. Petrographic examination of core sample taken from distressed joint with voids filled with ettringite at locations pointed with red arrows (Taylor et al. 2012)

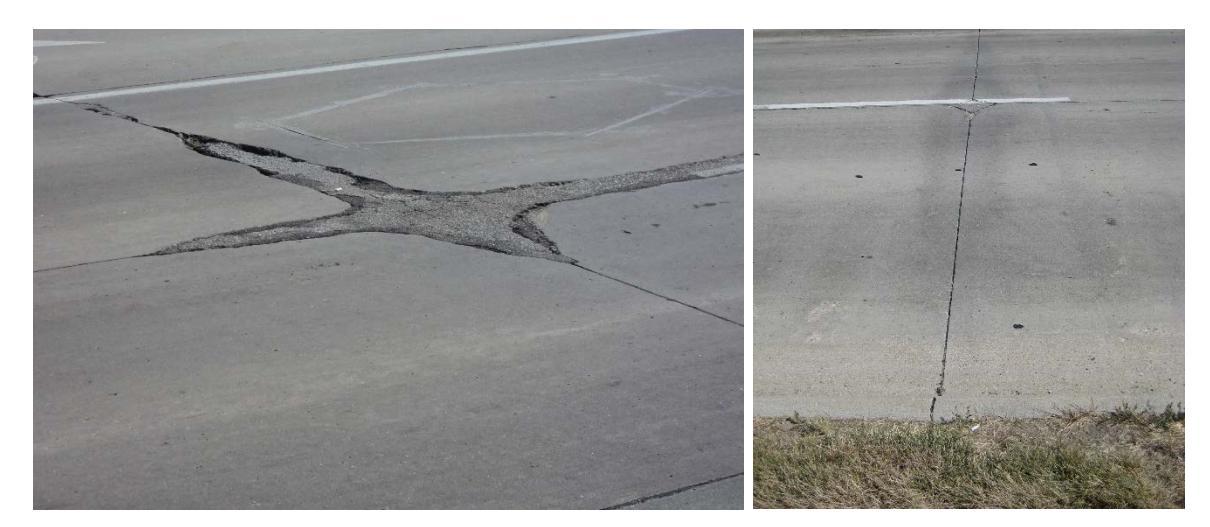
The pavement section experienced significant transverse joint failures along the corridor, specifically in the SB lanes from the interstate to the Meredith Drive intersection (Figure 4). Some longitudinal joint failures were also present. The City of Urbandale had attempted remedial patching since 2010.

Figure 4. Photos of joint deterioration observed on NW Urbandale Drive in July-August 2013 (pictures courtesy of Gary Reed, P.E. from CDA)

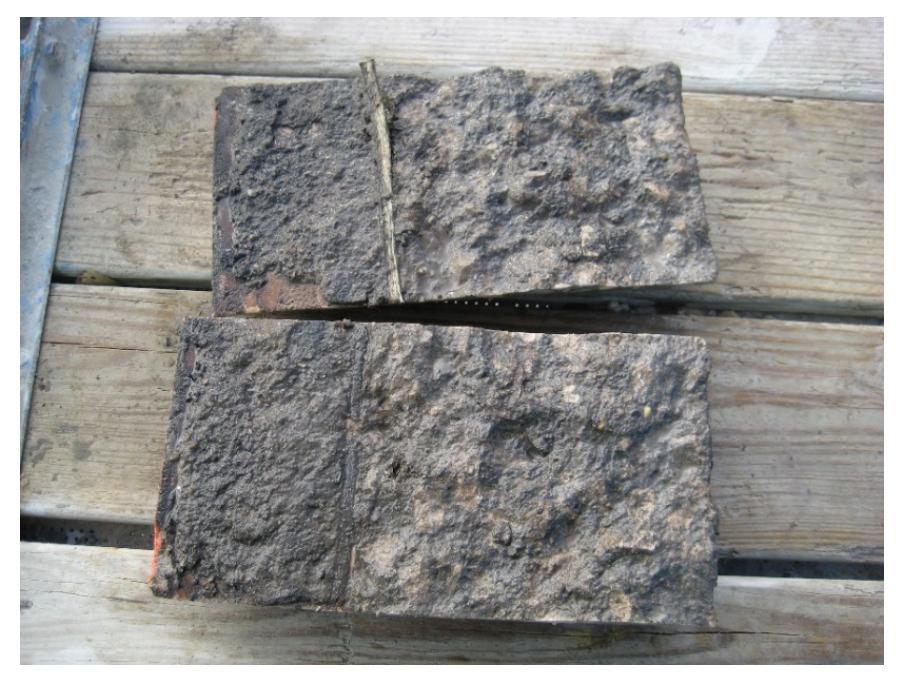
Figure 13. Core 4 on NB lane south of Plum Drive (TS2)

Core		
TS	Number	Location	Observations
	# 4	At joint	No damage was noticed at top or bottom of the core. Seal appeared to be missing, with backer rod at the bottom of the saw-cut and mud filled the cut (Figure 13).
2	# 5	Away from joint	The core sample was in good condition (Figure 14).

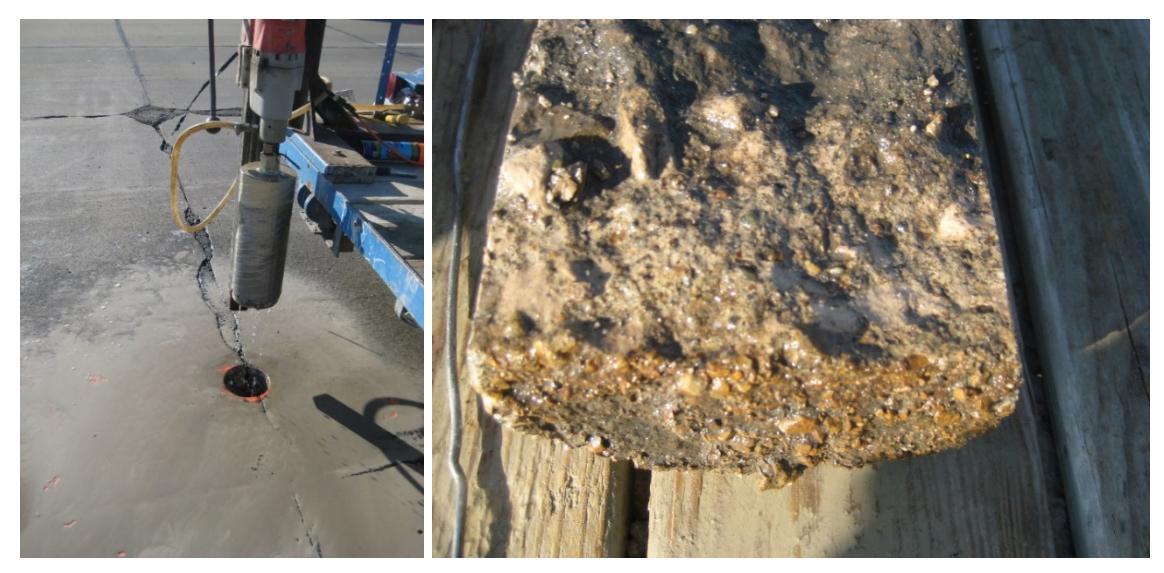
Figure 15. Core 6 on NB Lane south of Plum Drive (TS2)

The distress observed in the cores is consistent with saturated freeze-thaw damage caused by undrained trapped water at the joints (in the void below backer rod) and freeze-thaw cycles.

# 6	At joint	The joint was severely damaged at the surface. Visual observations indicated some distress at the bottom of the core, along with a piece of steel (Figure 15). Backer rod was located at the bottom of the saw-cut.
3	#7	At joint	The joint was severely damaged at the surface. Some damage was observed below the saw cut (Figure 16). No damage was observed at the bottom of the core.

Locations where the damage in distressed joints is confined to the top half of the slab are likely good candidates for partial depth repairs, as described by Frentress and Harrington (2012). Locations with extensive damage will require a full depth repair. In the case of a full depth repair, the following alternative solutions are suggested:
