EL11-2017 Implementation Assistance Program

Tools to Improve PCC Pavement Smoothness During Construction (R06E)

FIELD REPORT: IOWA US 20 EQUIPMENT LOAN

The equipment loan was performed in May of 2017 on a project in Woodbury and Ida Counties, Iowa. Table 1 summarizes the pertinent project details.

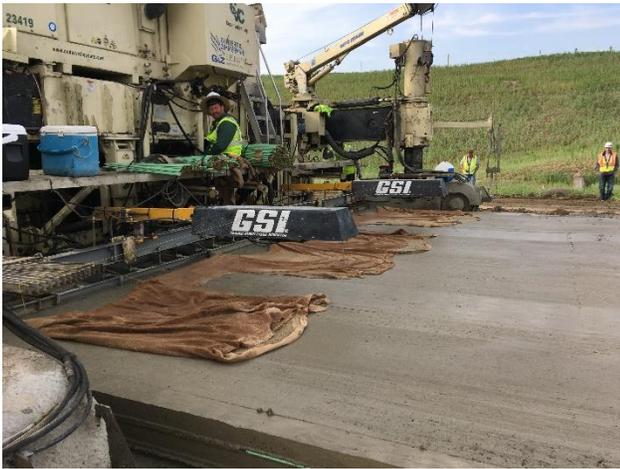
Figure 1. GSI Installed Directly at the Rear of the Paver

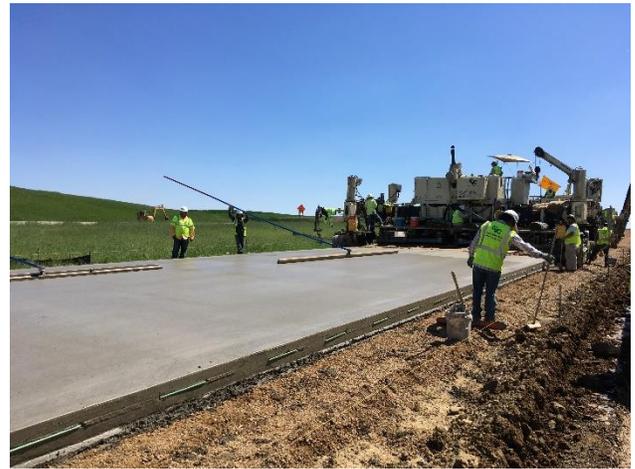
Figure 2. Typical Hand Finishing With a Straightedge and Channel Mop

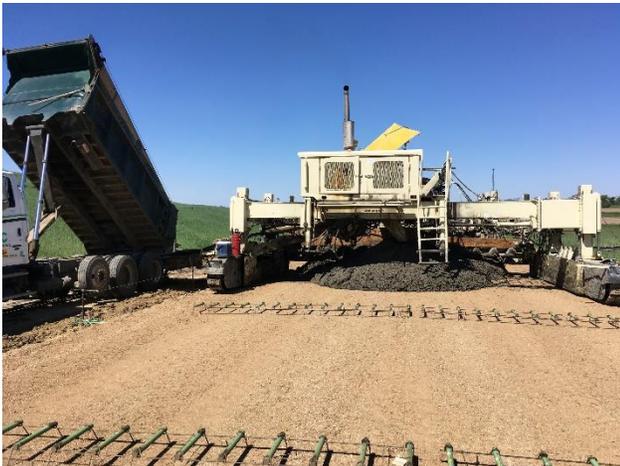
Figure 3. Belt Placer/Spreader Ahead of the Paver

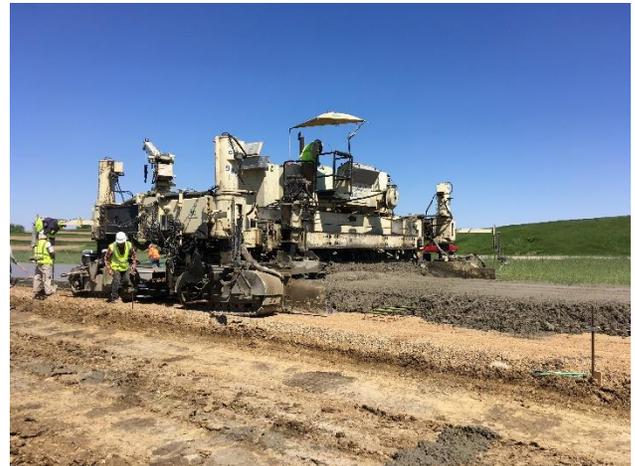
Figure 4. Concrete Spread Ahead of the Paver

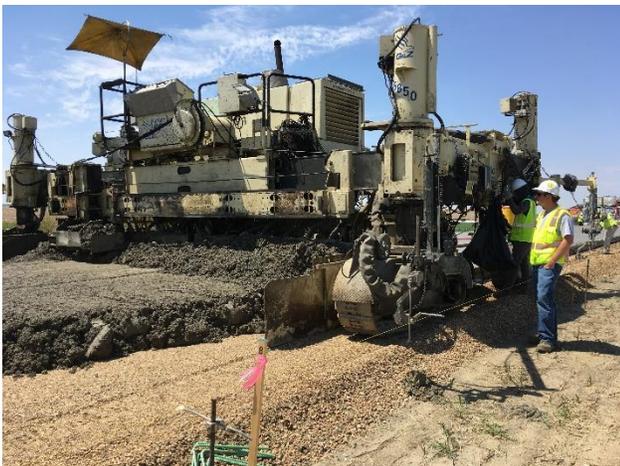
Figure 5. Stable and Trimmed Paver Track Line
