Methods to Reduce Traffic Speed in High Pedestrian Areas

Final Report

*Center for Transportation
Research and Education*

March 2002

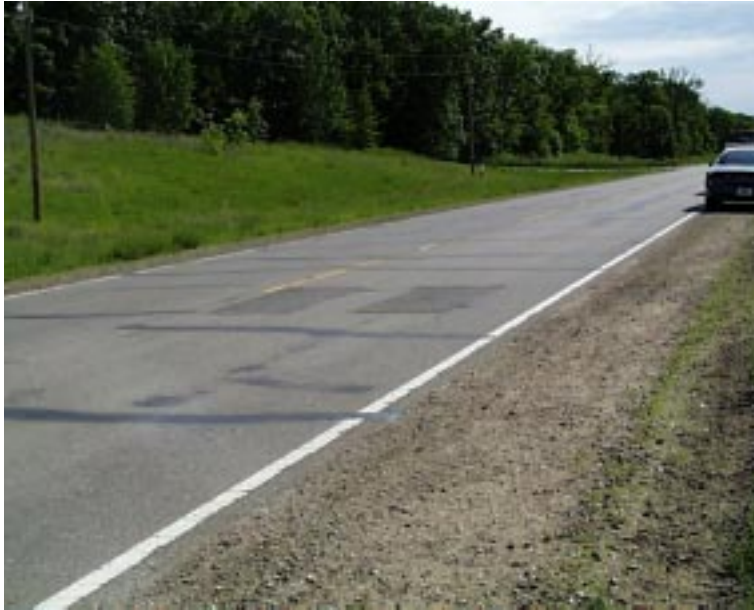
A set of nine grooved rumble strips was placed perpendicular to the path of vehicles' wheels on the highway before the 40 mph speed zone (see Figure 3.1). The purpose of rumble strips is to alert motorists of an upcoming speed reduction zone by producing an audible and tactile stimulus when they are driven over.

Figure 3.1 Rumble Strips—Twin Lakes

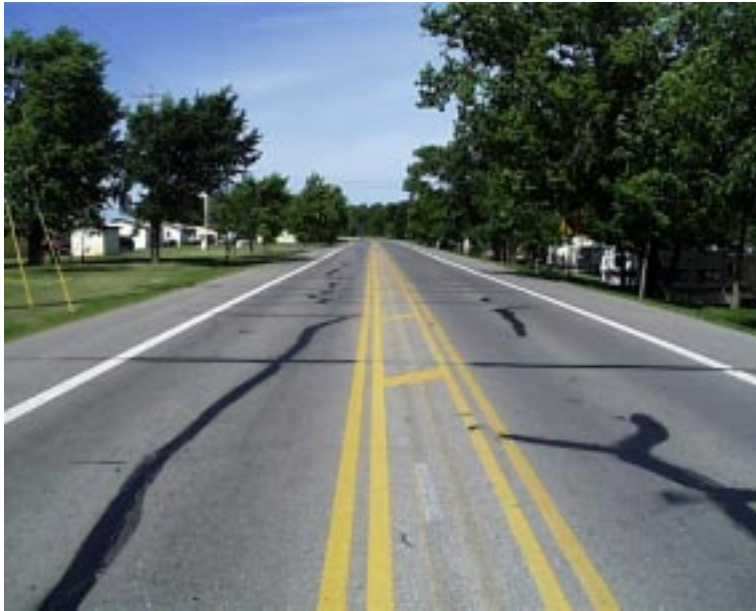
The median was also crosshatched with varying widths and frequencies of striping (see Figure 3.2). The median is four feet in width and contains a 500-foot taper from one foot to four feet in width. The distances between the stripes decrease from 33 to 20 feet within the 500-foot taper. Transverse stripes are used to affect drivers' perceptions of their speeds. The gradually decreasing distances between the stripes create an illusion that drivers are speeding, resulting in speed reductions.

Figure 3.2 Centerline Stripes—Twin Lakes

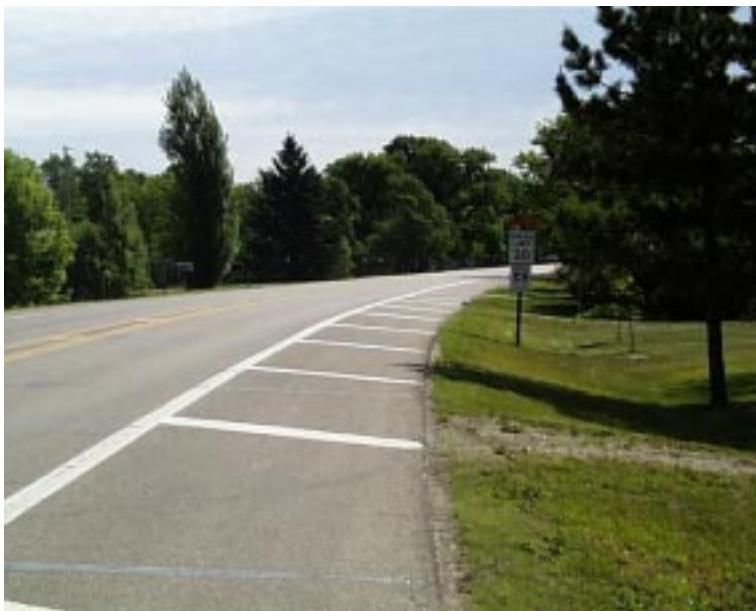
Another speed reduction remedy, implemented at the site in 1997, was reducing the lane width to 11 feet through pavement markings and transverse stripes on the eight foot shoulders (see Figure 3.3). In general, narrower lanes demand more attention, influencing drivers to reduce their speeds.

Figure 3.3 Shoulder Stripes—Twin Lakes

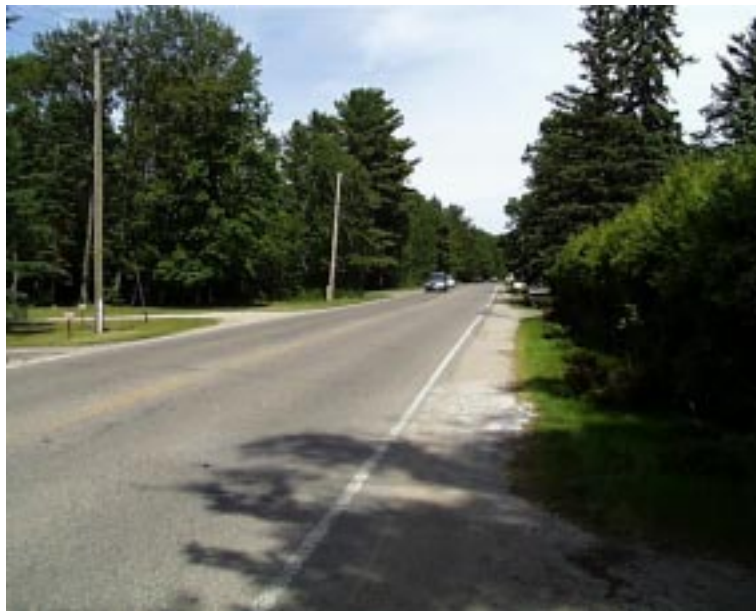
Figure 3.4 Unpaved Shoulders—Bemidji

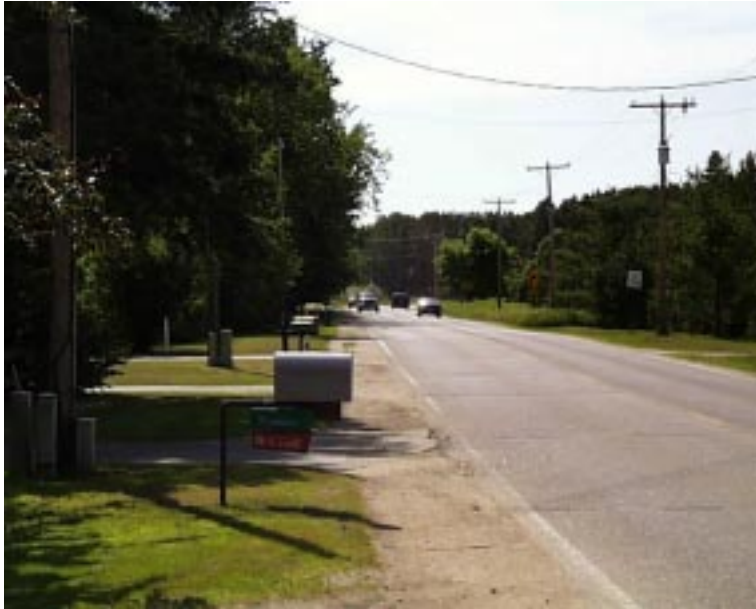
Figure 3.5 Narrow Shoulders—Bemidji

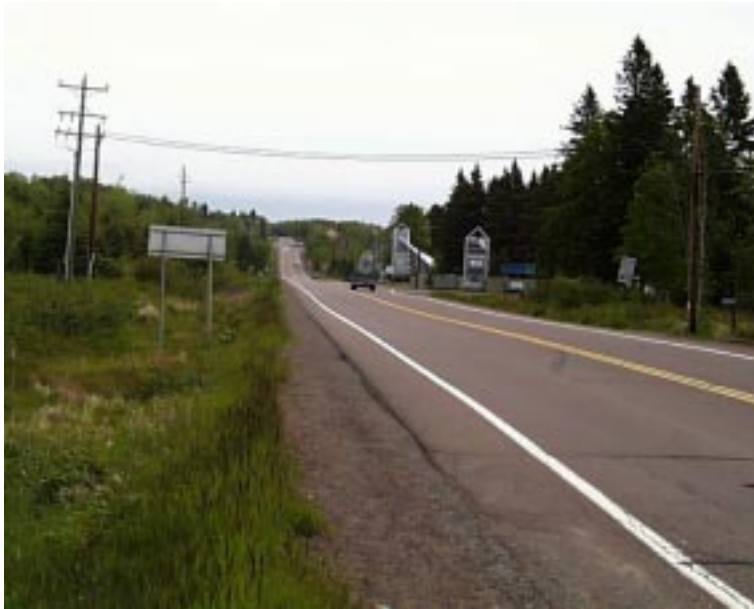
Figure 3.6 Tofte, US 61

On June 14, 2000, the research team met with Rod Garver of the Minnesota Department of Transportation (Mn/DOT) in Duluth. They then visited the cities of Tofte and Schroeder. Tofte is about 80 miles north of Duluth on US 61 (see Figure 3.6). The proposed HFRL traffic calming strategies (i.e., colored pavement, landscape treatments, and lighting poles) were scheduled to be implemented in the summer of 2001 in Tofte.

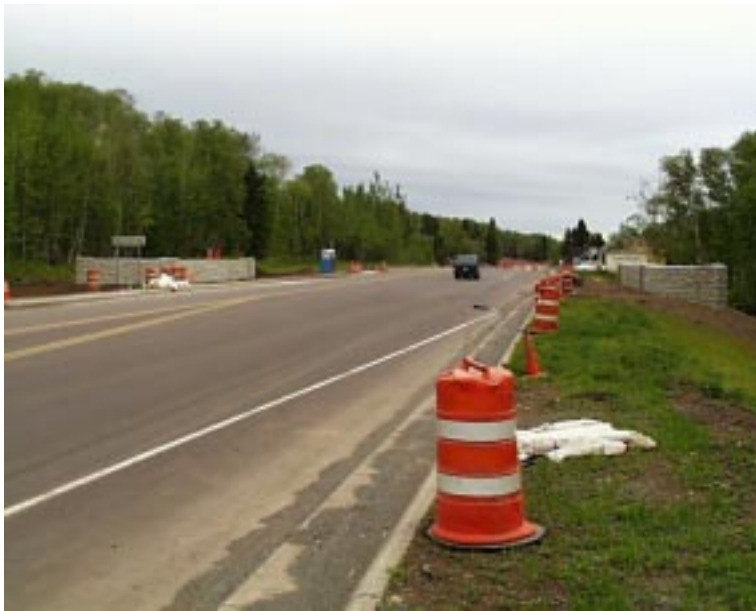
On the day of our visit, the US 61 highway at Schroeder was under construction. The shoulders and median were to be paved with colored bituminous pavement (i.e., the light colored pavement evaluated by the HFRL simulator on Tofte). Entrance gates and roadside walls (see Figures 3.7 and 3.8) were also being added to urbanize the city environment.

Figure 3.7 Entrance Gate, Schroeder, US 61

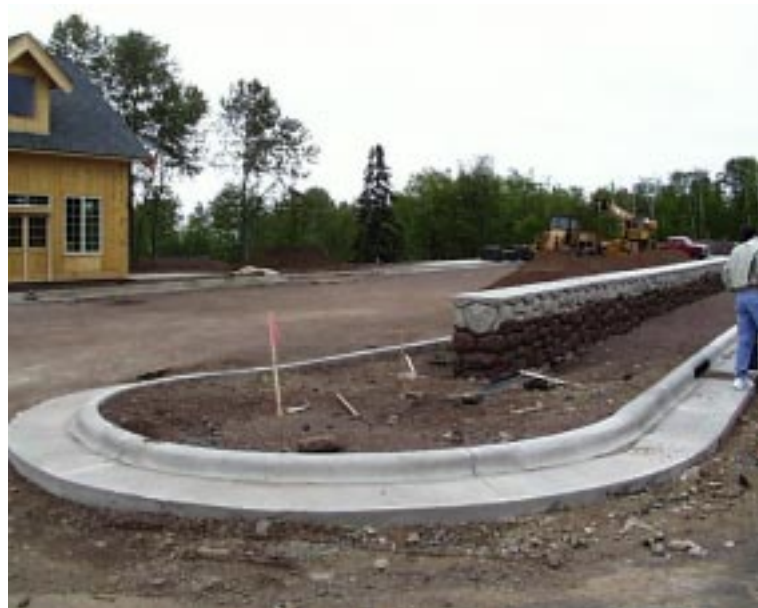
Figure 3.8 Side Walls, Schroeder, US 61

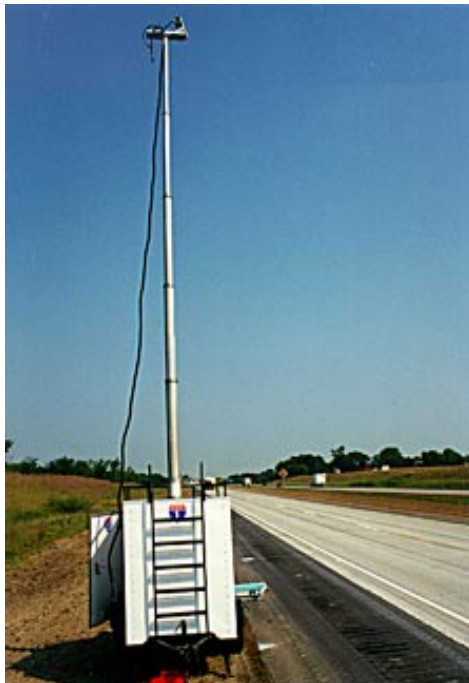
Figure 4.1 Traffic Data Collection Trailer

Traffic data were collected using two traffic data collection trailers. The trailer, shown in Figure 4.1, includes a pneumatic mast to hoist two video cameras 30 feet above the pavement's surface in order to videotape traffic operations. Videos were later reduced into traffic flow performance data through the use of image processing technology.

Traffic flow performance data (vehicle speed, headways, volume, etc.) were recorded before and after a speed reduction technique was in place. Using the Autoscope image processing technology, the recorded videotapes were analyzed to determine the vehicle types (i.e., passenger cars and nonpassenger cars), arrival times, and speeds of approaching vehicles.

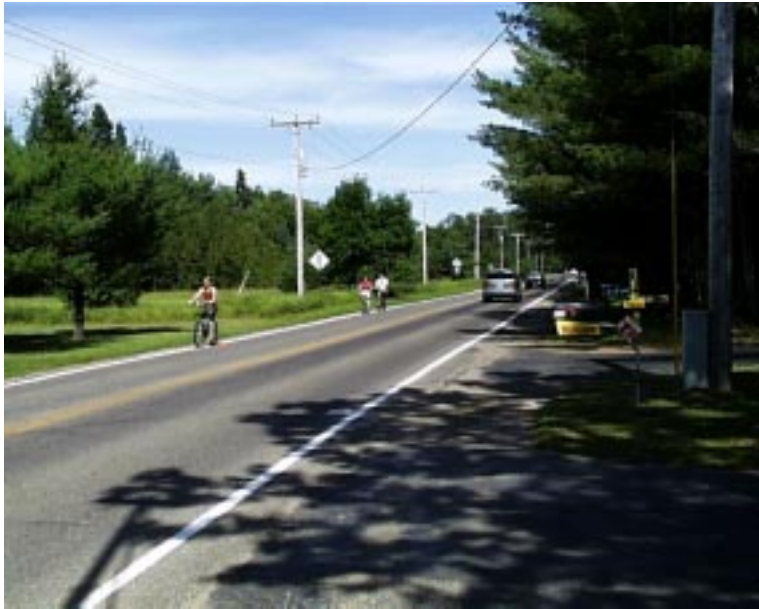
Figure 4.8 Bicyclists—Bemidji Lake

Lack of bike paths and paved shoulders on CSAH 20 at this site forces bicyclists to use the roadway (see Figure 4.8). The observed high number of trucks has created an unsafe situation for the bicyclists on CSAH 20 at this site (see Figure 4.9).

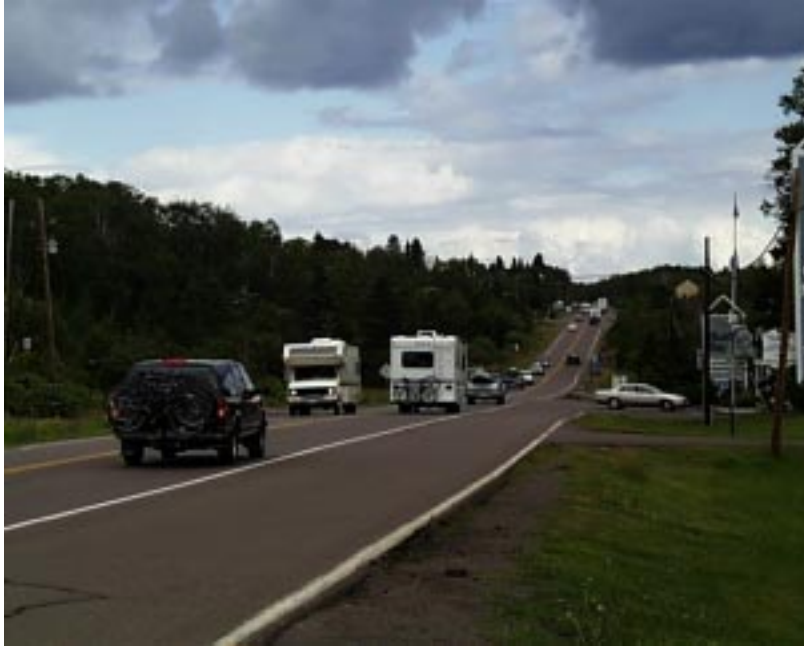
Figure 4.11 Observed Traffic on Sunday Morning of August 6, 2000—Tofte

The US 61 through Tofte carries a high traffic volume, especially on Friday through Sunday during the summer (see Figure 4.11). The existence of two paper mills in Thunder Bay, Canada, has drawn a significant truck traffic to the area (see Figure 4.12).

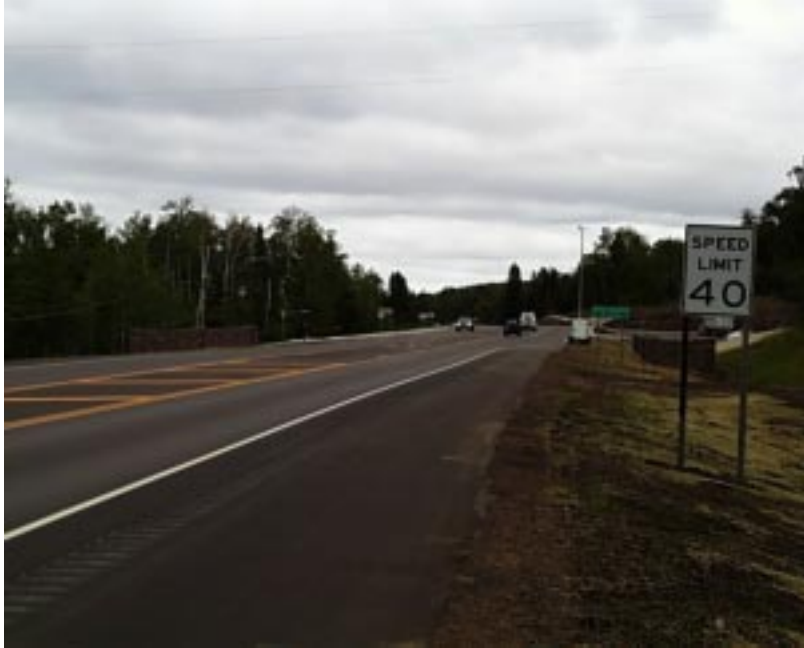
The speed data were collected in the city of Schroeder on Monday August 7, 2000, as well as on Friday and Saturday, August 11–12, 2000 for about eight hours each day. The data collection trailers were placed approximately 350 feet downstream of the posted 40 mph speed limit signs and about 100 feet after the city entrance gates on both north and south directions of US 61 to capture approaching speeds (see Figures 4.13 and 4.14).

Figure 4.14 Trailer’s Position with Respect to the Gates and Speed Limit Sign—Schroeder

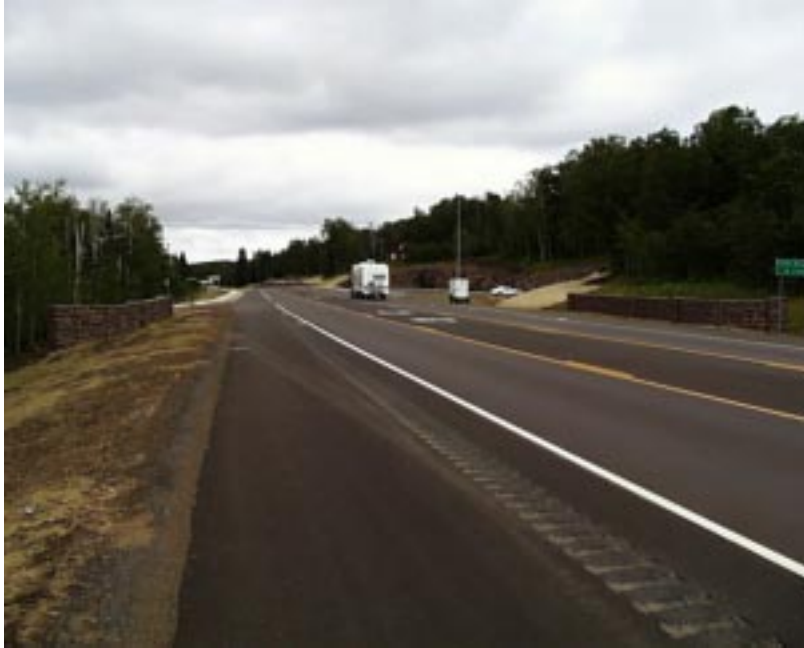
US 61 highway through the city of Schroeder had recently gone under a major construction. The two-lane highway has been widened to include a new two-way left-turn lane (see Figure 4.15). The surface of the two-way left-turn lane and shoulders were to be paved with light-colored bituminous pavement. However, due to a problem in the material mixture, the dark pavement color of the median and shoulders remained unchanged. As shown in the schematic of the site in Figure 4.13, in addition to the raised stone walls at the city entrances and roadsides, two parking lots have been added for trucks and other motorists who stop to rest and/or tour the Cross River and surrounding areas.

Figure 4.15 New Pavement and Added Two-Way Left-Turn Lane—Schroeder

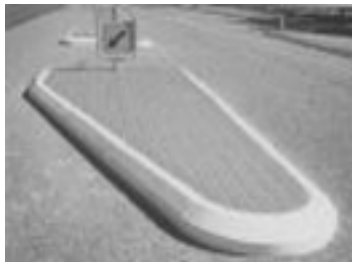
Figure 5.1 Rubber Curbing

The techniques deployed at the Twin Lakes consisted of removable pedestrian islands and pedestrian crossing devices (see Figures 5.1 and 5.2). These were supplied by the RubberTough Industries in Concord, New Hampshire. The combination of islands and signs created an urban effect that helped reduce motorist speed. The curbs and signs were used to concentrate pedestrian street crossings at marked crosswalks.

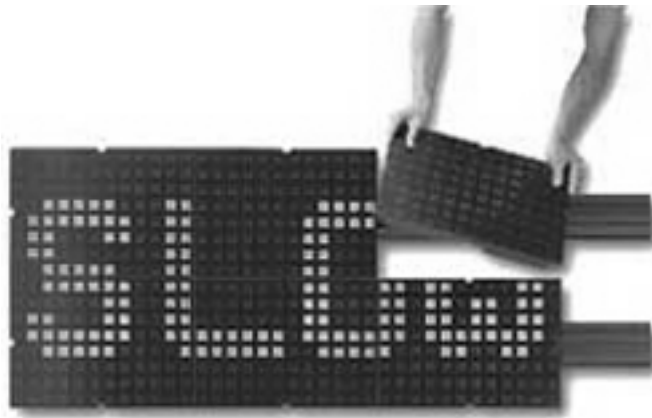
ADDCO, a St. Paul-based manufacturer of the dynamic variable message sign (see Figure 5.4), loaned one to Minnesota DOT for the project free of charge for two months. The Beltrami County highway department provided assistance in installing the sign on a metal frame and running power to the sign. Following installation, as in Twin Lakes, CTRE collected 2–3 days of speed data on two occasions to study the short-term and long-term impacts of the sign.

Figure 5.4 Dynamic Variable Message Sign

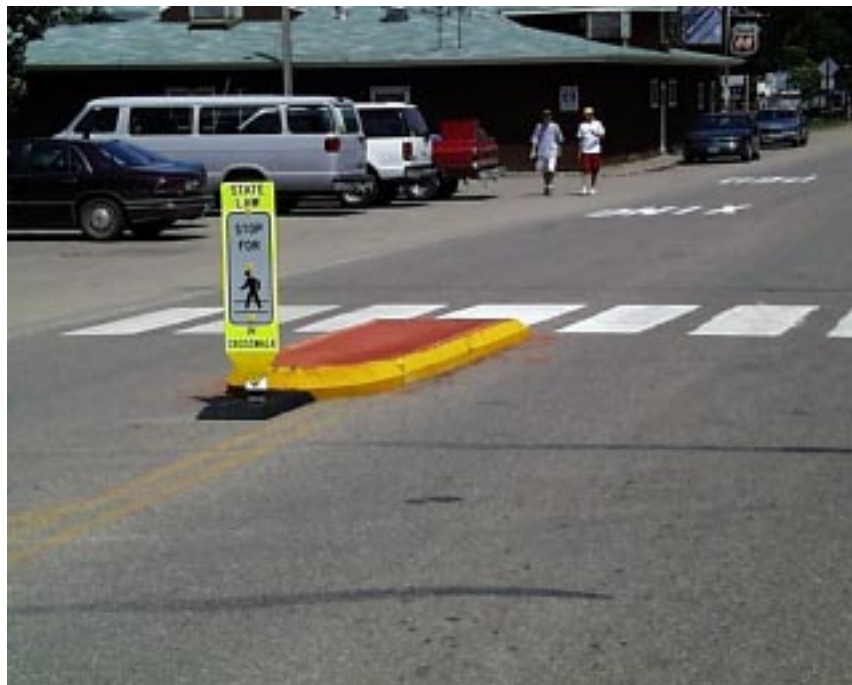
As shown in Figures 6.1 through 6.3, four signs, spaced at 100 feet, were lagged down on the centerline of CSAH 4 on each direction in Twin Lakes. The signs meet the Minnesota state regulations, that is, wording “STATE LAW, STOP FOR PEDESTRIANS IN CROSSWALK.” The islands and signs were used to concentrate pedestrian street crossings at marked crosswalks.

Figure 6.1 Pedestrian Island and Sign—Mahnomen

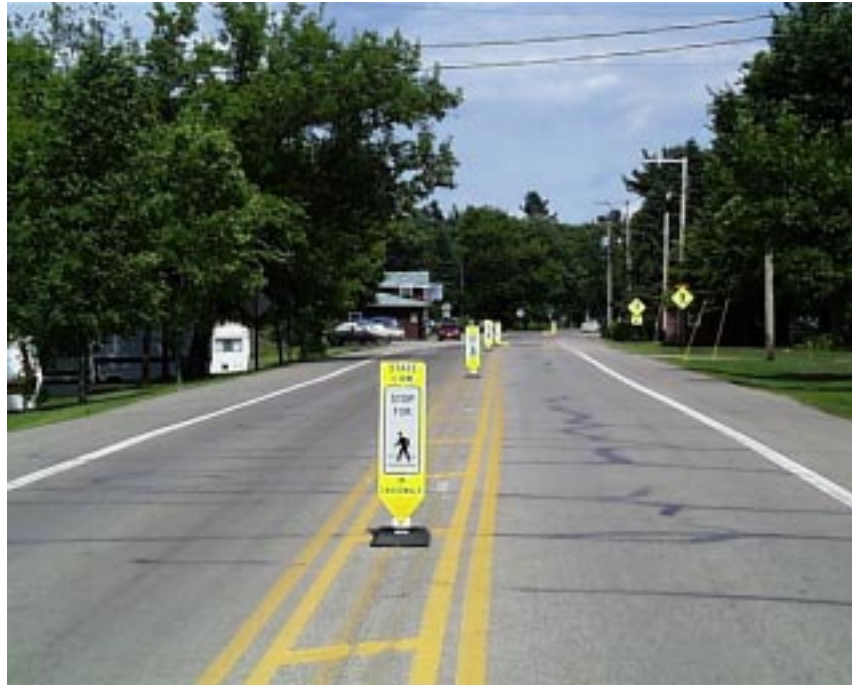
Figure 6.2 Pedestrian Crossing Devices—Mahnomen

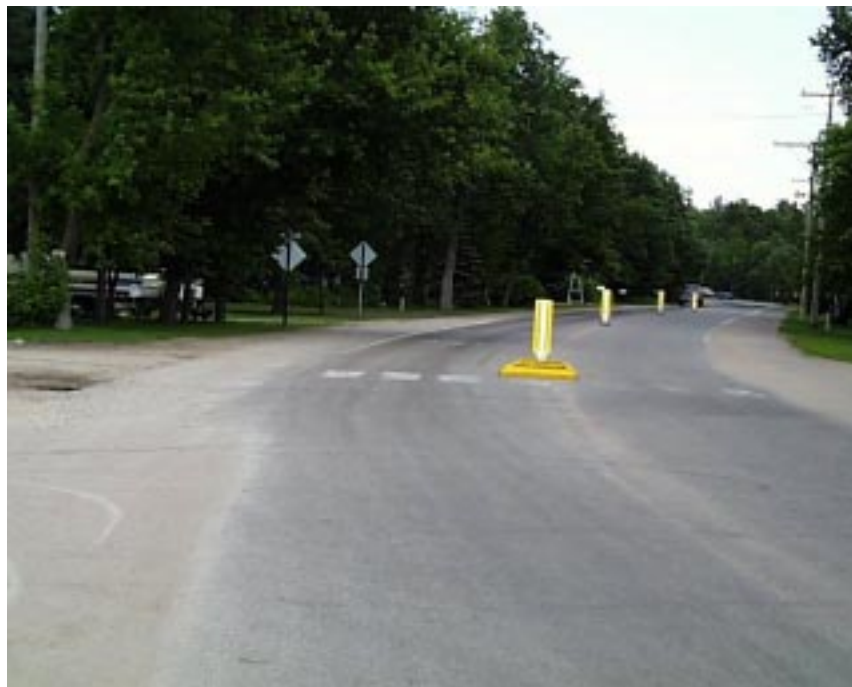
Figure 6.3 Another View of the Island and Signs—Mahnomen

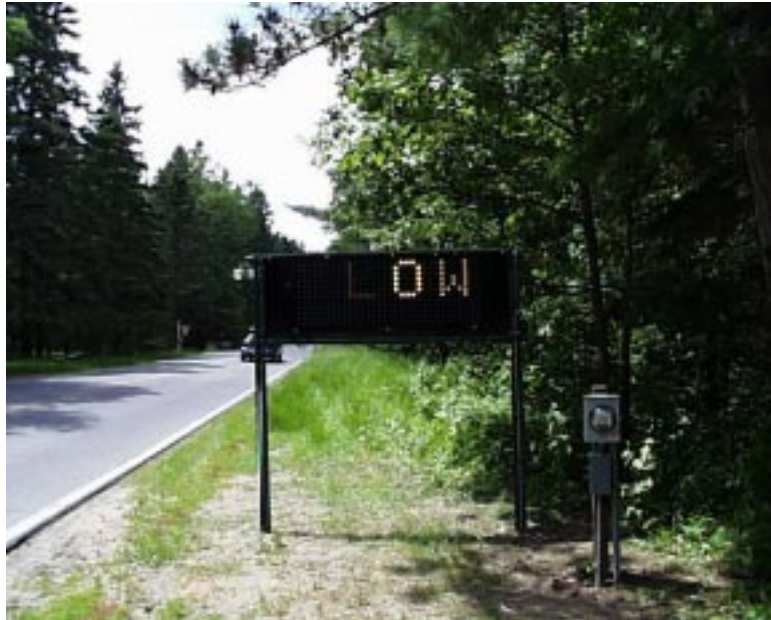
A dynamic variable message sign, sending a single-word message SLOW to motorists traveling over the speed limit (i.e., 35 mph), was installed at the Bemidji site (see Figures 6.4 and 6.5). The sign was mounted on the westbound direction of CSAH 20 about 600 feet downstream of the posted regulatory speed limit sign.

Figure 6.4 Dynamic Variable Message Sign—Bemidji

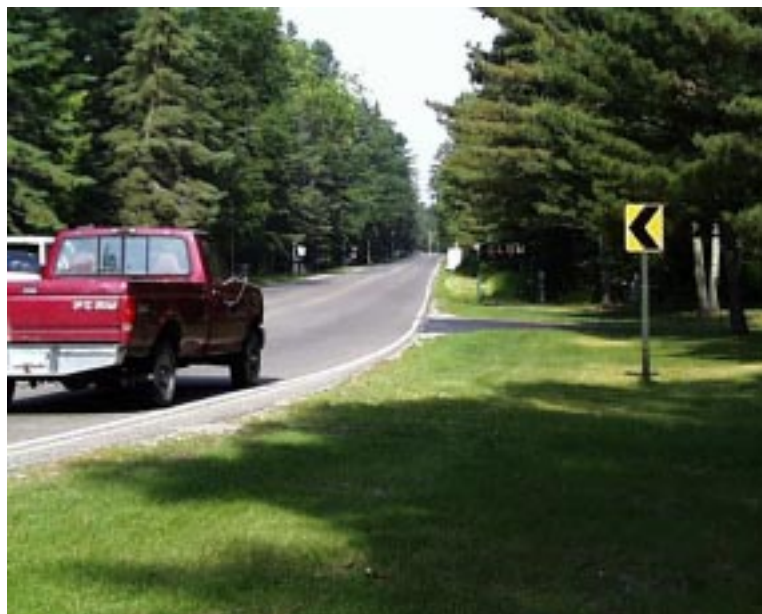
Figure 6.5 Another View of the Sign—Bemidji

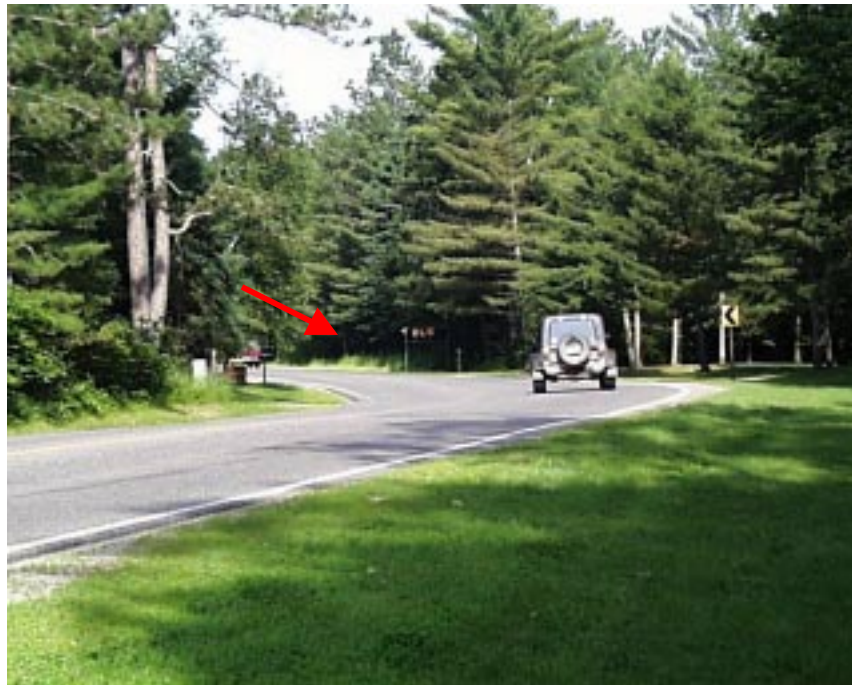
The primary reasons for the dynamic variable message sign’s inefficiency in encouraging motorists to comply with the posted speed limit are the sign’s single-word message (i.e., SLOW), location, and most importantly, lack of enforcement. Because of the area’s power source limitation, the sign was posted at the end of a horizontal curve (pointed by an arrow in Figure 6.8) providing a limited exposure to the approaching motorists.

Figure 6.8 Dynamic Variable Message Sign Location on CSAH 20 in Bemidji

The single-word message by itself was not informative enough to adequately encourage drivers to slow down. It is suggested that messages like “SLOW DOWN, YOU ARE SPEEDING” or “YOUR SPEED IS ... , SLOW DOWN” would have been more effective in controlling speed.
