# **Performance Evaluation of Very Early Strength Latex-Modified Concrete (LMC-VE) Overlay**

**Final Report  
October 2024**

**Sponsored by**  
Iowa Highway Research Board  
(IHRB Project TR-771)  
Iowa Department of Transportation  
(InTrans Project 19-688)

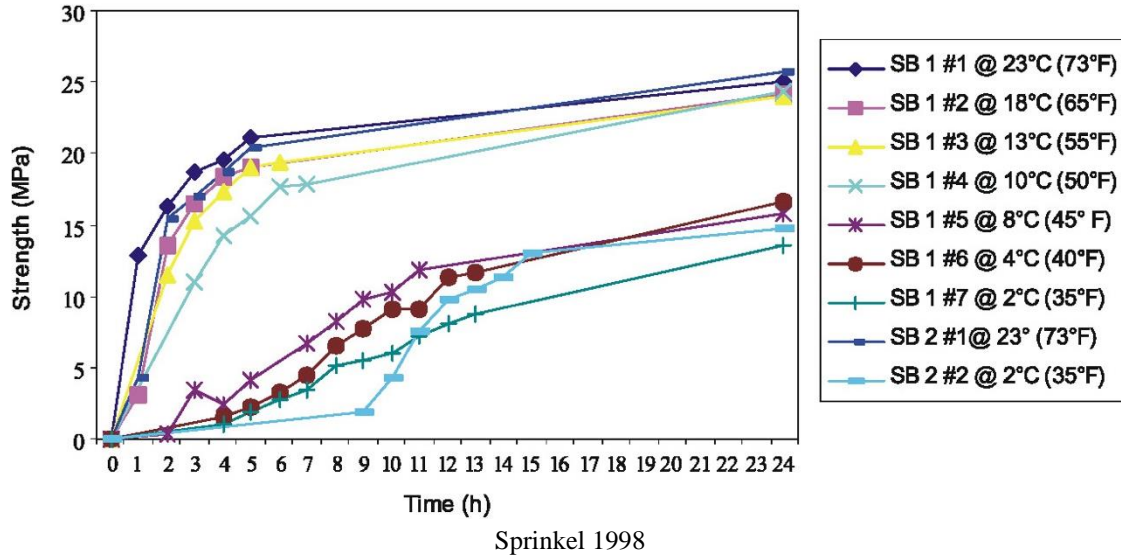
**Figure 2.2. Influence of curing temperature on the strength development of two batches (SB1 and SB2) of LMC-VE**

LMC was first used on a bridge deck in Virginia in 1969. The material was a PCC containing an admixture of styrene-butadiene latex particles suspended in water to replace a portion of the mixing water (Sprinkel 1999). LMC can be classified as (1) conventional LMC, (2) high early strength LMC (LMC-HE), and (3) LMC-VE. Conventional LMC overlays utilize Type I/II cement, whereas special cements are used for LMC-HE and LMC-VE. The rate of slump loss in LMC-VE is higher than in other types of LMC and hence requires the contractor to work at a faster pace. Conventional LMC has a curing period of around 72 hours and traffic is usually allowed after 4 to 7 days (Sprinkel 1999), while the curing period for LMC-VE is approximately 3 hours because it provides high early strength. However, the precise strength of LMC-VE depends on the curing temperature, a major factor in the development of compressive strength (Sprinkel 1998). This can be well understood from Figure 2.2, which shows the temperature dependence of strength development in LMC-VE. Therefore, there is a restriction on the use of LMC-VE below certain temperatures. For instance, the Virginia DOT (VDOT) restricts the application of LMC-VE below 10°C (Sprinkel 1999).

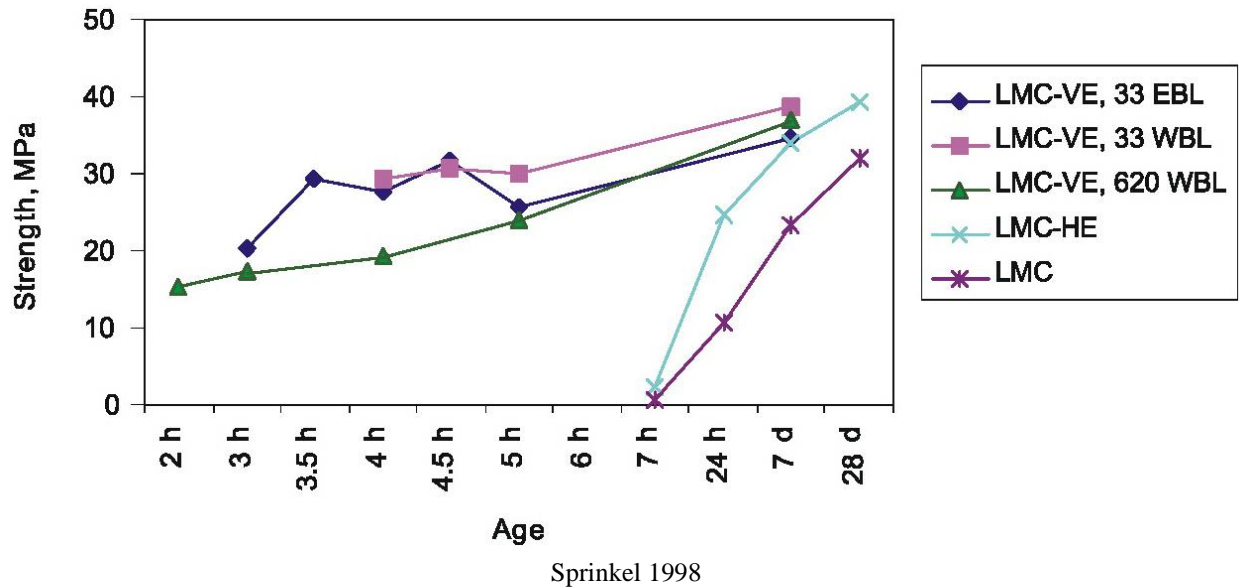
**Figure 2.5. Strength development in LMC-VE, LMC-HE, and LMC**

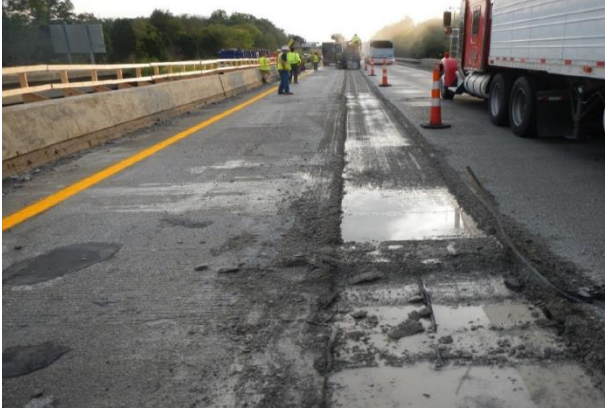
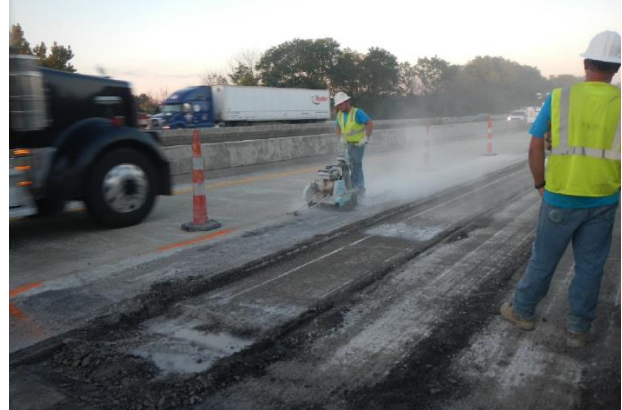
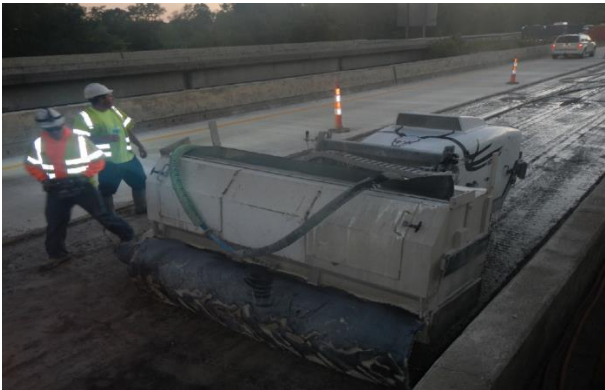
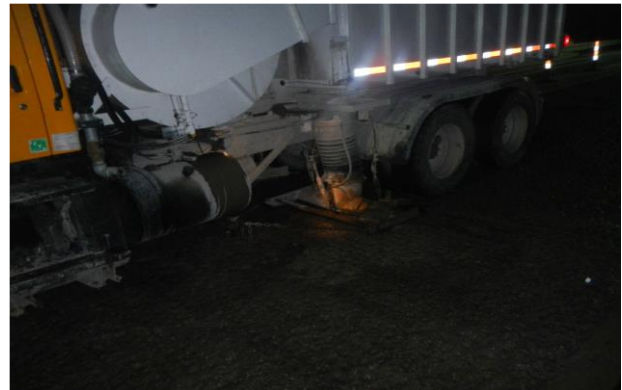
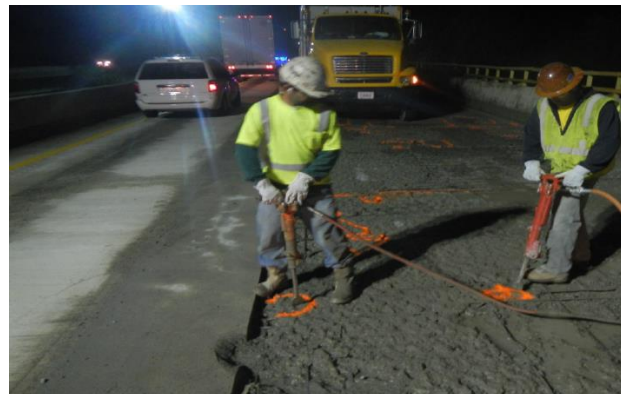
**Figure 2.7. Deck preparation prior to pouring LMC-VE**

(a) Bridge deck after surface milling

(b) Vertical perimeter of overlay work being sawed

(c) Hydrodemolition to remove distressed concrete

(d) Vacuum truck cleaning concrete debris from the deck after hydrodemolition

(f) Jackhammering to remove unsound or delaminated concrete detected by the chain drag method after hydro-blasting; resulting debris collected by vacuum truck

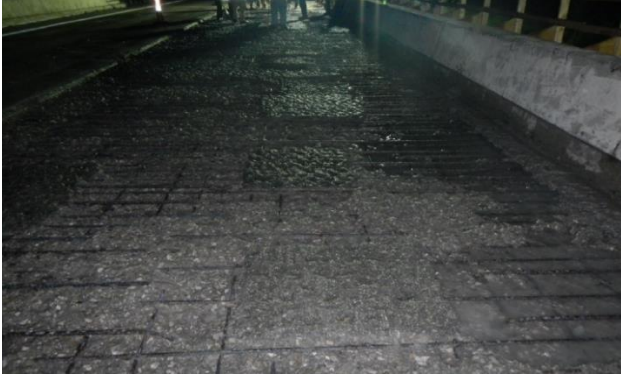
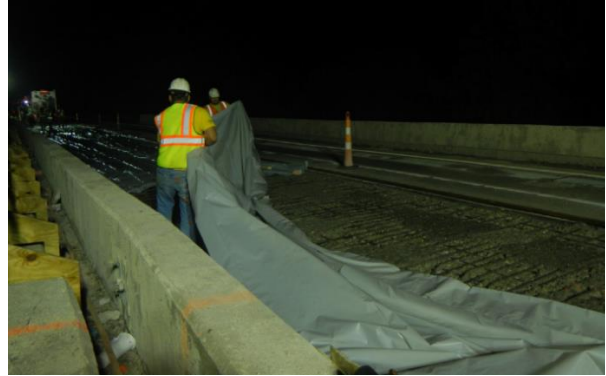
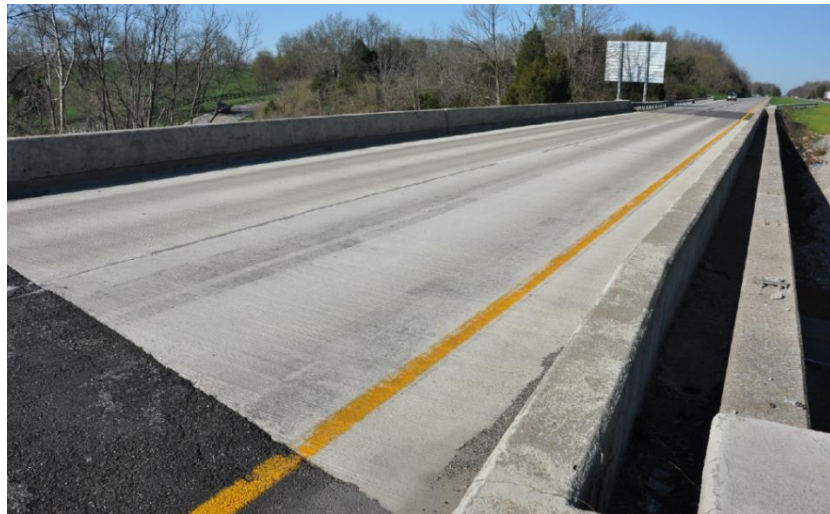
(a) Bridge deck after hydro-blasting and vacuuming showing patched concrete remaining above the upper mat of reinforcing steel

(b) Workers placing plastic sheets on prepared deck to prevent contamination of the prepared surface prior to overlay placement

(e) Finished bridge deck

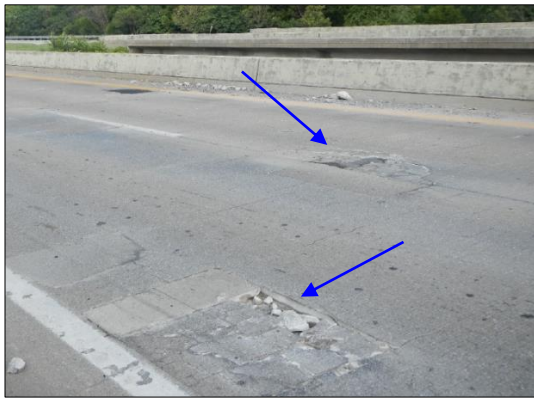
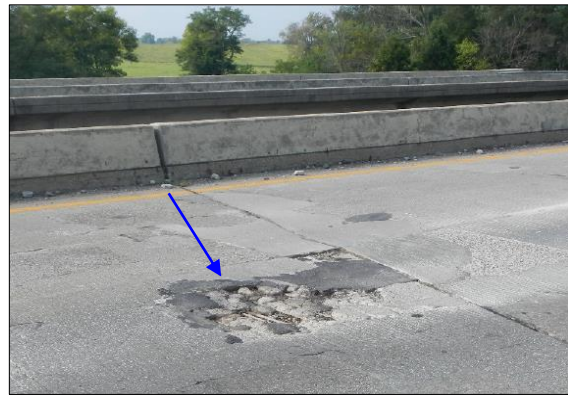
**Figure 2.9. Poor deck condition before placing the LMC-VE overlay**

(a) Portion of a deck surface showing spalling on the riding surface (marked with arrows)

(b) Deck surface showing exposed reinforcement steel (marked with an arrow)

A major factor that affects the life of an overlay is the strength of its bond with the existing deck concrete. Hence, the condition of the existing deck concrete plays an important role in providing an adequate bond with the overlay and must be examined prior to the beginning of the overlay work. Distresses, if present, need to be addressed. Figure 2.9a and Figure 2.9b show instances of distresses that existed on two bridge decks in Kentucky before LMC-VE overlay work was conducted by the Kentucky Transportation Cabinet (KYTC) (Theodore II et al. 2015). The riding surfaces of the decks exhibited extensive spalling and transverse cracking, with one deck exhibiting exposed reinforcement steel on the surface.

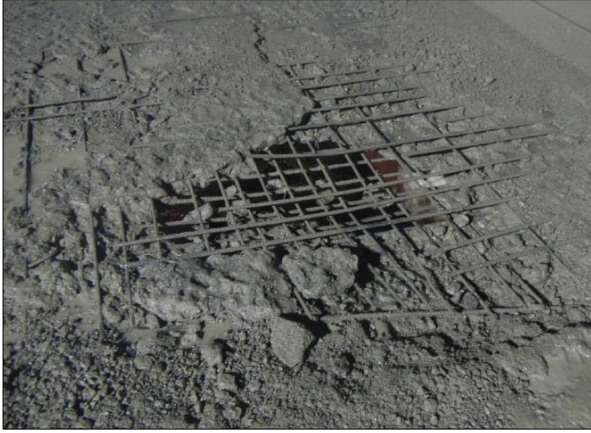
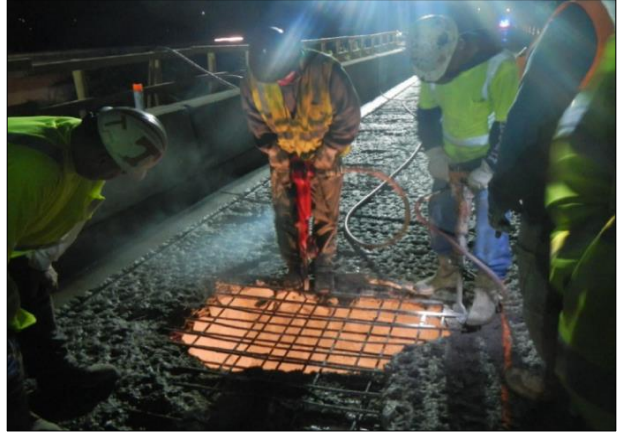
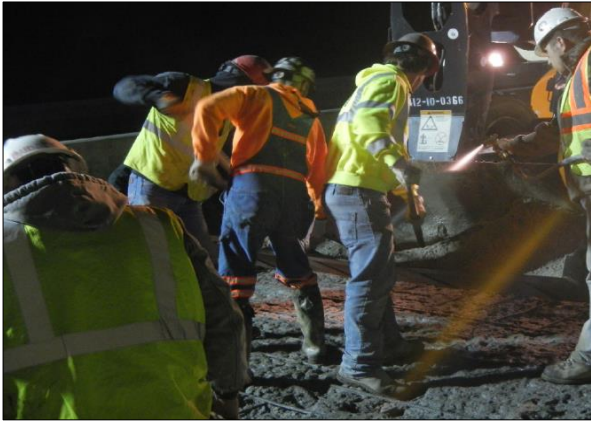
(a) Punch-through in deck, post hydrodemolition

(b) Repairing punch-through by jackhammering to remove loose concrete

(c) Duracal patching compound being mixed to fix the punch-through

Another key issue that may be encountered due to hydrodemolition is the occurrence of a punch-through, which must be fixed alongside the already ongoing overlaying work. One such incident (Figure 2.11a) was observed by the KYTC as a result of hydro-blasting during LMC-VE overlay work (Theodore II et al. 2015). Efforts to remove unsound concrete using jackhammers (Figure 2.11b) further expanded the hole to a size of 3 x 5 ft. Extra reinforcing steel in the void area and a plywood sheet at the bottom of the deck were placed to allow for casting of a partial deck repair. USG Duracal, a patching compound with a 3,200 psi break strength and a two-hour cure time, was used to fix the hole. The compound was poured to just below the upper reinforcing steel level, as shown in Figure 2.11d.

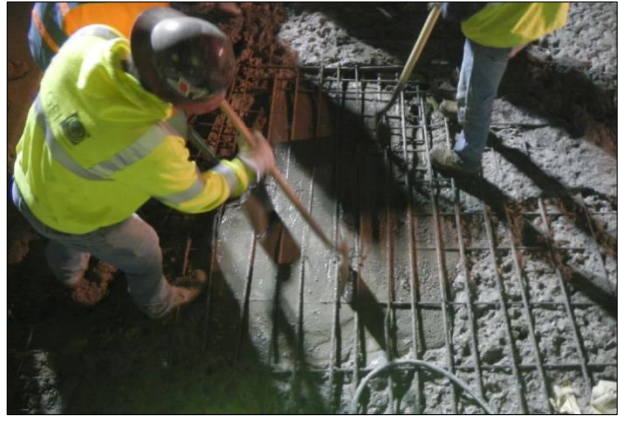
(d) Patching material being applied to fill the punch-through

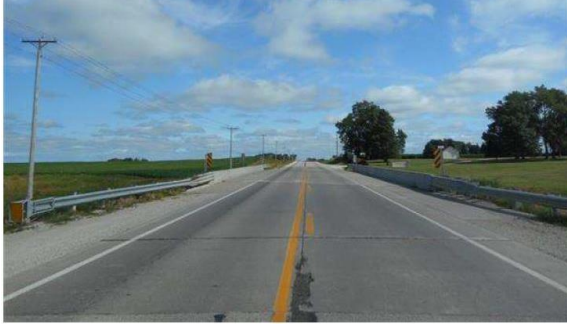
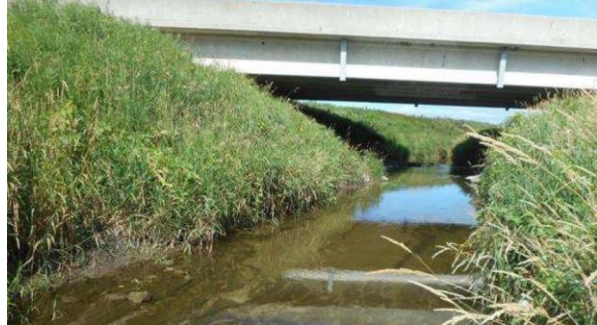
(a) Old deck surface

(b) Side profile of the bridge

The IA 15 bridge over Black Cat Creek consists of prestressed concrete beams with galvanized steel intermediate diaphragms and a cast-in-place concrete deck. Both abutments are integral concrete and are supported on steel H-piling. The most recent repair of this bridge occurred on October 8, 2013, according to an Iowa DOT report of a routine inspection conducted on July 3, 2017. Figure 3.2 shows an overview of the bridge, and Figure 3.3 presents the deck profile and the layout of the bridge.

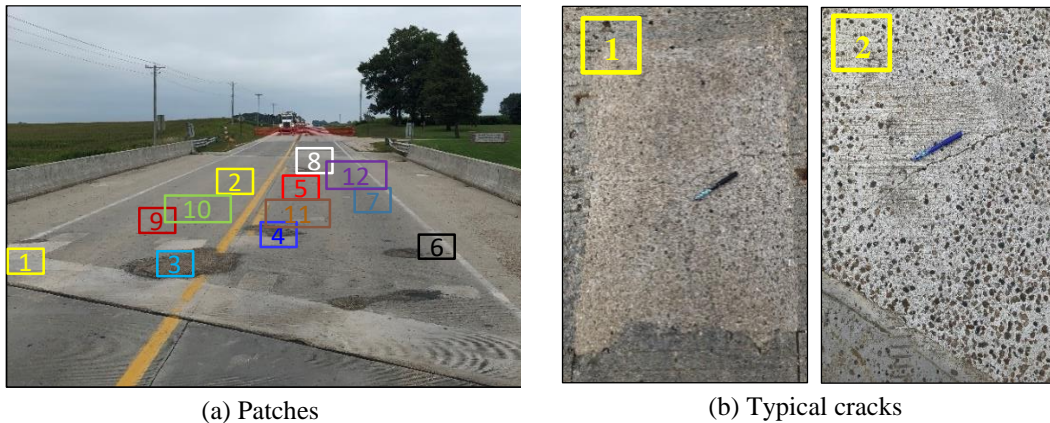
**Figure 3.5. Patch locations and cracks on bridge deck surface**

As shown in Figure 3.4, several patches and several fine cracks were observed on the deck, but there were few/no large cracks or instances of severe joint deterioration, scaling, or spalling. The shaded areas in the figure indicate the partial-depth repair areas required for the present project. Figure 3.5a shows patch locations, and Figure 3.5b presents some cracks found on the surfaces of the patches.

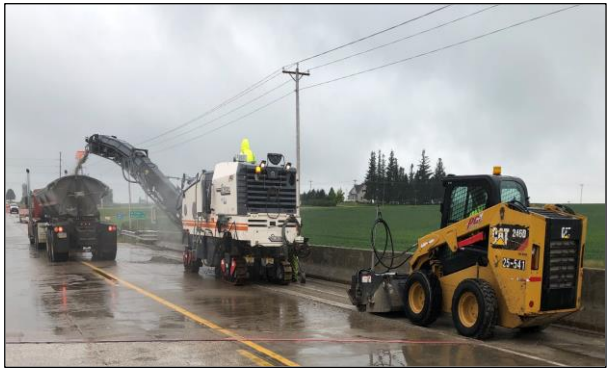
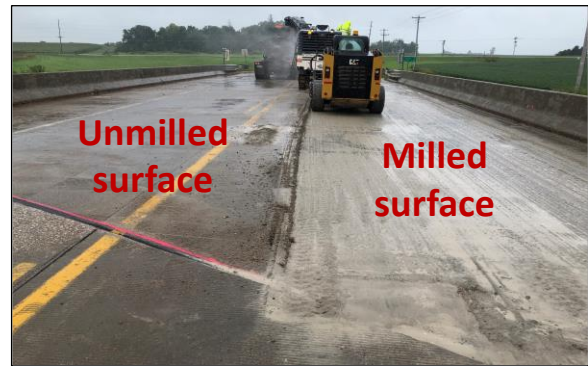
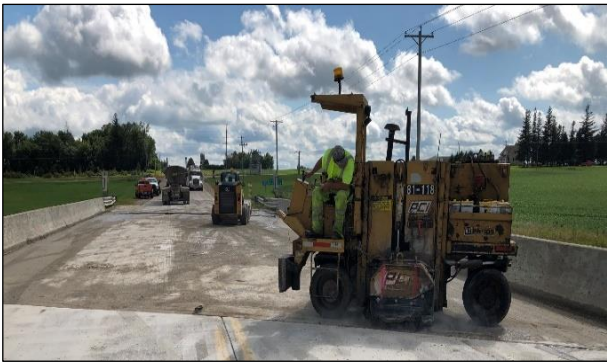
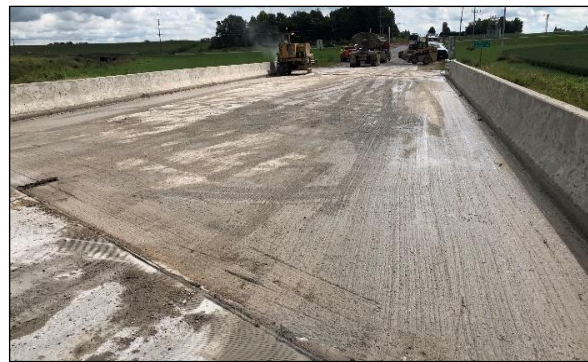
**Figure 3.6. Sequence of milling operation**

(a) Overview of milling process

(b) Milled and unmilled surfaces

(c) Micro milling at the edges

(d) Deck surface after completion of milling

Figure 3.6a shows an overview of the milling process. The surface of the deck was milled, and the resulting debris was placed in a dump truck. Any remaining debris was cleared by a skid steer loader that followed the milling machine. Figure 3.6b shows a comparison between the milled and the unmilled surfaces of the deck. The corners and edges were milled using a micro miller, as shown in Figure 3.6c. Figure 3.6d shows the final deck surface after the milling operation was completed. The entire milling procedure was completed over a duration of 2 hours on August 26, 2019.

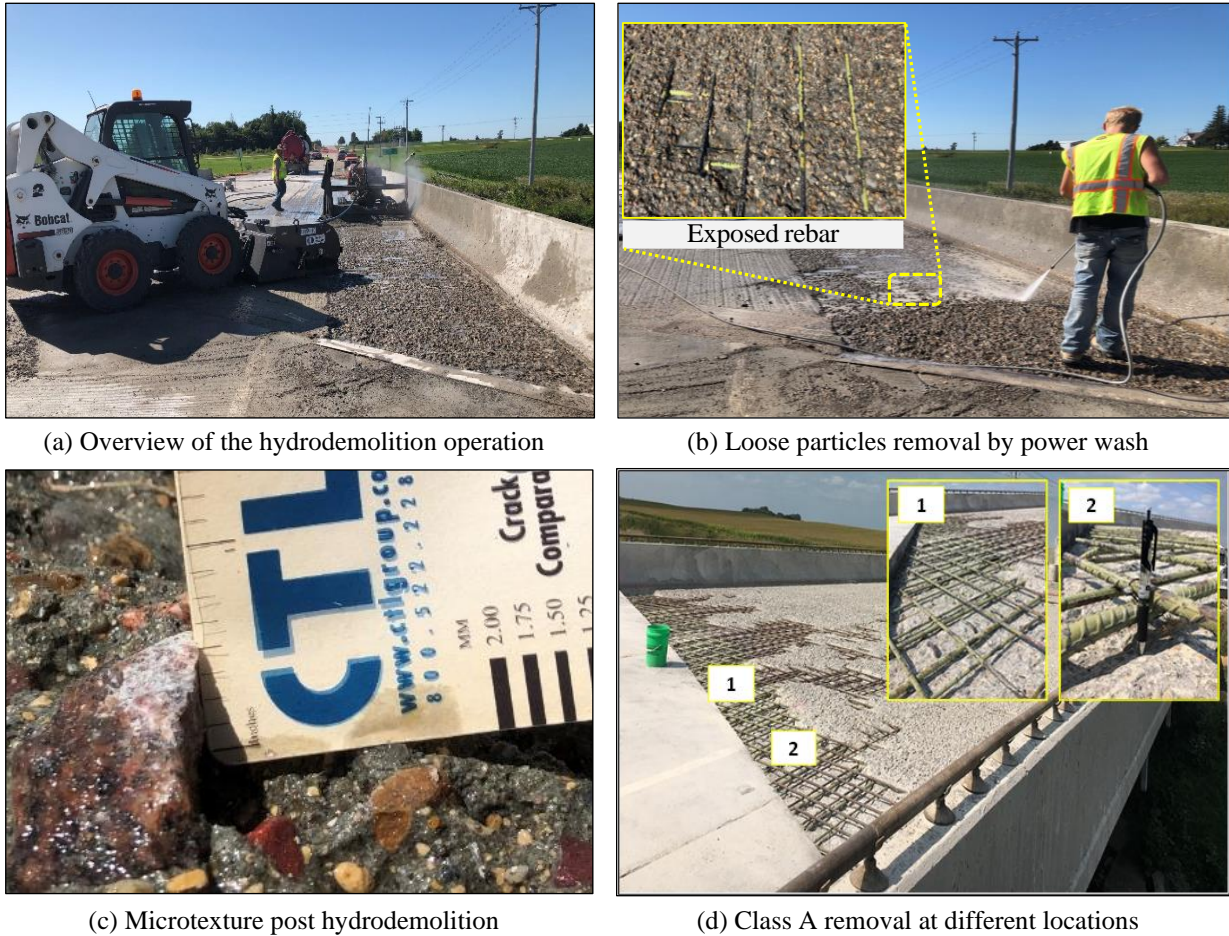
**Figure 3.7. Hydrodemolition operation**

The hydrodemolition and power washing provided a rough and exposed aggregate surface, as shown in Figure 3.7c. Figure 3.7d shows the Class A removal at different locations where excess substrate concrete was removed above and, in some cases, below the reinforcement bars. Both the milling and hydrodemolition operations together removed a total depth of 3 in. from the existing deck.

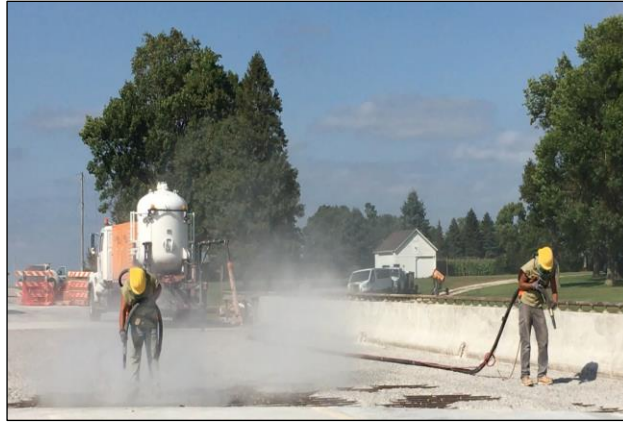
**Figure 3.8. Sand-blasting of the surface**

(a) Overview of sand-blasting operation

Prior to overlay placement, the prepared surface was cleaned thoroughly via sand-blasting. Sand-blasting was performed at noon on the same day of but prior to overlay placement. Figure 3.8a shows the manual sand-blasting process, which left the textured surface shown in Figure 3.8b.

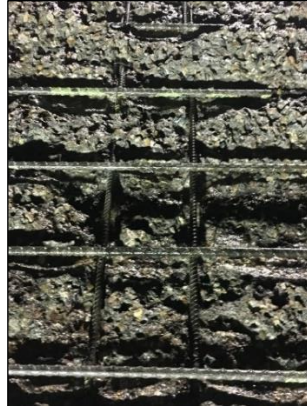
(b) Pre-wetted rebar

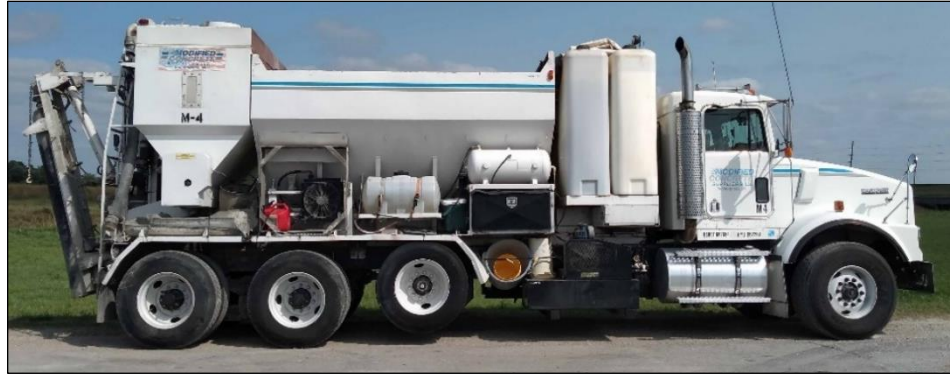
(a) Mobile mixing truck

The overlay was cast in two passes (or in two different pours). The first pass began at 10:45 p.m. on September 5, 2019, and ended at 1:20 a.m. on September 6, 2019. The actual ambient temperatures measured at the nearest town were 54°F (low) and 82°F (high) on September 5, 2019, and 60°F (low) and 76°F (high) on September 6, 2019. The LMC-VE materials were mixed using the volumetric mobile mixer truck shown in Figure 3.10a, which was then backed onto the deck in front of the finishing machine. All of the required materials were preloaded into the mixer truck in designated containers, as shown in Figure 3.10b.

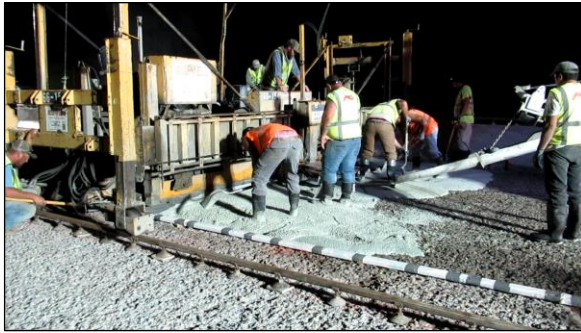
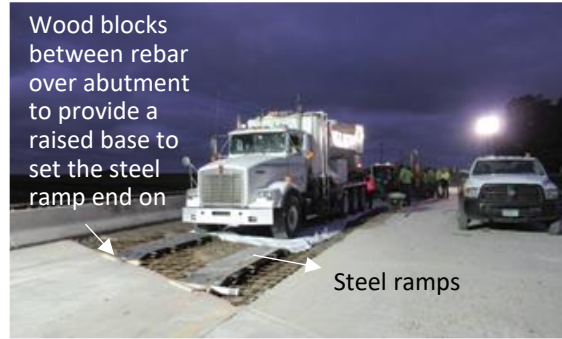
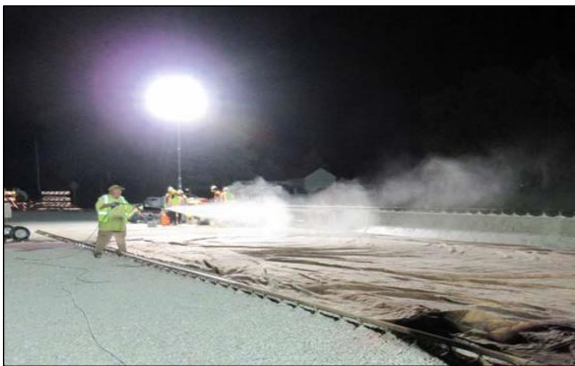
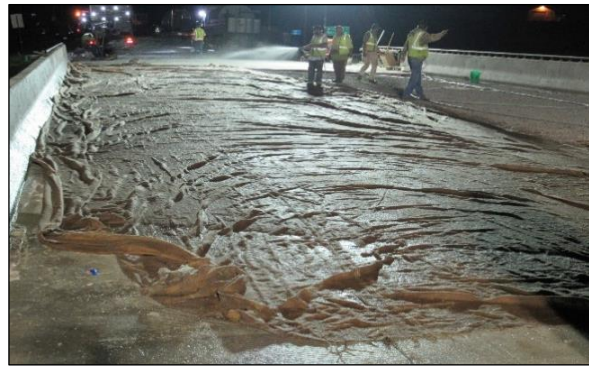
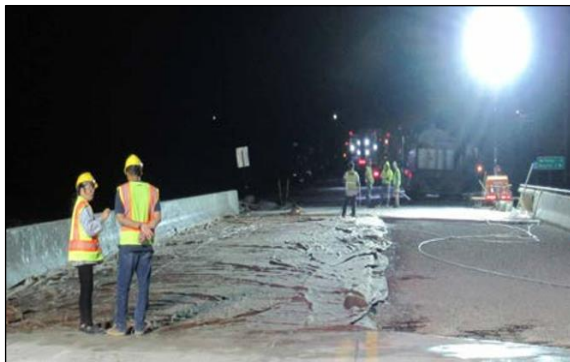
**Figure 3.11. First half of overlay casting**

(a) Overview of the overlay casting operation

(b) Cast surface covered with presoaked burlap

(c) Fogging over the wet burlap cover

(d) Wet burlap kept for 4 hours of wet curing

(e) Overlay cast on half of the deck surface

Immediately after being dispensed from the mixer, the concrete was poured from one end of the deck surface to the other (from north to south). The poured concrete was spread manually and then finished with a Bidwell finishing machine (screed), as shown in Figure 3.11a. The LMC-VE was highly flowable and was self-consolidating.

As the paver progressed, the cast overlay surface was immediately covered with a clean, single layer of presoaked burlap to prevent any loss of moisture from the concrete surface, as shown in Figure 3.11b. Fog was manually sprayed over the wet burlap surface immediately and continuously to ensure prevention of moisture loss (Figure 3.11b). This was an especially important step because the rate of hydration is particularly fast in LMC-VE, and any moisture loss would result in high shrinkage and the formation of shrinkage cracks.

The cast surface was moist cured (Figure 3.11e) for 4 hours according to Section 150447.03.C.5.b of the special provisions (SP-150447), after which the wet burlap was removed (Figure 3.11f).

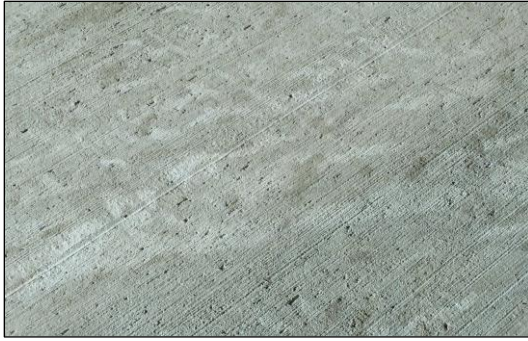
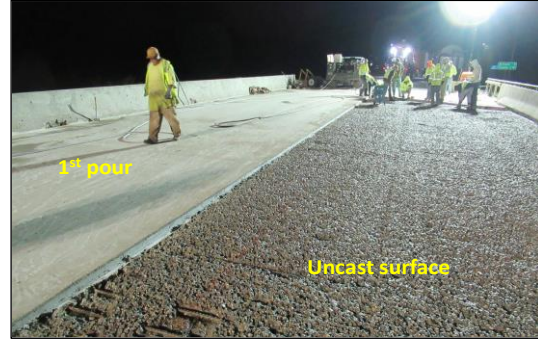
**Figure 3.12. Completion of the first half of overlay casting**

(a) Overlay surface after wet burlap removal

(b) Cast versus uncast surface

Figure 3.12a shows the finished and cured surface of the LMC-VE overlay after 4 hours, and Figure 3.12b shows the cast and uncast surfaces of the deck.

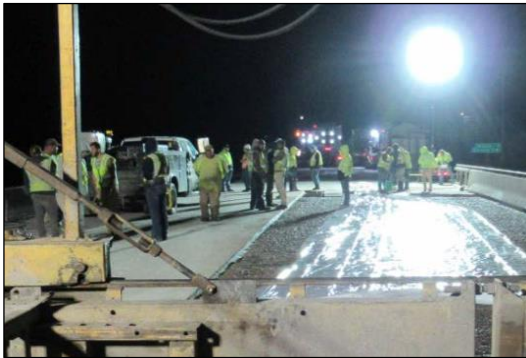
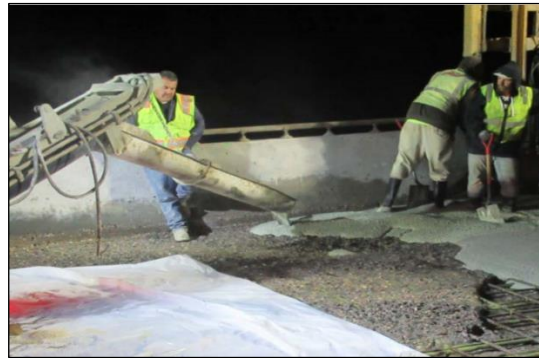
(a) Preparation for second pour

(b) Beginning of second pour

Casting of the second half of the LMC-VE overlay began around 5:45 a.m. and ended at about 7:30 a.m. on September 6, 2019. The LMC-VE was made using the same mix proportions and was poured using the same procedures as those used to cast the first half of the overlay, and pouring proceeded from north to south. As shown in Figure 3.13a, construction vehicles had already moved onto the first half of the overlay, which had been poured only about 3.5 hours earlier. After the pouring, the overlay was similarly wet cured for 4 hours (Figure 3.13d).

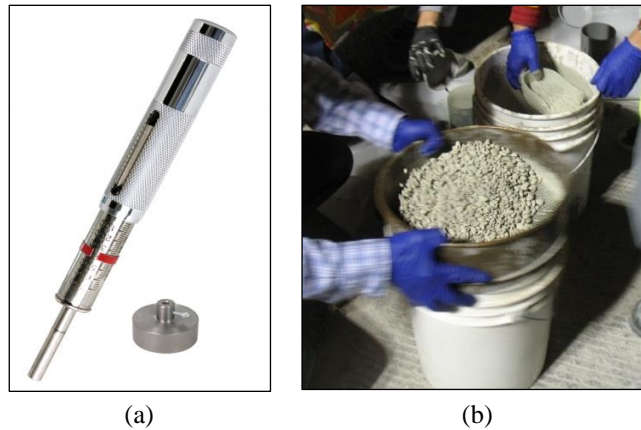
**Figure 3.14. (a) Pocket penetrometer and (b) mortar sieved from LMC-VE**

The setting time of the LMC-VE was measured on site during the overlay construction. The measurements were obtained according to ASTM WK27337 using a pocket penetrometer, shown in Figure 3.14a. The measurements were made on fresh mortar that was sieved from the LMC-VE using a #4 sieve, as shown in Figure 3.14b.

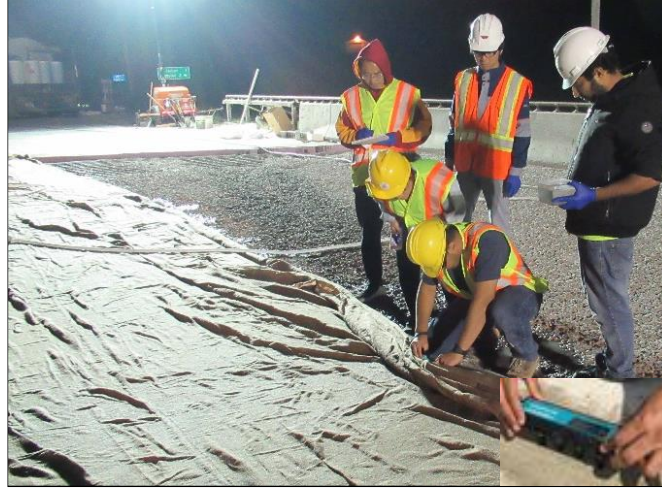
(a) On-site SR measurements

About 3 hours after the first pour of the LMC-VE overlay, the SR of the overlay was measured on site using a handheld four-point Wenner probe (Proceq Resipod). The testing was done in accordance with AASHTO T 358. Because the freshly cast overlay was very moist, the measurements were taken by directly placing the four electrodes of the device on the surface at the selected locations (Figure 3.16a). Measurements were taken at various locations on the left shoulder and close to the longitudinal construction joint of the deck surface. At each location, two measurements were made. The test locations and the average of the two SR measurements at each location are shown in Figure 3.16b. The distances of the locations (in feet) with respect to the construction joints are given in red numbers, and the SR values (in kΩ-cm) are given in blue numbers. The SR measurements near the longitudinal construction joint varied from 8.1 to 16.4 kΩ-cm, and those on the left shoulder varied from 8.8 to 40.1 kΩ-cm. (At the time of the first SR measurement, it was noticed that the LMC-VE overlay covered by wet burlap felt very warm due to the heat released by rapid cement hydration.)

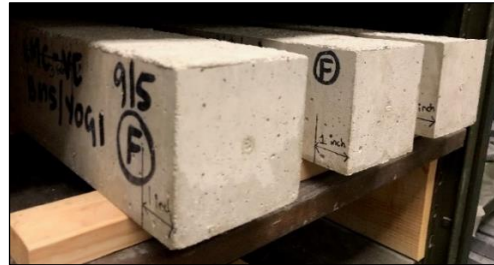
**Figure 4.1. Mechanical strength and elastic modulus test specimens**

(b) Flexural strength test specimens

The compressive strength of LMC-VE was evaluated at specimen ages of 3 hours, 12 hours, 1 day, 3 days, 7 days, and 28 days. Testing was done using standard 4 × 8 in. cylinder specimens (Figure 4.1a) in accordance with ASTM C39. An average of three specimens were measured at each testing age. Flexural strength was evaluated at specimen ages of 3, 7, and 28 days. Testing was done on 3 × 3 × 11 in. beam specimens (Figure 4.1b) using the third-point bending test in accordance with ASTM C78. An average of three specimens were measured at each testing age.

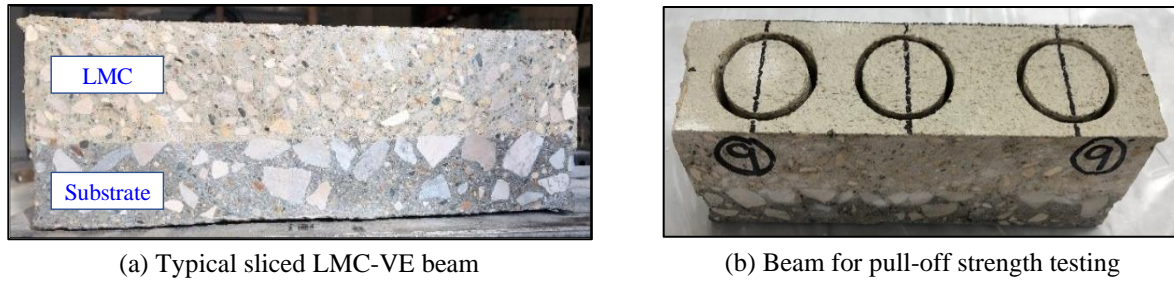
**Figure 4.3. LMC-VE-overlaid beam specimens sliced from the cast slab specimens**

These substrate slabs were then overlaid with LMC-VE to a depth of 1.75 in. (to simulate the average thickness of the LMC-VE overlay in the field) during construction of the field overlay. The overall dimensions of the slabs, including both the substrate and LMC-VE overlay, were 12 × 12 × 3.5 in. (l × b × h). Prior to placing the overlay material over the substrate concrete, a thin layer of mortar (sieved from the LMC-VE) was applied to the substrate's surface to ensure a better bond between the overlay and substrate concretes. The overlaid slabs were cured in the moisture room for 3 days and then air cured until a specimen age of 28 days. After 28 days, the slabs were sliced to prepare beams with dimensions of 11 × 3 × 3.5 in. (l × b × d). A typical sliced beam is shown in Figure 4.3a. The prepared beams were divided into two sets. One set of beams was used to determine pull-off strength, and the other set of beams was utilized to determine freeze-thaw performance.

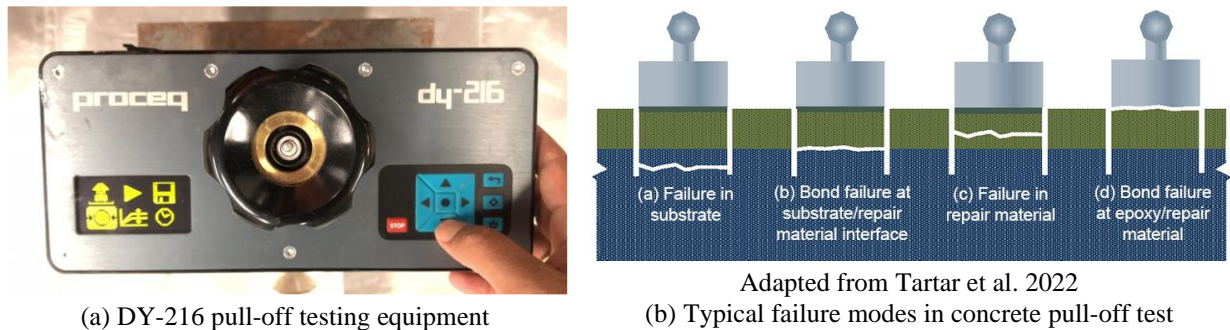
**Figure 4.4. Pull-off testing equipment and typical failure modes obtained during testing**

1. Three shallow cores were drilled to a depth of 3 in. on each specimen, as shown in Figure 4.3b.
2. The top surfaces were brushed using sandpaper to remove any dirt and loose material that was present.
3. A puck was glued to each of the three locations using high-strength epoxy.
4. The pucks were left undisturbed for 4 to 5 hours. Once the pucks were firmly adhered to the surface, the pucks were screwed to the pull-off test equipment and a load was applied until failure occurred.
5. The strength value and the specimen failure mode (Figure 4.4b) were recorded.

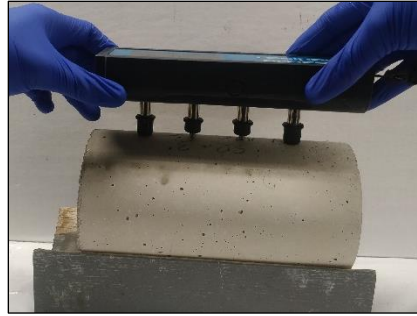
**Figure 4.5. Surface resistivity measurement using four-point Wenner probe**

room at  $23 \pm 3^\circ\text{C}$ . However, the air cured specimens gave fluctuating/unstable readings at 28 days. Therefore, further measurements at later ages (170 days, 340 days, and 440 days) were taken after the cylinders had been soaked in water for 2 days to ensure stable SR readings. An average of eight values were measured for each cylinder specimen, and an average of three cylinders were measured at each testing age.

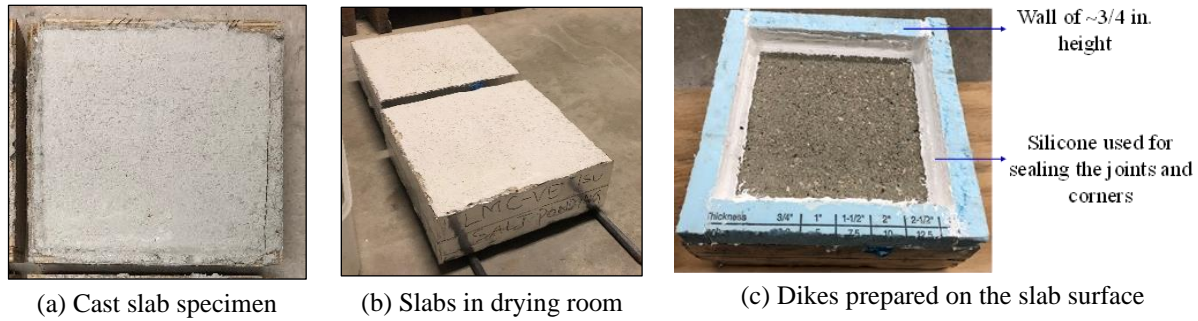
**Figure 4.8. Salt ponding test slabs overlaid with LMC-VE**

The salt ponding test was performed on cast  $12 \times 12 \times 3.5$  in. ( $l \times b \times h$ ) LMC-VE slab specimens in accordance with AASHTO T 259. The substrate for each of the slab specimens was prepared as shown in Figure 4.2, and these specimens were overlaid with the LMC-VE used in the field, as shown in Figure 4.8a. The prepared slabs were cured in a moist curing room for 3 days, as explained above, and then air cured until an age of 14 days. After 14 days, the slabs were moved to a drying room (Figure 4.8b) maintained at room temperature and an RH of 50%, where the slabs were kept for the next 28 days. After 28 days (i.e., a total 42 days since casting), dikes were made using Styrofoam at the top surface to hold the salt solution, as shown in Figure 4.8c. The slabs were then ponded with 3% NaCl solution for 90 days to evaluate the performance of the overlaid LMC-VE to the natural ingress of chloride ions.

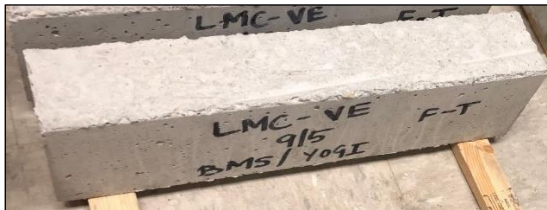
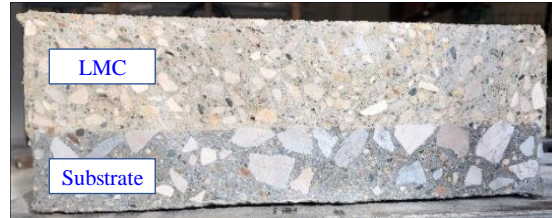
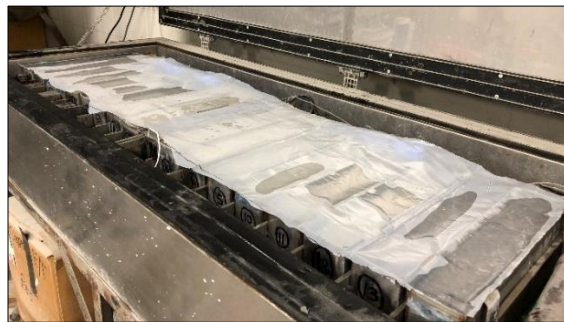
**Figure 4.12. Freeze-thaw testing of the cast beam specimens**

(a) LMC-VE-only beam

(b) LMC-VE-overlaid beam

(c) Overview of the freeze-thaw chamber with test beams

Freeze-thaw testing was performed on cast LMC-VE-only beams (i.e., beams made entirely of LMC-VE) and on sliced beams (i.e., beams sliced from LMC-VE-overlaid slabs prepared as explained above). The cast (Figure 4.12a) and sliced (Figure 4.12b) beams had dimensions of  $3 \times 4 \times 16$  in. ( $l \times b \times h$ ) and  $12 \times 3 \times 3.5$  in. ( $l \times b \times h$ ), respectively. Specimens were wet cured for 3 days and air cured thereafter and were tested for freeze-thaw resistance at a specimen age of 28 days. Testing was performed according to ASTM C666 using a freeze-thaw chamber, as shown in Figure 4.12c. The test beams were evaluated for their mass loss, relative dynamic modulus, and deterioration (via visual inspection) after every 36 cycles until failure.

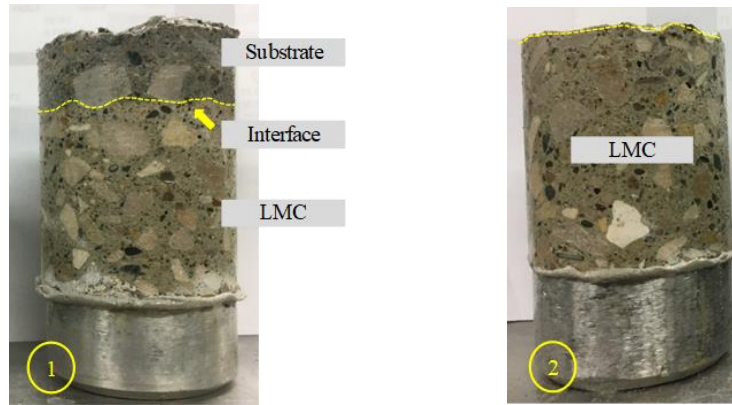
(a) Failure in the substrate in Specimen 1    (b) Failure at the bond in Specimen 2

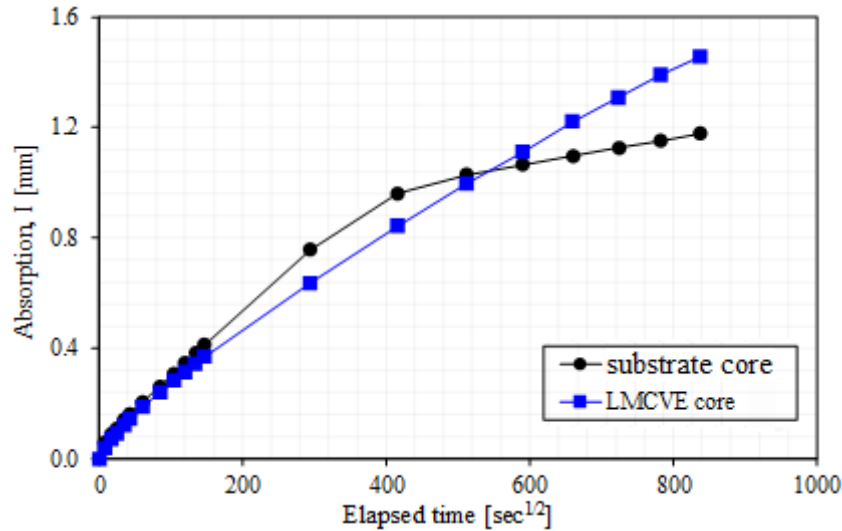
**Figure 4.19. Comparison between sorption behavior of substrate concrete core and LMC-VE core**

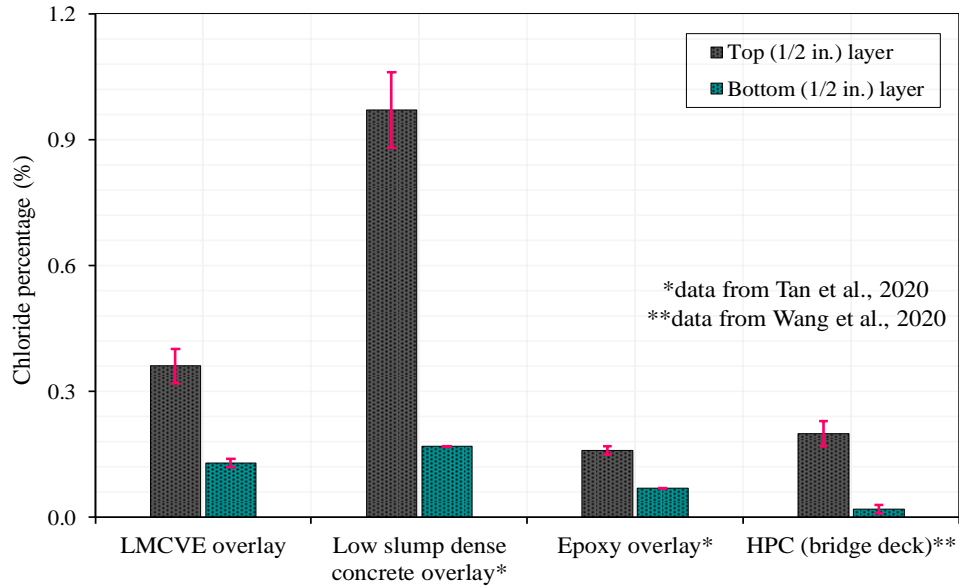
**Figure 4.21. Salt ponding test results of LMC-VE overlay in comparison with other overlays and HPC**

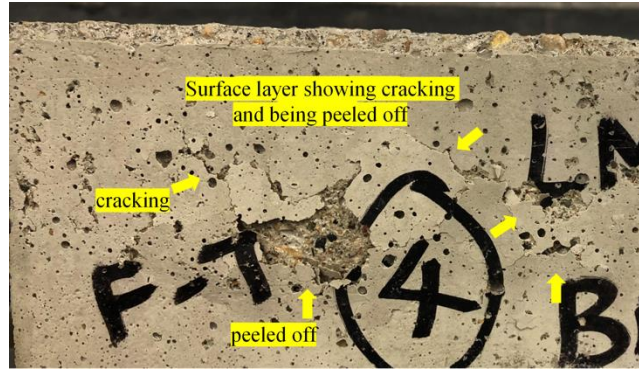
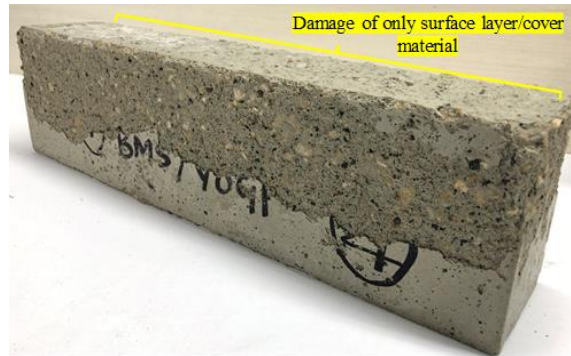
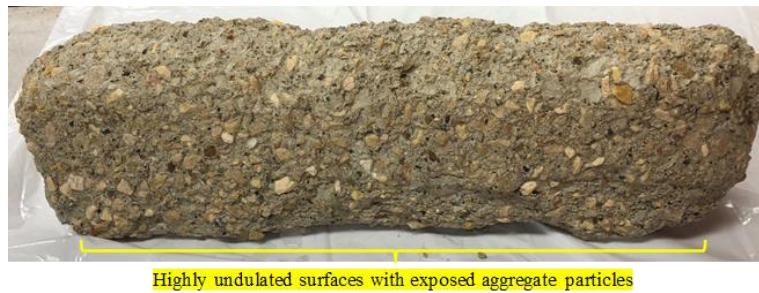
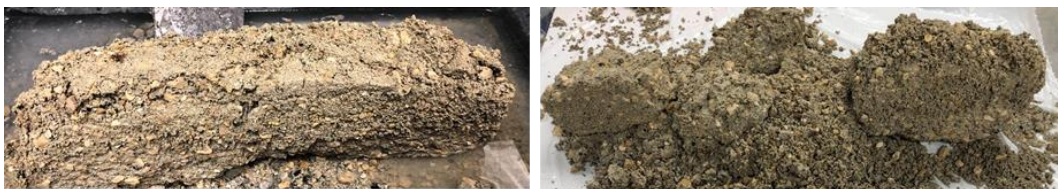
(a) Beginning of surface layer degradation (marked with arrows) after 36 freeze-thaw cycles

(b) More than 40% to 50% degradation of only surface layer material after 72 cycles

(c) Surfaces with aggregate particles exposed on the surfaces after 108 freeze-thaw cycles

(d) Completely deteriorated beams after 144 freeze-thaw cycles

Magnified images of the key features of freeze-thaw-related deformation observed in both the LMC-VE-only and LMC-VE-overlaid beam specimens are shown in Figure 4.25 (a–d) and Figure 4.26 (a–c), respectively.

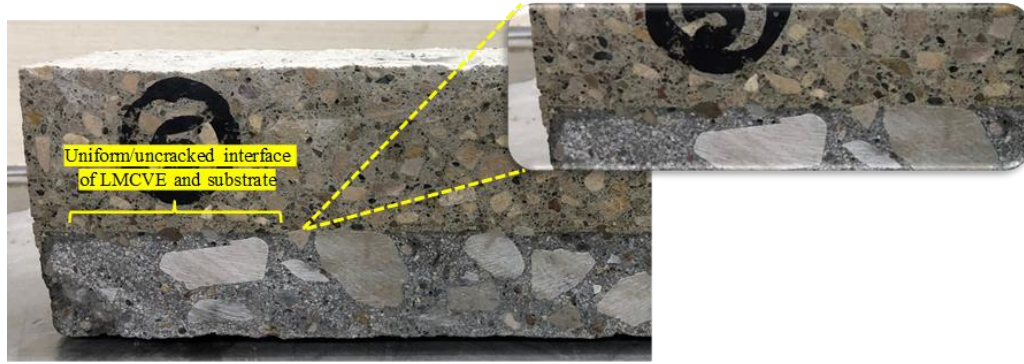
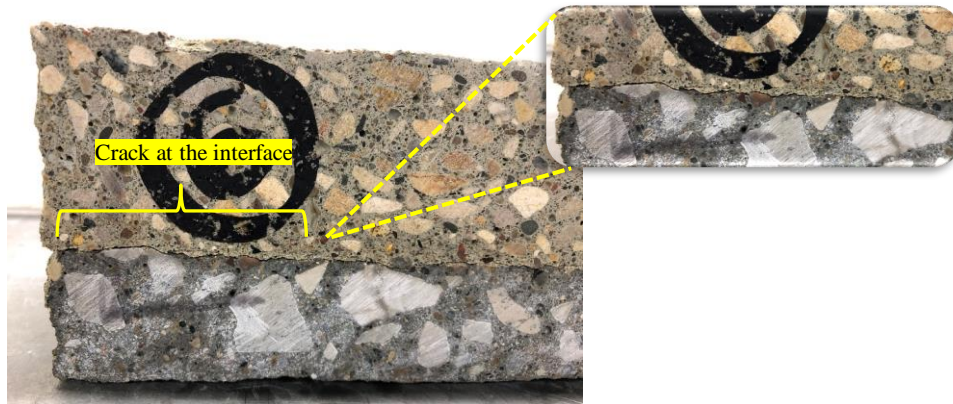
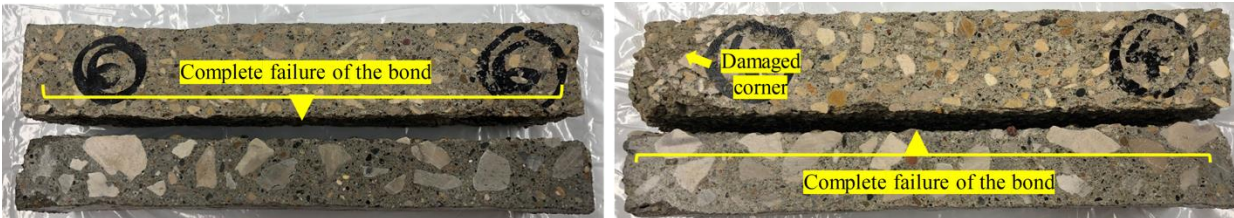
(a) LMC-VE-overlaid beam without any visible or measurable damage after 72 freeze-thaw cycles

(b) Cracking at the interface of LMC-VE-overlaid beam at 108 freeze-thaw cycles

(c) Complete failure at the LMC-VE-substrate interface (separation of overlay and substrate) after 144 freeze-thaw cycles

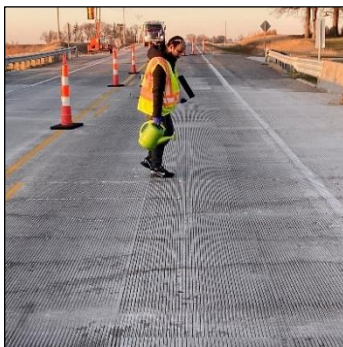
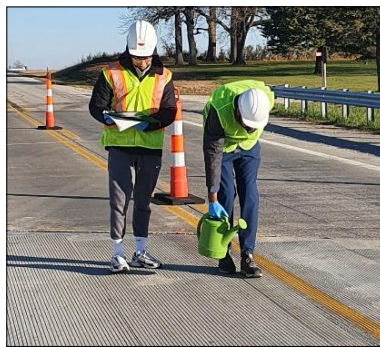
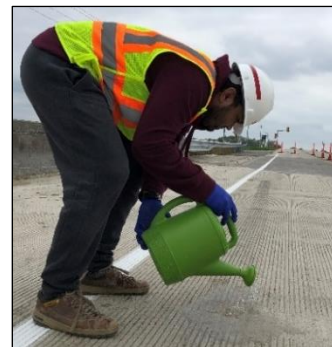
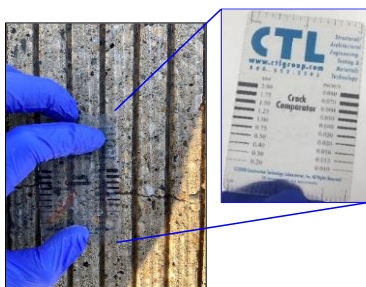
(a) Spraying water to wet small portion of overlay surface

(b) Careful examination for cracks

(c) Crack comparator used for crack width measurement

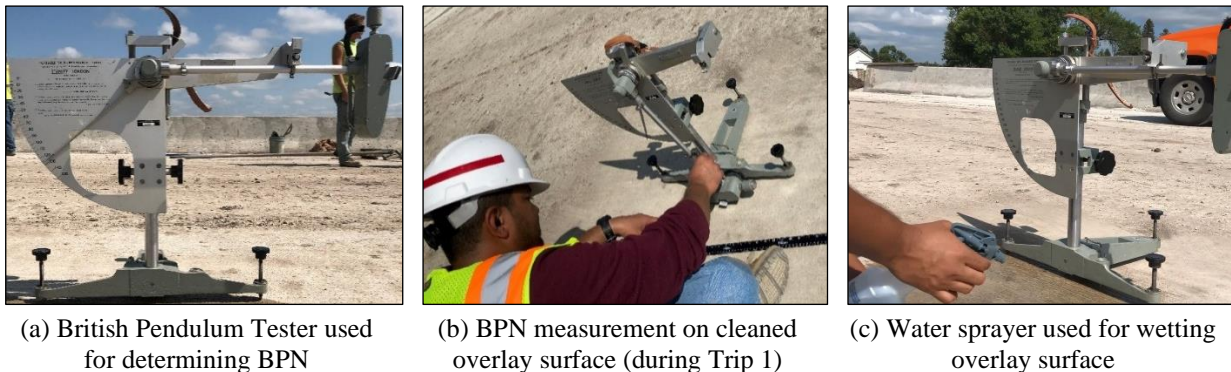
**Figure 5.2. British Pendulum Tester used for measuring BPN**

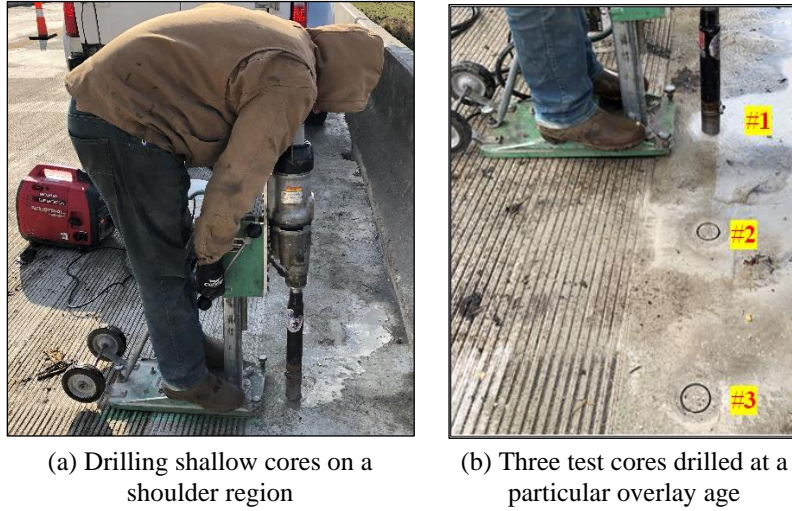
**Figure 5.6. Drilling cores for pull-off strength test in the field**
