# **Performance Evaluation of Very Early Strength Latex-Modified Concrete (LMC-VE) Overlay**

**Final Report  
October 2024**

**Sponsored by**  
Iowa Highway Research Board  
(IHRB Project TR-771)  
Iowa Department of Transportation  
(InTrans Project 19-688)

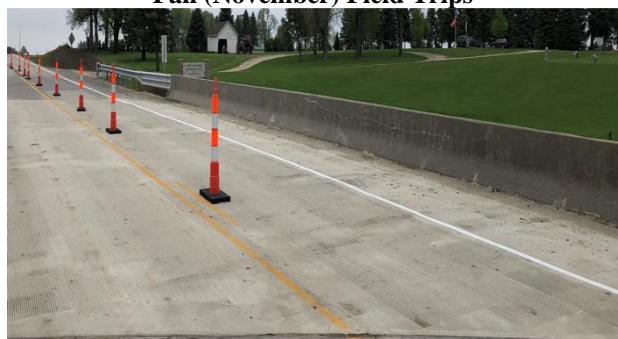
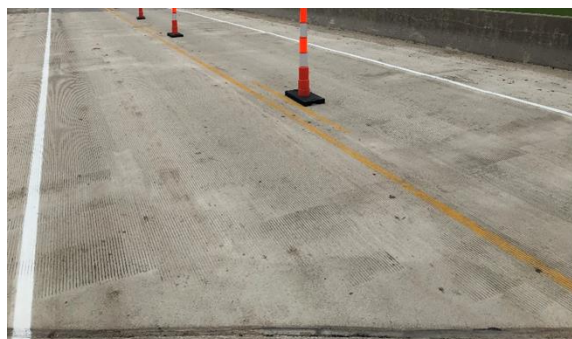
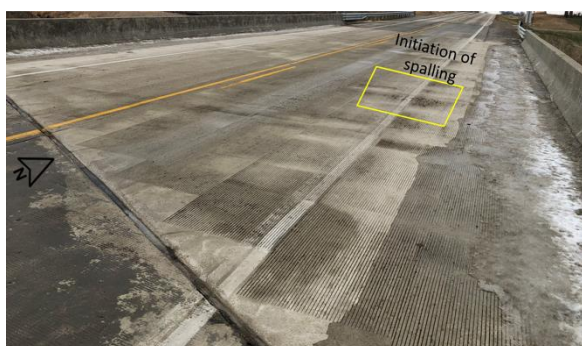
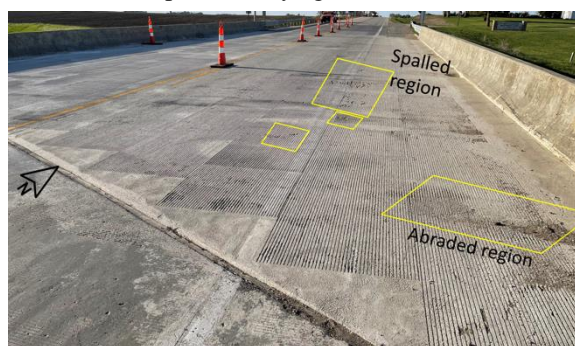
**Figure 5.11. Comparison of overlay deck surface at different ages (up to 44 months)**

(a) Trip 2 (overlay age of 2 months)

(b) Trip 3 (overlay age of 8.5 months)

(c) Trip 4 (overlay age of 14 months)

(d) Trip 5 (overlay age of 20 months)

Figure 5.11 compares the deck surface and Figure 5.12 shows the deteriorations observed at different ages throughout the project.

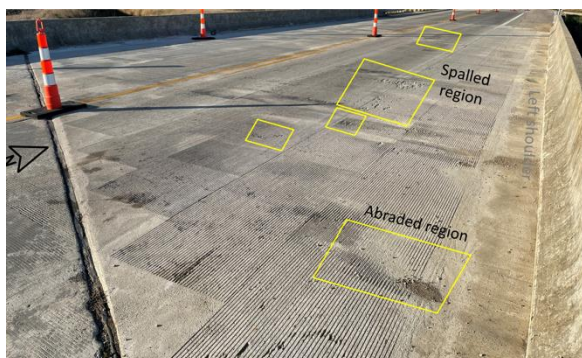
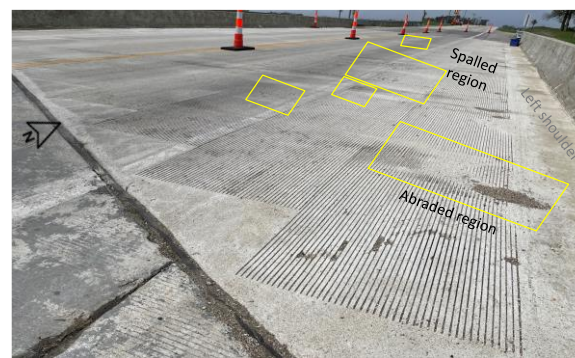
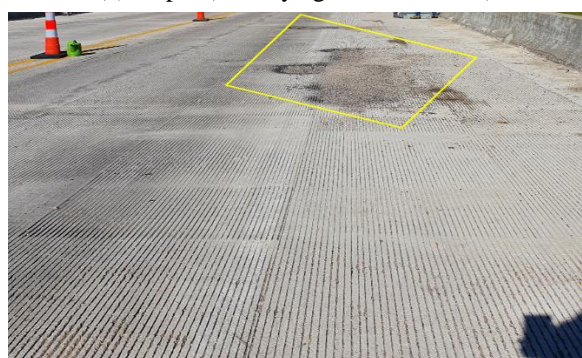
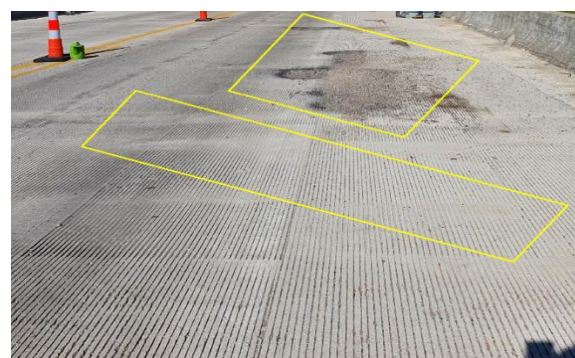
(e) Trip 6 (overlay age of 26 months)

(f) Trip 7 (overlay age of 32 months)

(g) Trip 8 (overlay age of 38 months)

(h) Trip 9 (overlay age of 44 months)

The crack survey sketches in Figure 5.9 and Figure 5.10 indicate the occurrence of mostly transverse cracks, cracks that are perpendicular to the bridge abutments, and diagonal cracking at corner areas. However, there is no evidence of longitudinal cracking. The observed cracking pattern on the overlay surface could possibly be a result of a combination of factors, such as early-age shrinkage, thermal-based reflective cracks from the substrate, and structural factors (such as early loading and bridge skew angle). Generally, it is difficult to conclusively point to a single factor that causes the cracks observed in any structure such as a concrete deck or an overlay surface, as highlighted by Phares and Harrington (2016). Previous literature has reported that LMC-VE is susceptible to early-age shrinkage cracking as a result of high autogenous and thermal shrinkage (Yun et al. 2007). Although the laboratory investigation showed that the shrinkage behavior of LMC-VE was similar to that of conventional pavement concrete (Figure 4.22), the early opening of the overlay to traffic might have increased the likelihood of shrinkage cracks because the concrete continues to shrink after exposure to traffic loads. When such volumetric changes occur in an LMC-VE overlay that is placed on substrate concrete, the substrate concrete could act as a restraint, resulting in cracking of the overlay (Yun and Choi 2014). Such cracks could be visible even in a short period of time (a few weeks). Diagonal cracking observed only at the corners could be a result of the bridge skew angle because such cracking is most commonly observed in bridges with skew, as reported in Fu et al. (2007).

The cracking observed in the overlay could also be reflective cracking from the original deck surface. Bridge decks that are to be rehabilitated with a bridge deck overlay may have existing deck cracking (typically transverse deck cracking). At the point in a bridge deck's life cycle when a deck overlay is needed, the bridge deck has achieved its ultimate strength and maximum shrinkage. When a new deck overlay is placed and well bonded to the existing deck substrate (as was done for the LMC-VE overlay in the present case), any movement in the overlay will be restrained by the existing bridge deck substrate. If there are cracks in the existing bridge deck substrate, they will tend to propagate through the new bridge deck overlay during bridge expansion/contraction due to the bond between the new deck overlay and the existing bridge substrate. However, bridge inspection documentation prior to installation of the LMC-VE overlay showed minimal cracking, though a fair amount of deck patching and delamination was noted. Therefore, it is inferred that some cracks in the LMC-VE overlay might be reflective cracks, but most cracks observed in the LMC-VE overlay are likely not. Table 5.2 lists other possible reasons for the identified cracks on the LMC-VE overlay's surface.

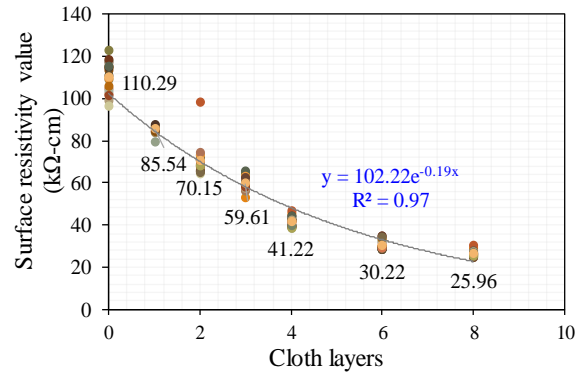
(a) Changes in SR due to different numbers of cloth layers

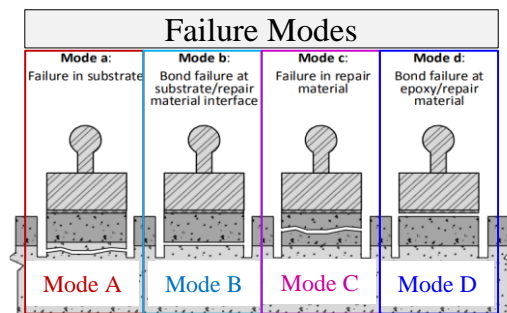
**Figure 5.16. Typical ASTM C1583 failure modes observed in pull-off tests**

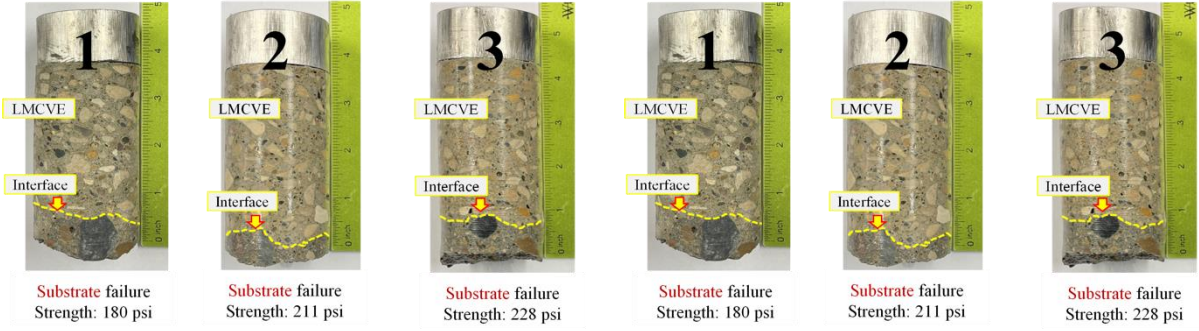
(a) Trip 10 (overlay age of 50 months)

**Figure 5.17. Comparison of pull-off test failure modes at different overlay ages (with bond failures highlighted in red dashed lines)**

- The LMC-VE-substrate bond failure mode changed with time. At a very early age (4 days), the failure of the pull-off specimens occurred in the LMC-VE. For specimens between 2 and 14 months old, most failures occurred at the LMC-VE overlay-substrate interface. After that time (from 14 to 50 months), all specimens tested failed at the substrate, indicating the growth of the bond strength between the LMC-VE overlay and substrate.

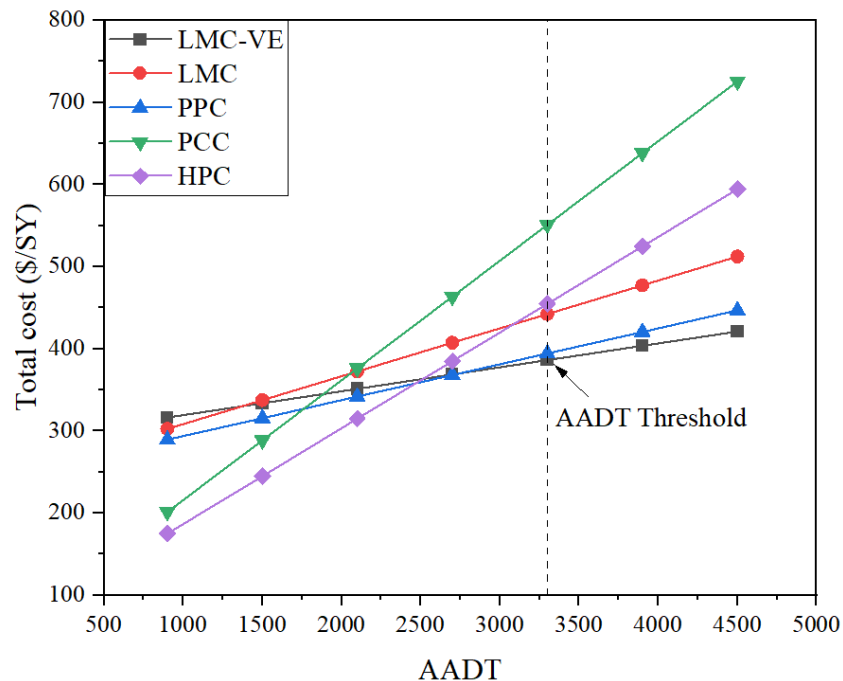
**Figure 6.4. Determining AADT threshold for LMC-VE overlay**

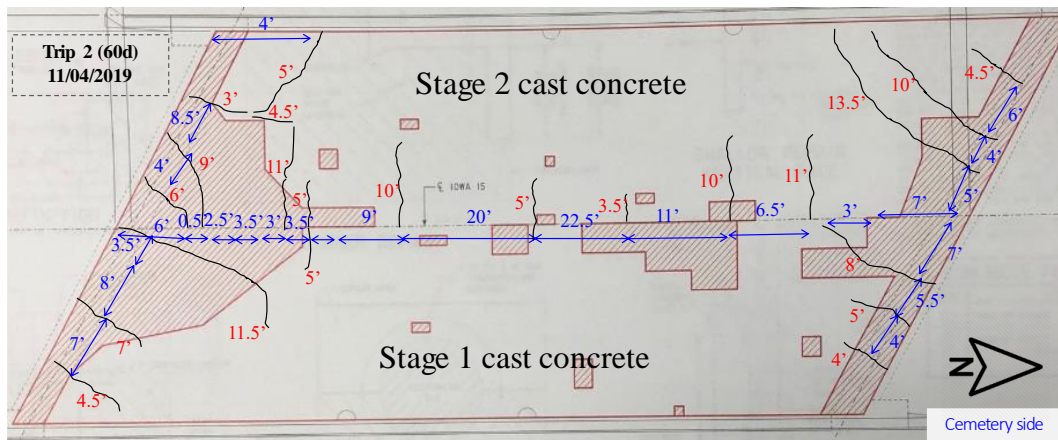
- Black: Cracks identified at 60d
- Red: Crack lengths at 60d
- Blue: Distances to cracks

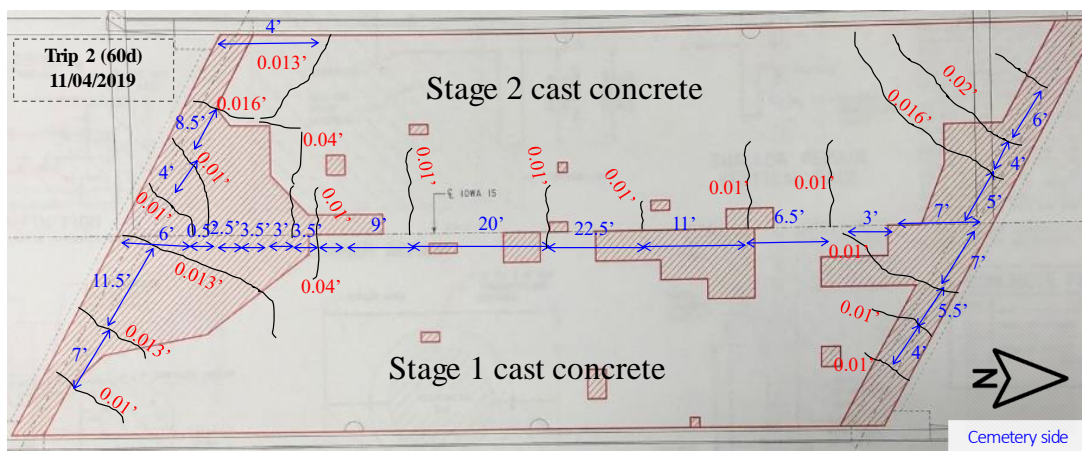
- Black: Cracks identified at 60d
- Red: Crack widths at 60d
- Blue: Distances to cracks

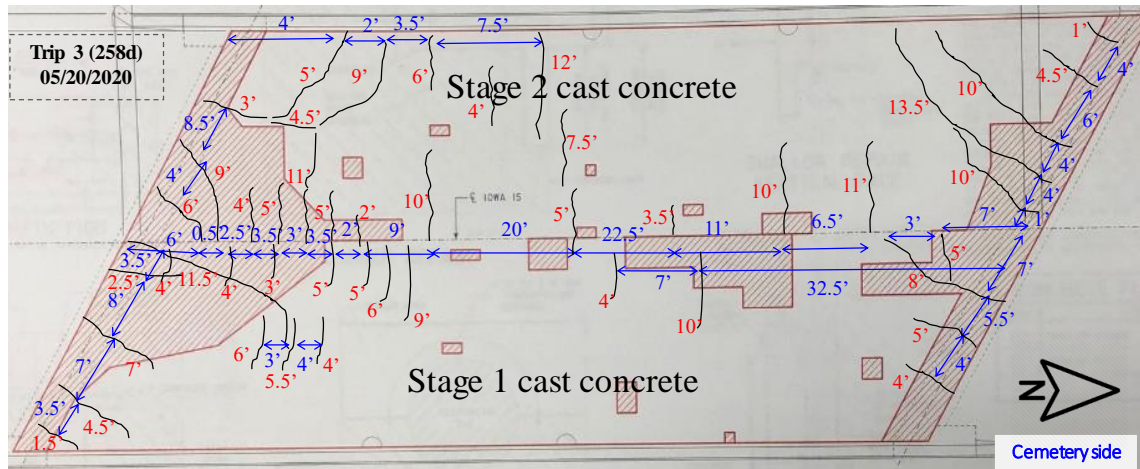
- Black: Cracks identified during Trip-3
- Red: Trip-3 crack lengths
- Blue: Distances to cracks

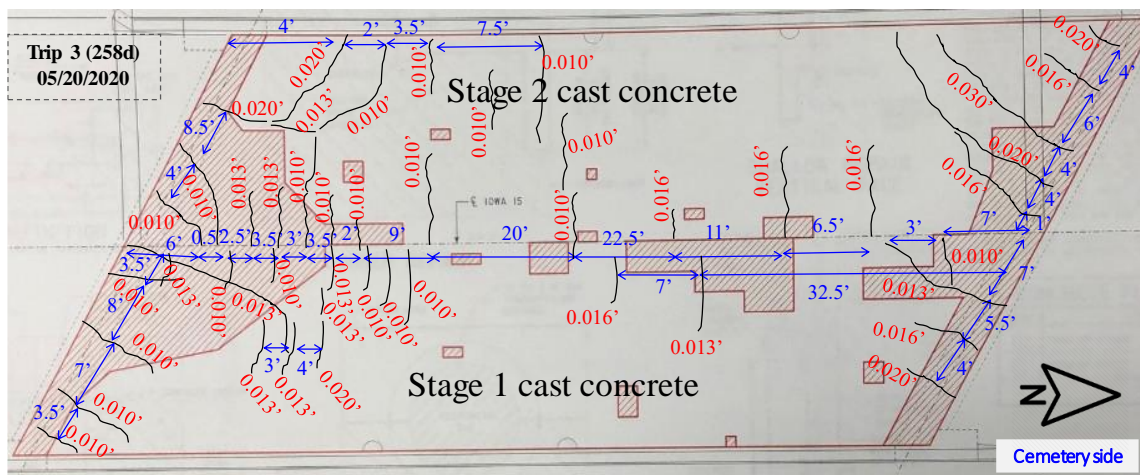
- Black: Cracks identified during Trip-3
- Red: Trip-3 crack widths
- Blue: Distances to cracks

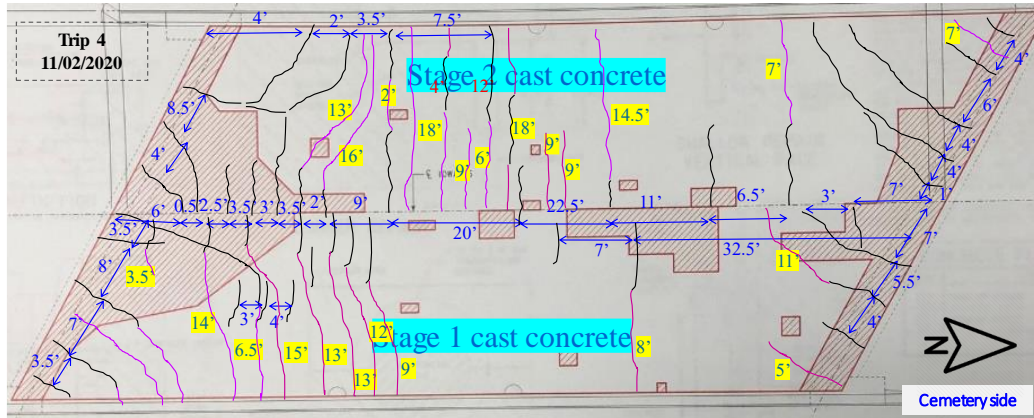
Black: Earlier cracks from Trip-3; Pink: Newer or extended cracks; Dark teal-Newer or extended crack lengths, Blue: Distances to cracks

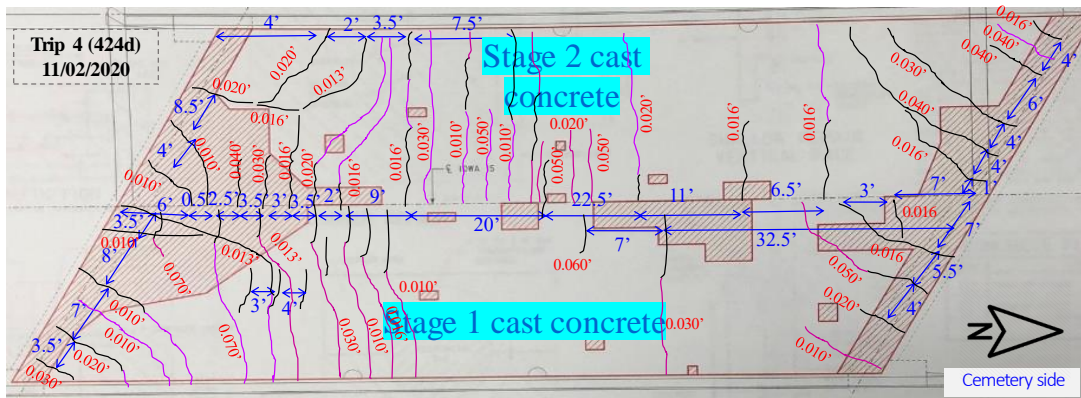
Black: Earlier cracks from Trip-3; Pink: Newer or extended cracks; Red: Latest crack widths from Trip-4, Blue: Distances to cracks

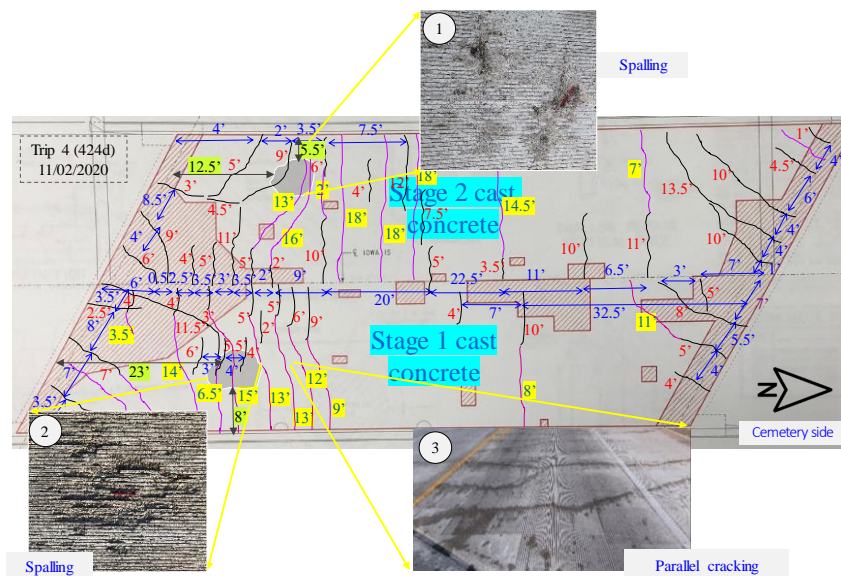
(c) Spalling damage observed at an age of 14 months
