# Demonstrating the Use of Small Uncrewed Aircraft Systems (Drones) Capabilities and Data for Iowa Transportation and Infrastructure Work

## Pilot Project No. 2 – Use of Small Uncrewed Aircraft Systems for Gravel Road Monitoring

Task Report | May 2026

**Sponsored by**  
Iowa Department of Transportation  
and Federal Highway Administration  
(SPR-RE24(010)-8H-00,  
InTrans Project 24-904)

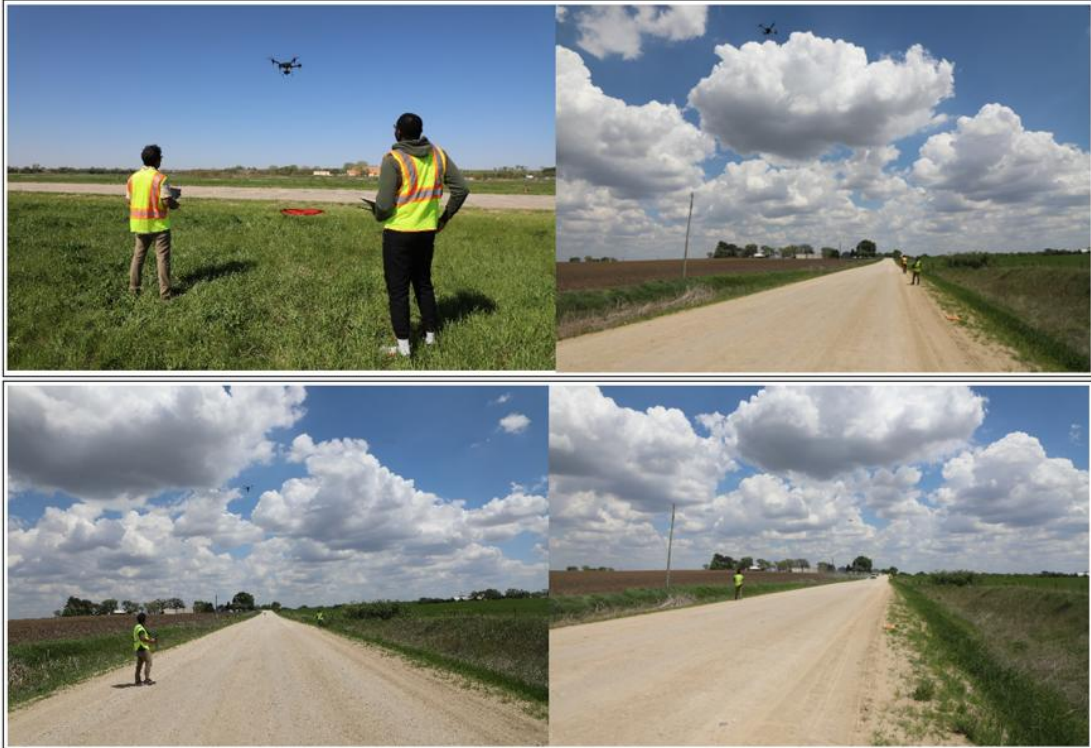
**Figure 2. Field photos captured during ongoing data collection at Iowa gravel road sites**

We visited gravel roads in Iowa that were either recommended by county engineers or observed while driving around the Iowa State University area. For example, upon request for sites with typical gravel road distress that have not yet been graded or maintained, the Buchanan County Engineer, Brian Keierleber, recommended that the gravel roads on 130th Street (between Grant Avenue and Henley Avenue) and 150th Street (approaching Amish Boulevard) in Buchanan County be addressed. While the 150th Street gravel road had developed corrugation and a significant number of potholes, the 130th Street gravel road had developed frost boils and rutting. Comparing the two sites, we noticed that the 150th Street gravel road generated more activated dust when driven on at 25 mph, though the level was still minimal. We measured the crown (cross-section) on 150th Street, and since we needed additional data for dust categorization, we identified other gravel roads in Iowa, including (1) Flemming Avenue, Story County, and (2) Frost Avenue, Buchanan County, that generated more dust. Figure 1 and Figure 2 provide overviews of the locations and field photos of the gravel roads.

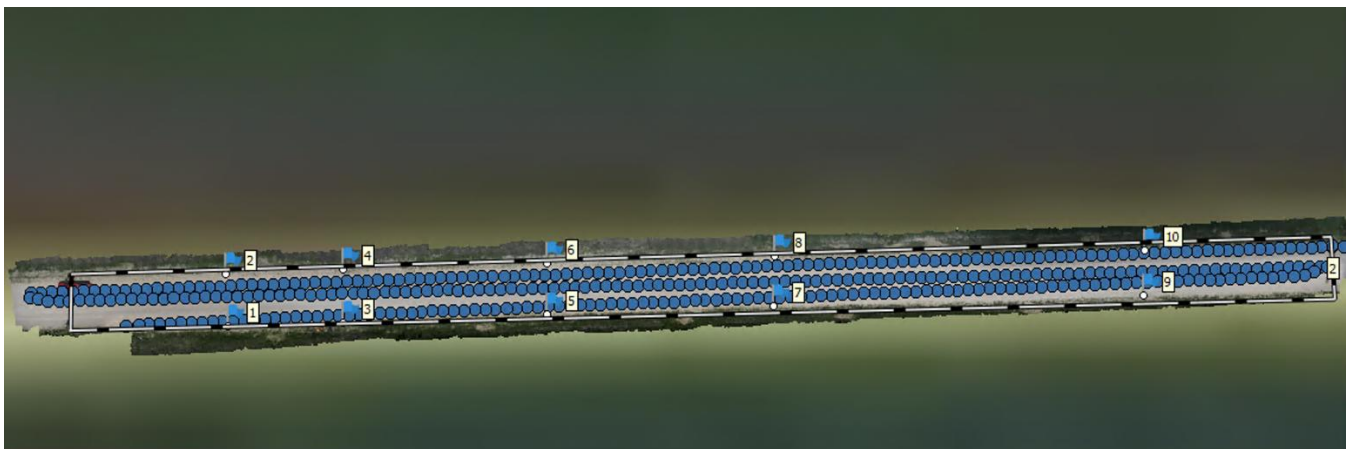
**Figure 3. sUAS image points on 150th Street, Buchanan County, Iowa, with ground control points represented with flags**

Data were collected under favorable wind conditions, which provided good flight stability and image clarity. Flight paths were flown at 80% forward and 70% side overlap to ensure high-quality orthophoto reconstruction.

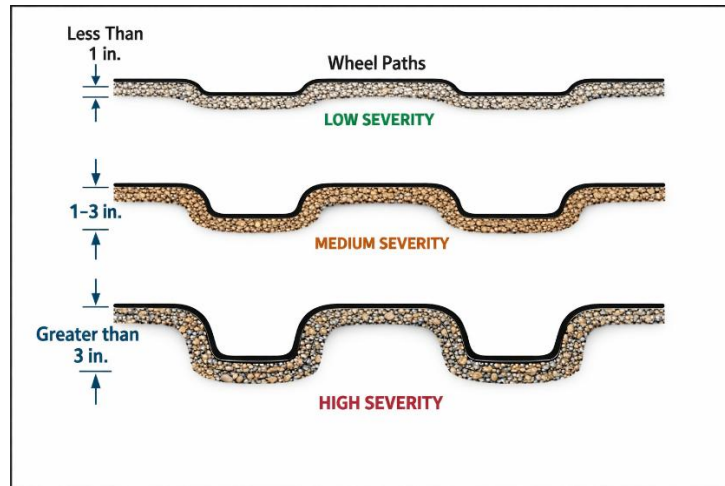
Rutting distress appears as depressions found along the wheel paths parallel to the road center (Eaton and Beaucham 1992). We followed the USACE technical guidelines in assessing the severity and overall deduct values resulting from the observed rutting distress, estimating the severity class (low, medium, or high) based on the elevation obtained from the DEM, and further estimated the width and length of each identified rut to approximate its area. As specified in the USACE technical manual, a low-severity rut depth is typically less than 1 in. (2.5 cm), a medium-severity depth is between 1 to 3 in. (2.5 to 7.5 cm), and a high-severity depth is greater than 3 in. (7.5 cm), suggesting that, in terms of severity, the rutting should be measured in square feet. For example, a sample unit may have 75 ft<sup>2</sup> of high-severity rutting. Figure 5 illustrates the severity levels of ruts provided in the USACE technical manual. Since our algorithm bins detected rut patterns according to three severity classes, we bounded the low-severity rutting between 0.5 in. (1.27 cm) and 1 in. (2.5 cm), ensuring that unrutted regions are not classified as low rutting distress.

**Figure 5. Rut severity illustration**

Our proof-of-concept algorithm’s accuracy directly relies on the resolution of the DEM data. Following the idealized rut pattern illustrated in Figure 5, we developed our rut detection toolbox to track ridges and intervening valleys, regardless of the roughness of the edges. To reduce false-positive detection, we assumed that the minimum height of the lower ridge sufficient for ponding and significant rutting should be 10% of the higher ridge level. The workflow of the adopted logic is presented in Figure 6.

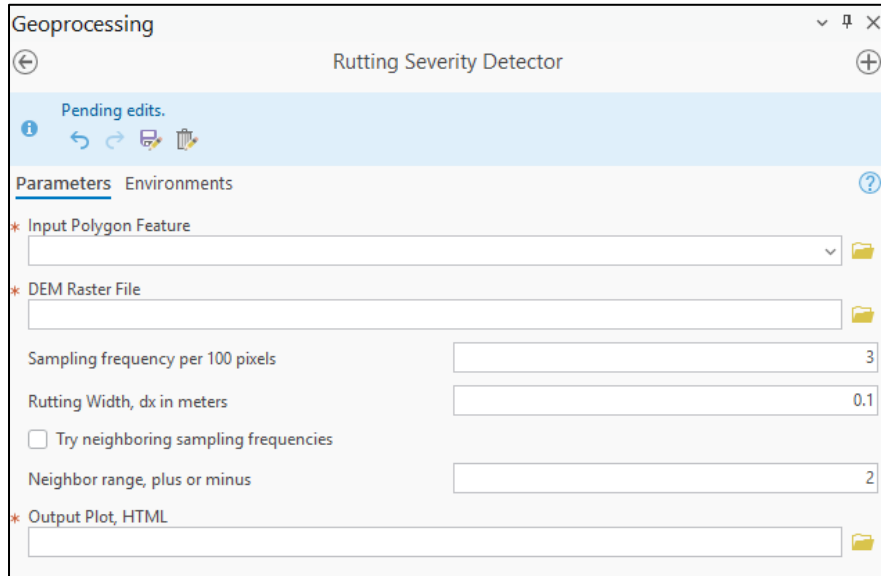
**Figure 7. Screenshot of the customized proof-of-concept rutting severity detection toolbox**

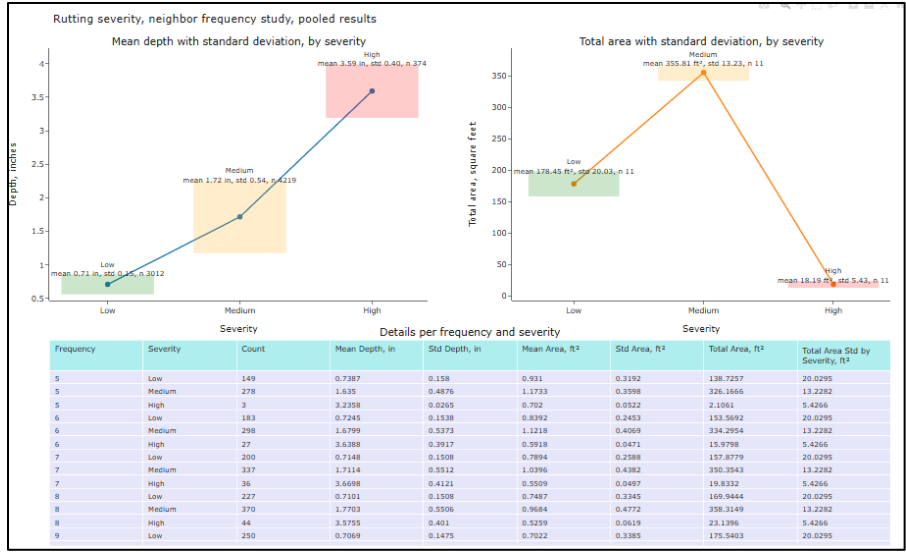
Figure 10. Screenshot from the HTML output with neighboring sampling frequency activated

Figure 10 and Figure 11 are screenshots from the HTML output files for both sampling cases. To ease rutting distress localization, our program adds feature layers to the map, showing regions of detected ruts. Finally, it is important to note that regions of frost boils are identified by the algorithm as high-severity rutting. While the user may constrain the expected wheel path region to better apportion rut regions, unsurfaced gravel roads are typically low volume and may lack a specific two-way traffic pattern. Therefore, we did not alter the algorithm, assuming that areas identified as high-severity rutting may instead indicate the frost boils.

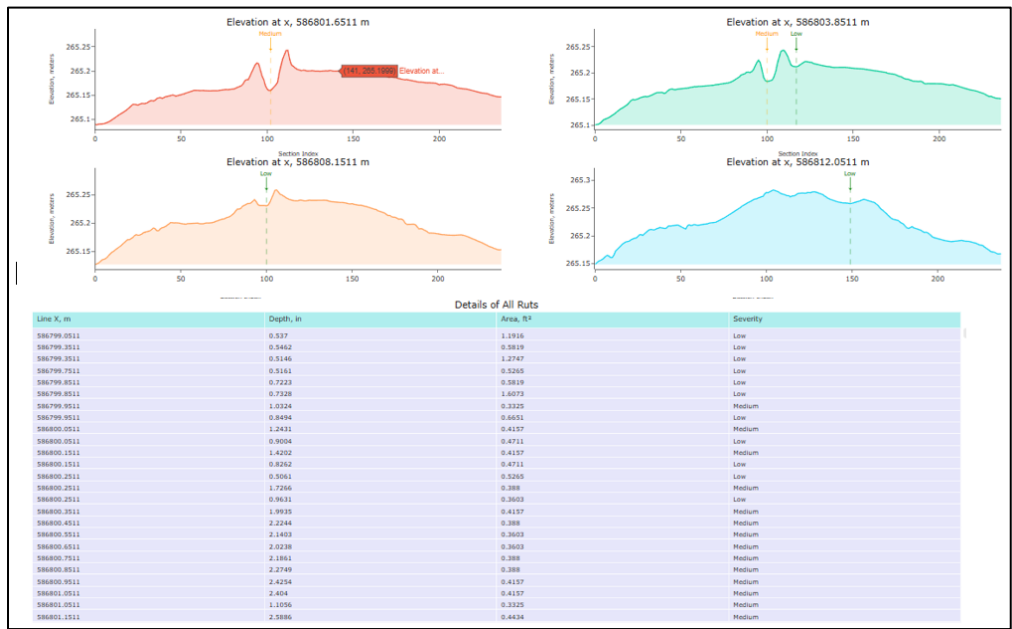
Figure 11. Screenshot from the HTML output without neighboring sampling frequency activated

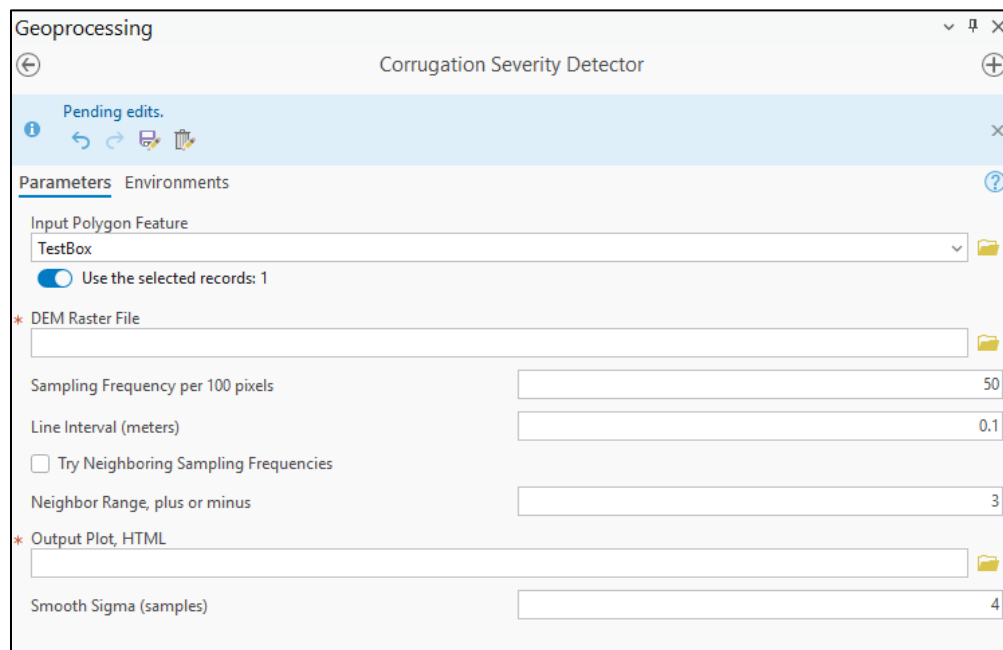
**Figure 18. Screenshot of the proof-of-concept corrugation detection toolbox**

While the proof-of-concept workflow is similar to the rutting toolbox, in that it shares the same input features, we added Gaussian smoothing to simplify the aggregation of predefined corrugation patterns. The smoothening effect is controlled by the standard deviation input parameter for the Gaussian kernel ( $\sigma$ ), which determines the width of the kernel filter. The rule of thumb is that the wider the  $\sigma$ , the stronger the smoothening effect on the input data. Screenshots of the customized toolbox and a polygon drawn over the orthophoto (with the DEM underneath) are shown in Figure 18 and Figure 19, respectively.

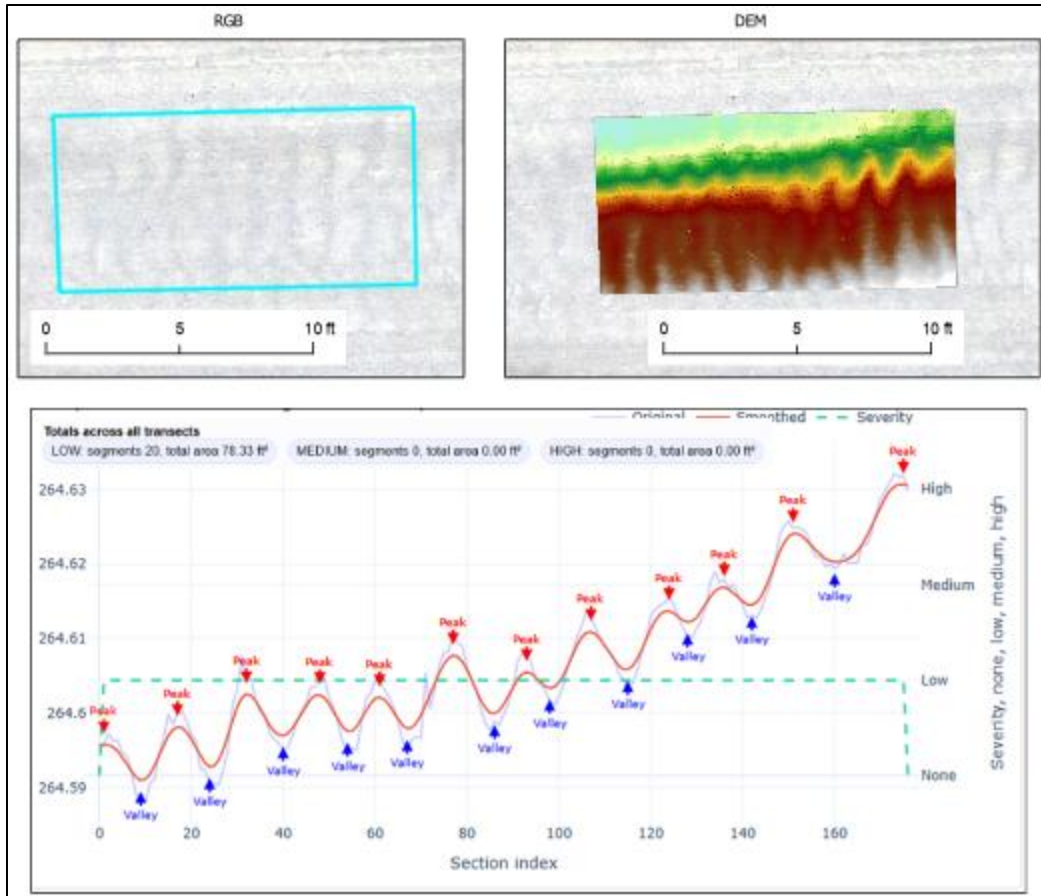
Figure 20. Screenshot of the HTML output file when neighboring sampling frequency is inactive

The proof-of-concept toolbox can generate different HTML outputs depending on whether the neighboring sampling frequency checkbox is activated, as in the rutting toolbox. If unchecked, the program uses a single sampling frequency and produces a plot like that shown in Figure 20, which includes the elevation plot, the smoothed elevation, and the severity plot across the horizontal guiding line. As observed in the small-region corrugation results, the results illustrated in Figure 21 show the probabilistic plot when neighboring sampling frequency is activated.

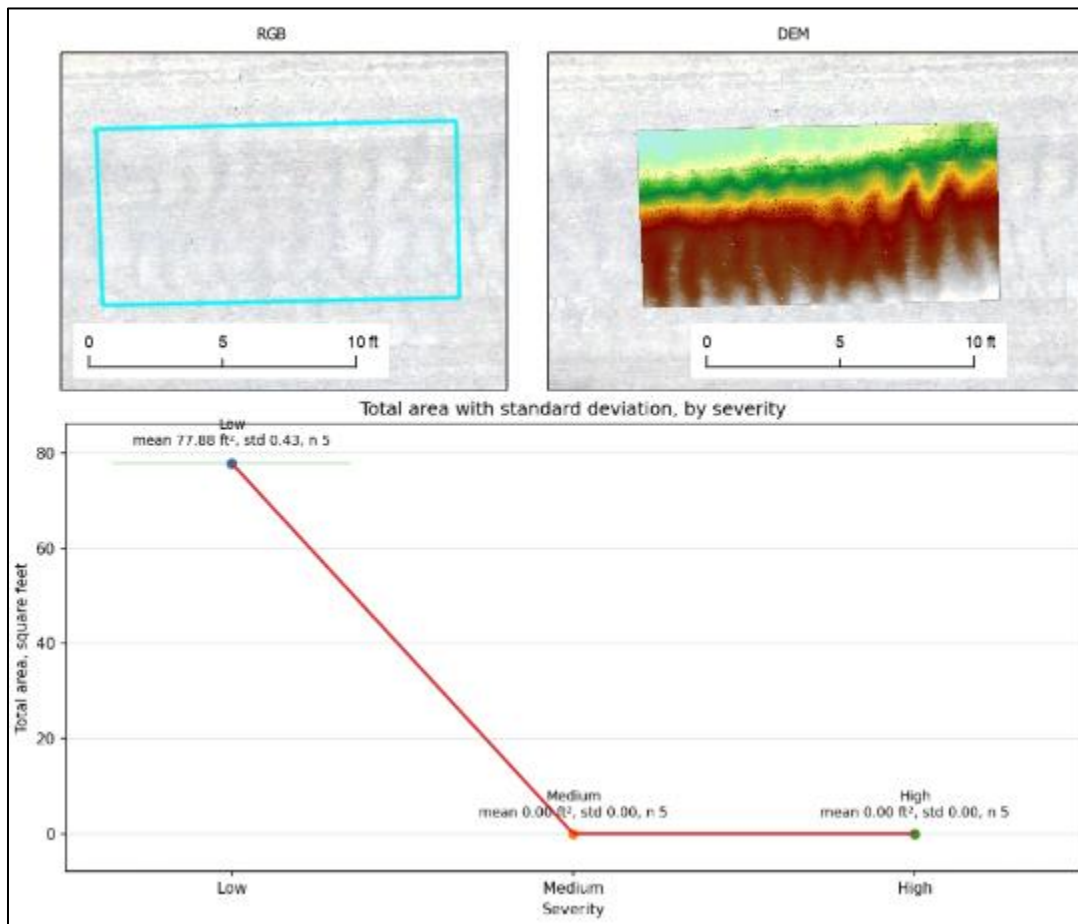
**Figure 21. Screenshot of the HTML output file when neighboring sampling frequency is active**

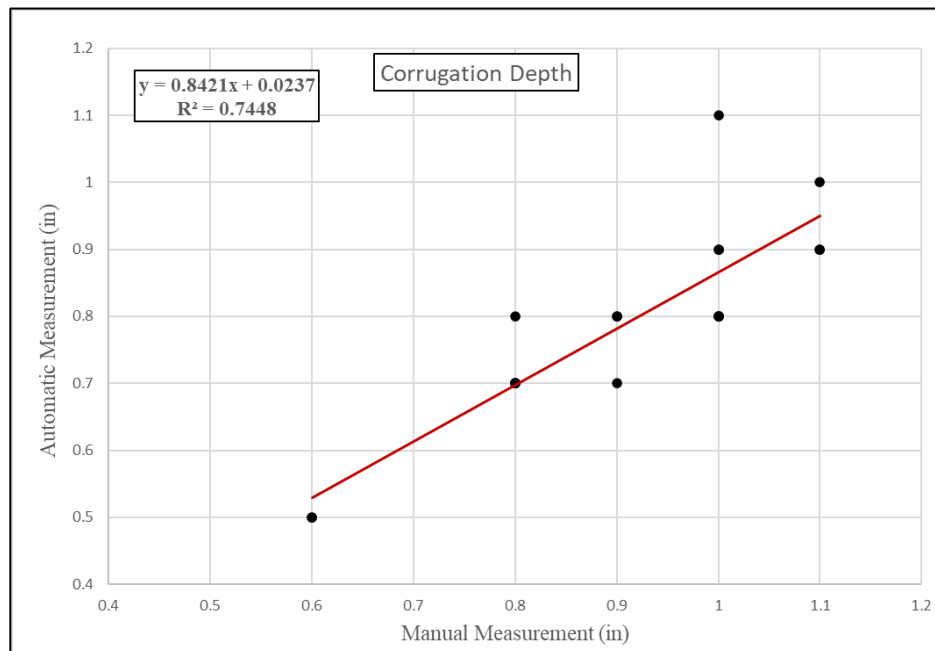
We manually measured 20 points of corrugation depth between the ridges and compared the results with the automatically derived depths. However, manually measuring all 20 points in the field was not only time-consuming but also unsafe for human observers due to moving traffic and dust stirred up by the traffic. The adoption of sUAS for these tasks would ensure that data are collected quickly and safely. The developed proof-of-concept corrugation detection algorithm outputs both the severity category and the extent of the distress, a task that would typically require significant time and personnel resources if done manually. Table 4 and Figure 22 present a comparison of the manually and automatically measured data points. We achieved an  $R^2$  of approximately 0.74 from the comparison. Because the drone flight occurred after all 20 corrugated points had been marked, we suspected that traffic during the intervening period most likely altered the corrugation's ridge-and-valley geometries, resulting in the observed differences between the manually measured and automatically measured depth values. Similar to rutting

**Figure 22. Manual versus automatic corrugation depth measurement**

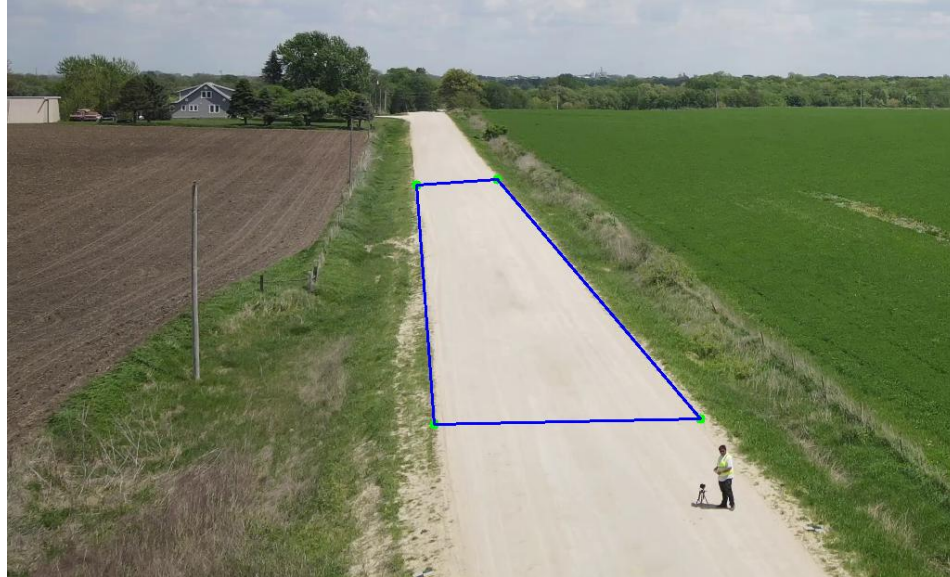
**Figure 24. Bounded sample unit for dust monitoring**

In addition to elevation-based pattern recognition, we developed a framework for classifying dust severity using color images and deep-learning models. As specified in the USACE technical manual, the severity level is determined by the visibility obstruction caused by the leading traffic at a speed of 25 mph. Based on this methodology, we adapted a method for dust data collection using sUAS. We identified a sample unit section during field data collection, then restricted our automatic detection framework to the sample unit by drawing a polygonal boundary using four key points, as shown in Figure 24. To capture the dust cloud trailing the leading traffic that generates the dust, we positioned the sUAS to hover in the sky with the camera capturing the leading traffic as it drove off.

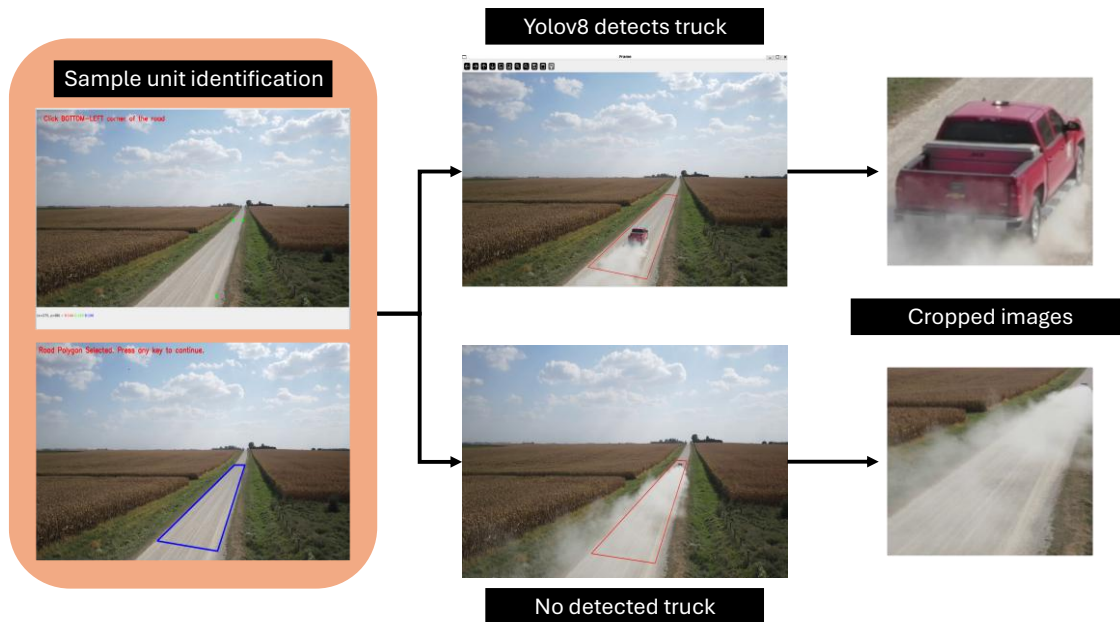
**Figure 26. Cropping mechanism for sUAS video frames**

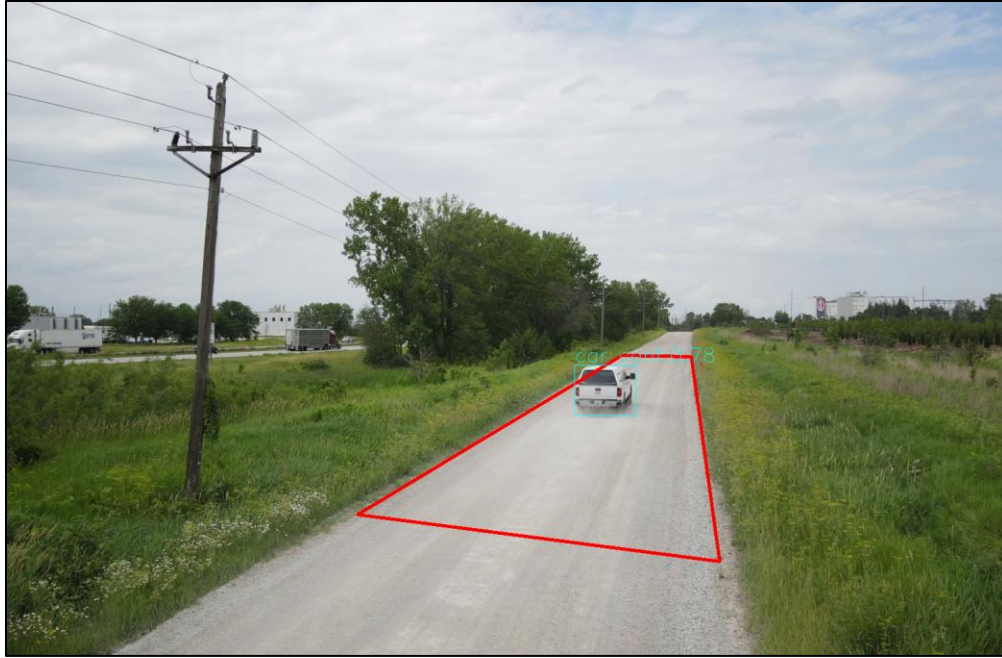
**Figure 27. YOLOv8 vehicle detection within a bounded region (Flemming Avenue, Story County)**

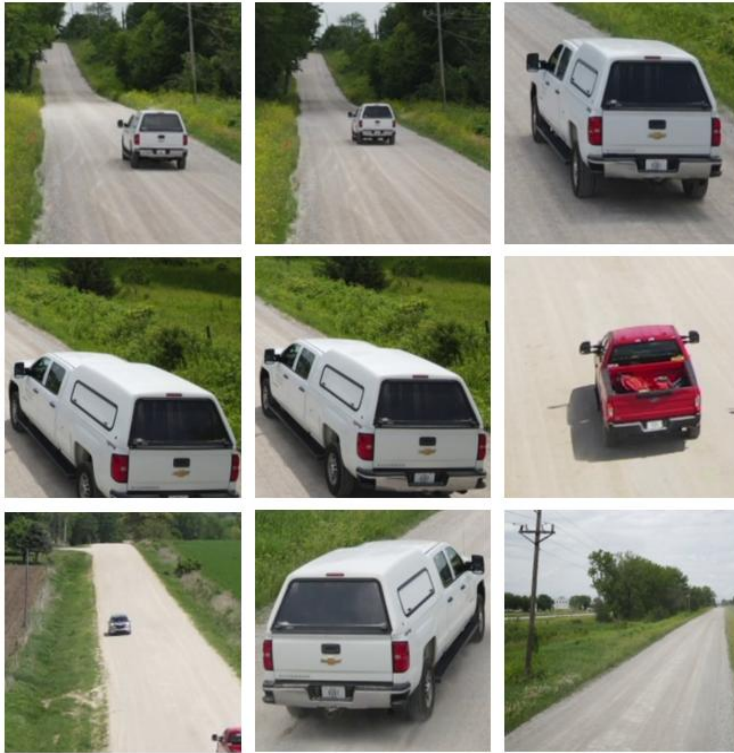
**Figure 28. No-dust images**

We manually labeled all of the cropped images from the video frames in Label Studio, an open-source data annotation hub (Label Studio n.d.), and randomly selected images from the three categories to create the collages shown in Figure 28, Figure 29, and Figure 30.

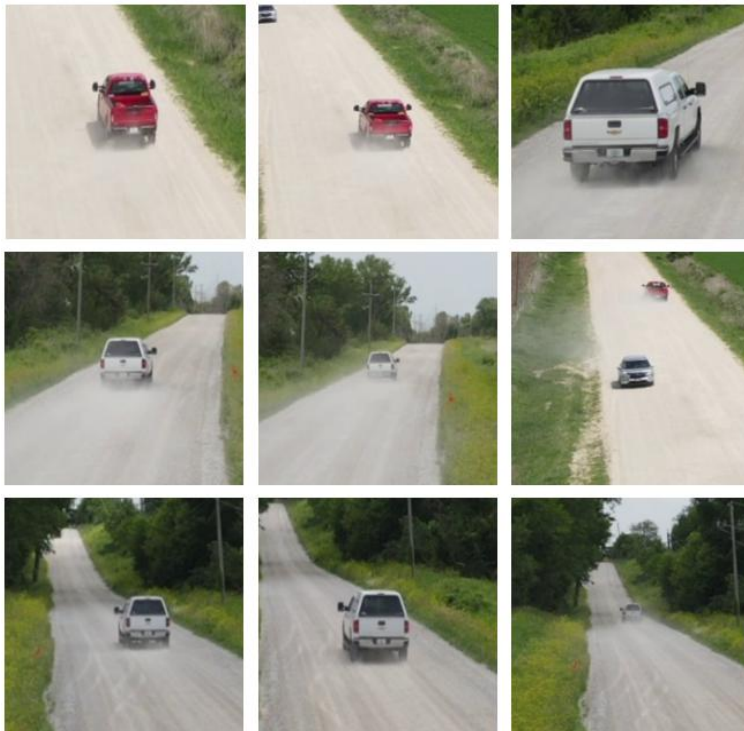
**Figure 29. Low-dust images**

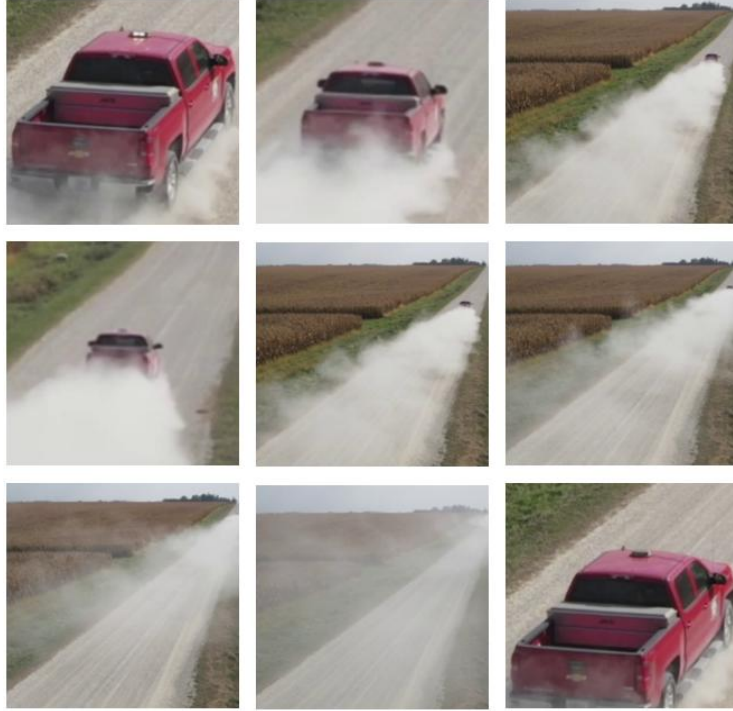
**Figure 30. High-dust images**

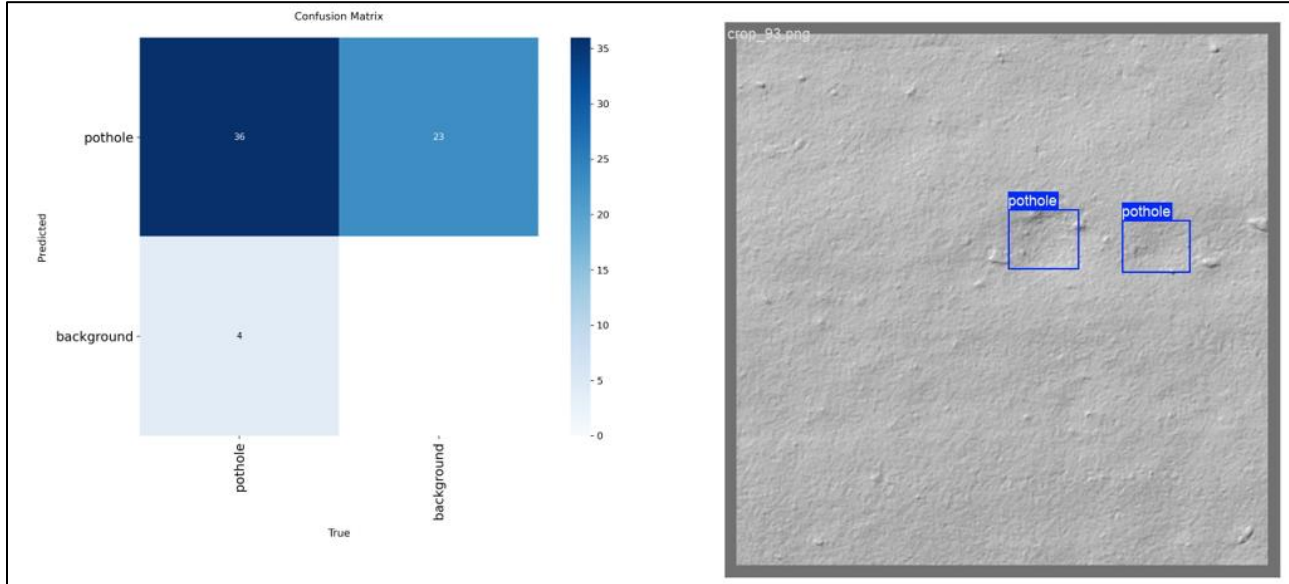
**Figure 33. Confusion matrix of Yolov5 performance on validation dataset (left) and sample prediction on validation dataset (right)**

72.7%. The model’s performance is expected to improve with the inclusion of additional high-quality processed sUAS data from gravel road sites containing a greater number of pothole distresses of varying severity levels, which would help reduce false positives and enhance overall detection accuracy.

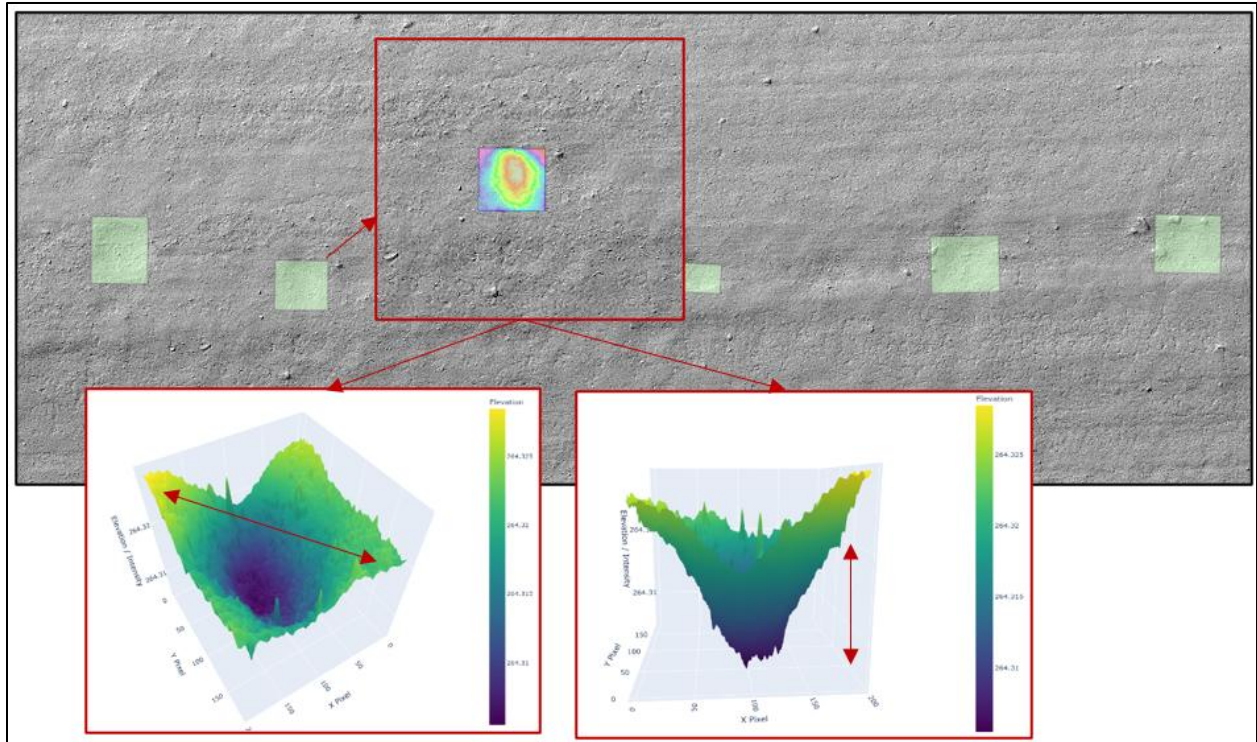
**Figure 34. Detected potholes and 3D plots of a sample pothole showing the extent of diameter and depth**

The bounded boxes around the potholes were clipped from the DEM data for diameter and depth approximations. Similar to the work done for other distresses, we developed a prototype toolbox in ArcGIS Pro for quick approximation of pothole depth and width. All of the detected potholes are input into the toolbox, and the toolbox assigns each a unique label and determines its severity level. A sample of a detected pothole region is shown in Figure 34, which shows a 3D plot of the pothole.

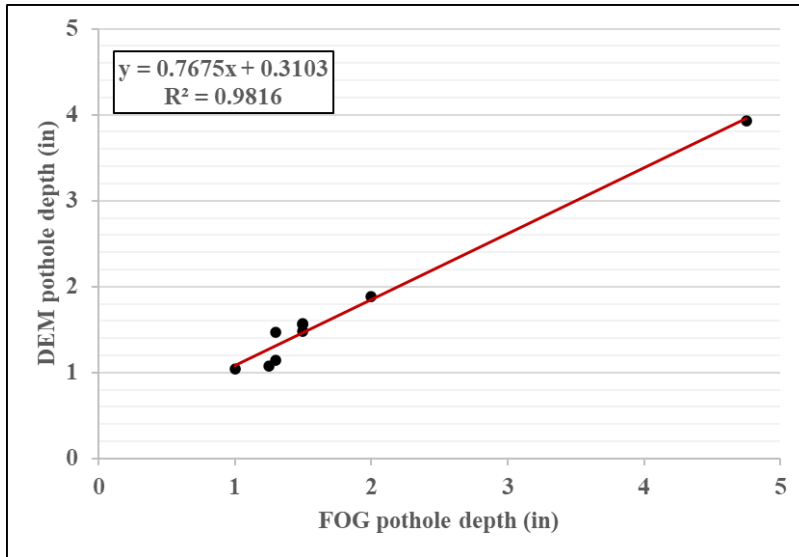
**Figure 35. Scatterplot of FOG versus DEM pothole depths with the line of best fit**

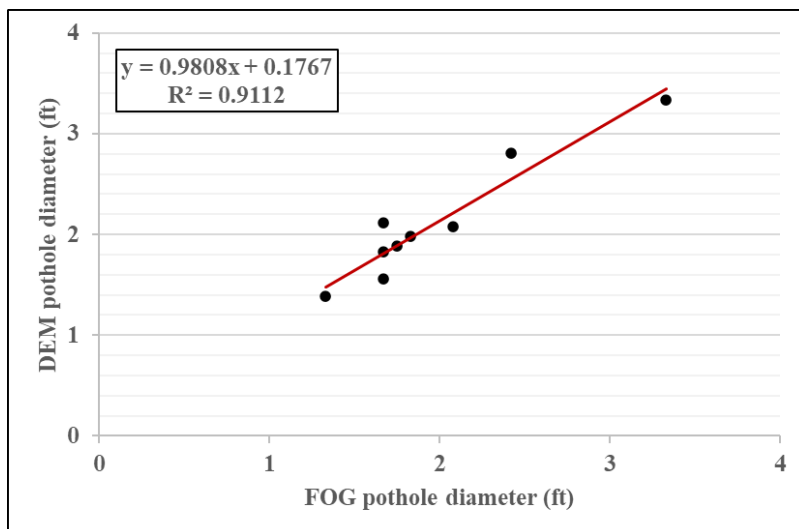
**Figure 36. Scatterplot of FOG versus DEM pothole diameters with the line of best fit**

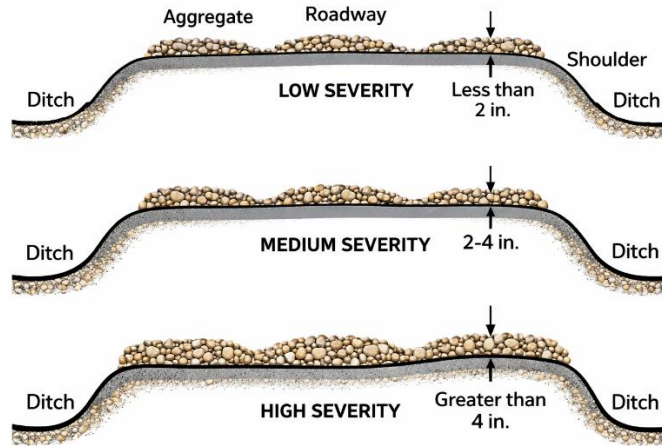
**Figure 38. USACE loose aggregate severity classification**

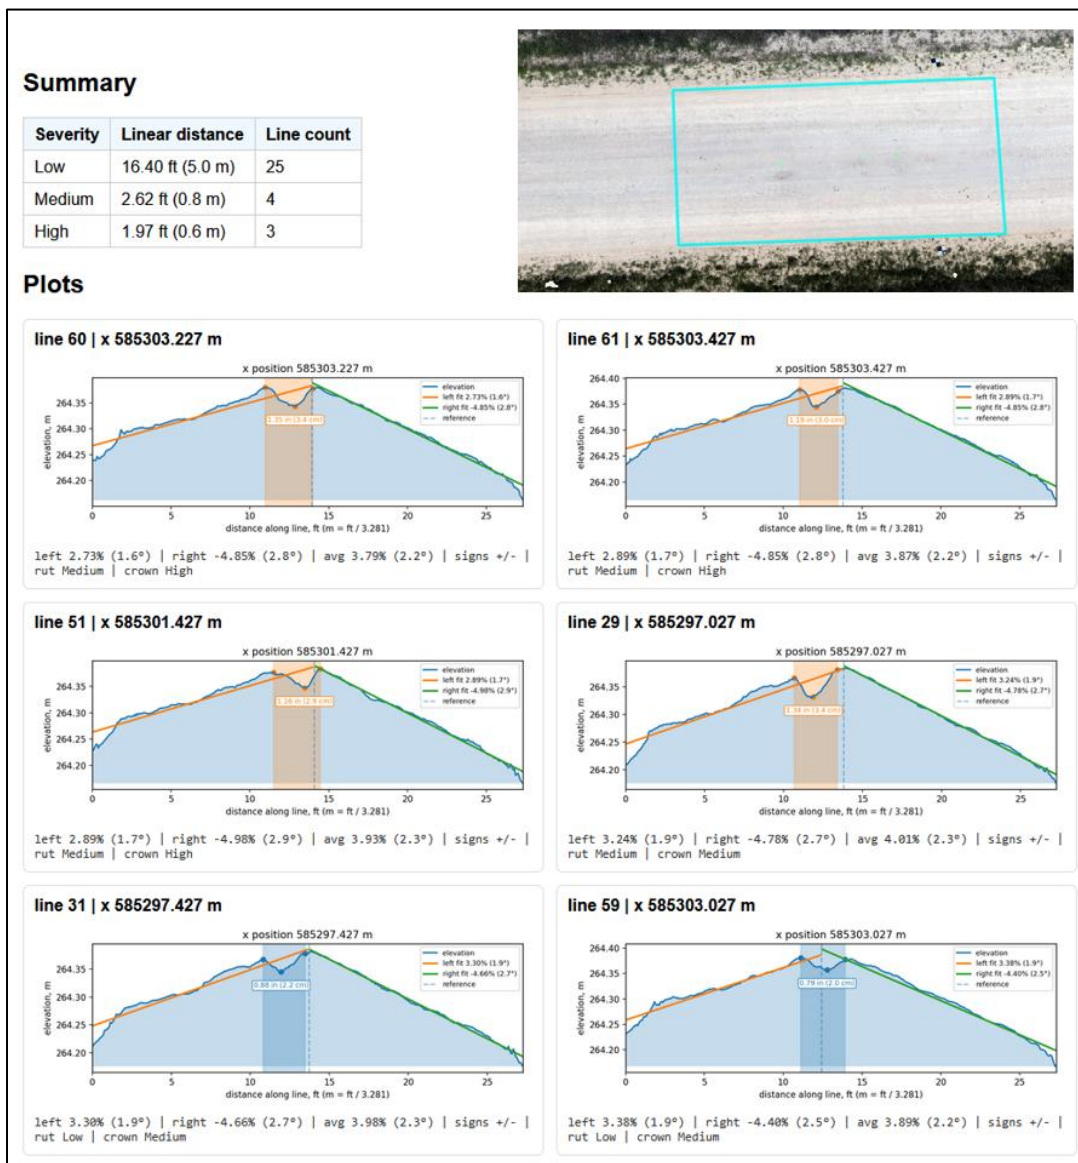
Figure 42. Crown distress report for a section on 150th Street

manual. We tested the algorithm for the two sites: 150th Street and 130th Street in Buchanan County, Iowa. Figure 42 and Figure 43 show the resulting reports for the two site sections, with the orthophoto of each selected section shown in the inset. While we set the spacing between the fictitious vertical line in the polygon to 0.65 ft (0.2 m), the DEM data points were sampled on each line at a constant frequency of 10 per 100 pixels. As noted in Figure 42, medium- and low-severity ruts were detected on the crown lines, resulting in the final crown severity based on the calculated slope and the formulated matrix in Table 9. As illustrated in Figure 43, the consistently high rut severity along the frost boil regions, combined with the estimated average slope index, resulted in an increase in the crown severity in the summarized report. It is essential to note that a more refined result would be achieved if the spacing between the fictitious lines were reduced, allowing the algorithm to limit the assumption of continued distress feature characteristics for each fictitious line within the polygon.

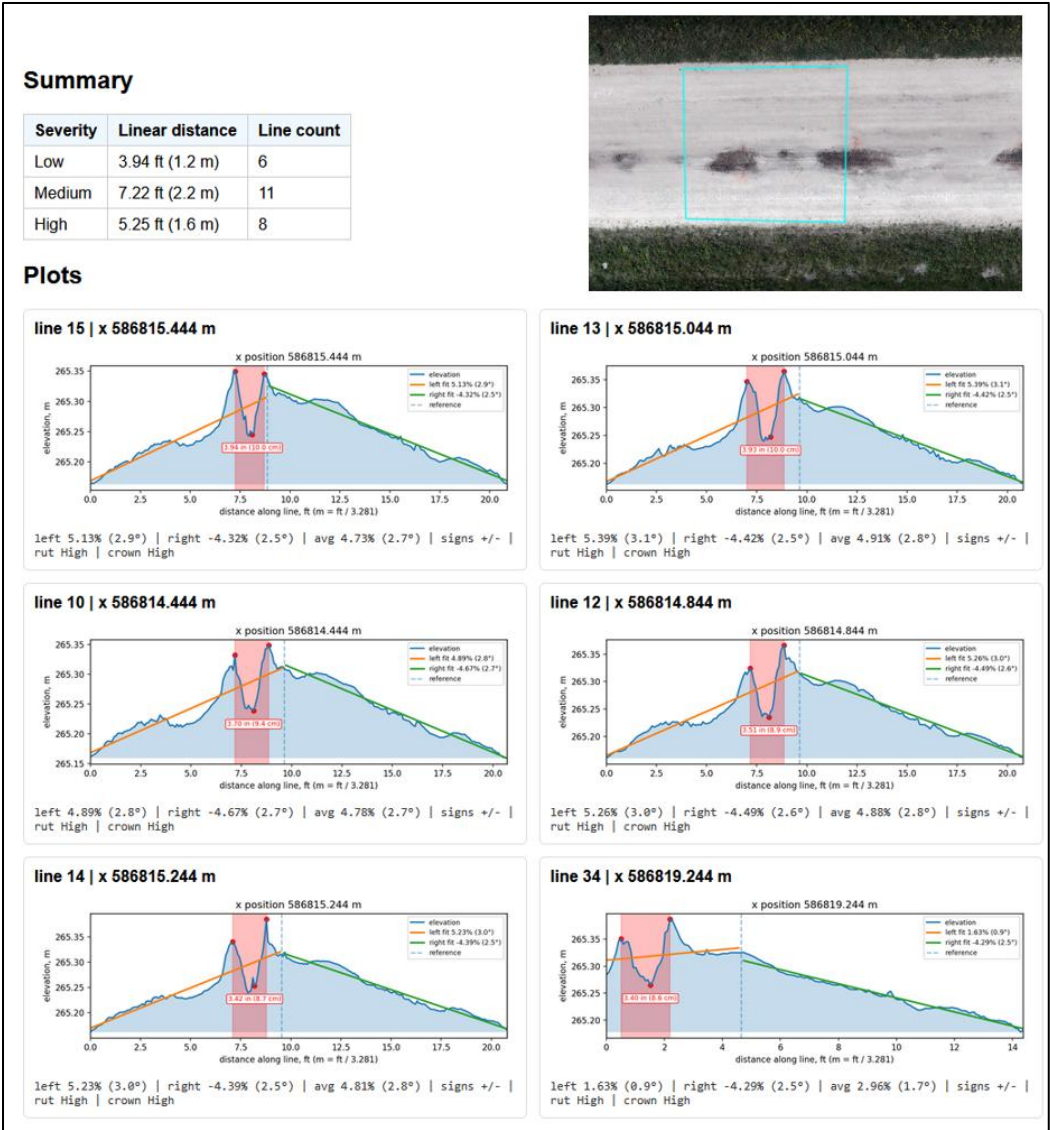
**Figure 43. Crown distress report for a section on 130th Street**

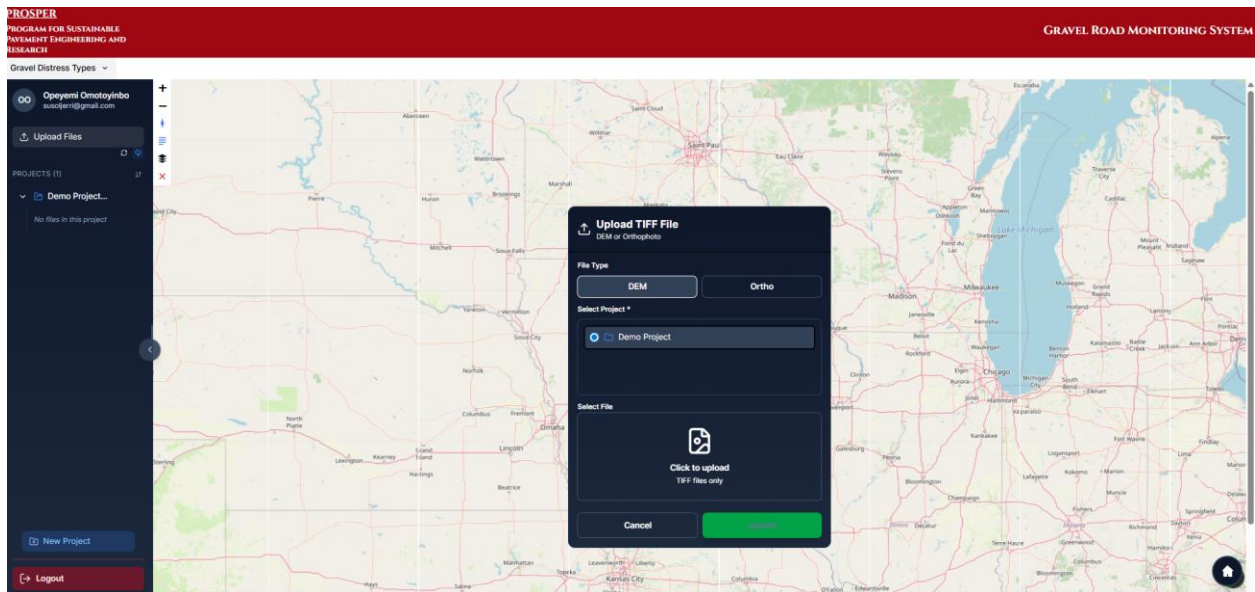
Figure 47. Interface for uploading processed sUAS data into the project folder

Logged-in users have access to the dashboard and the rut feature detection tool. To begin the analysis, users are expected to upload files such as DEMs and orthophotos, as shown in Figure 47.
