# Demonstrating the Use of Small Uncrewed Aircraft Systems (Drones) Capabilities and Data for Iowa Transportation and Infrastructure Work

## Pilot Project No. 3 – Use of Small Uncrewed Aircraft Systems for Erosion and Sediment Control Device Monitoring

Task Report | May 2026

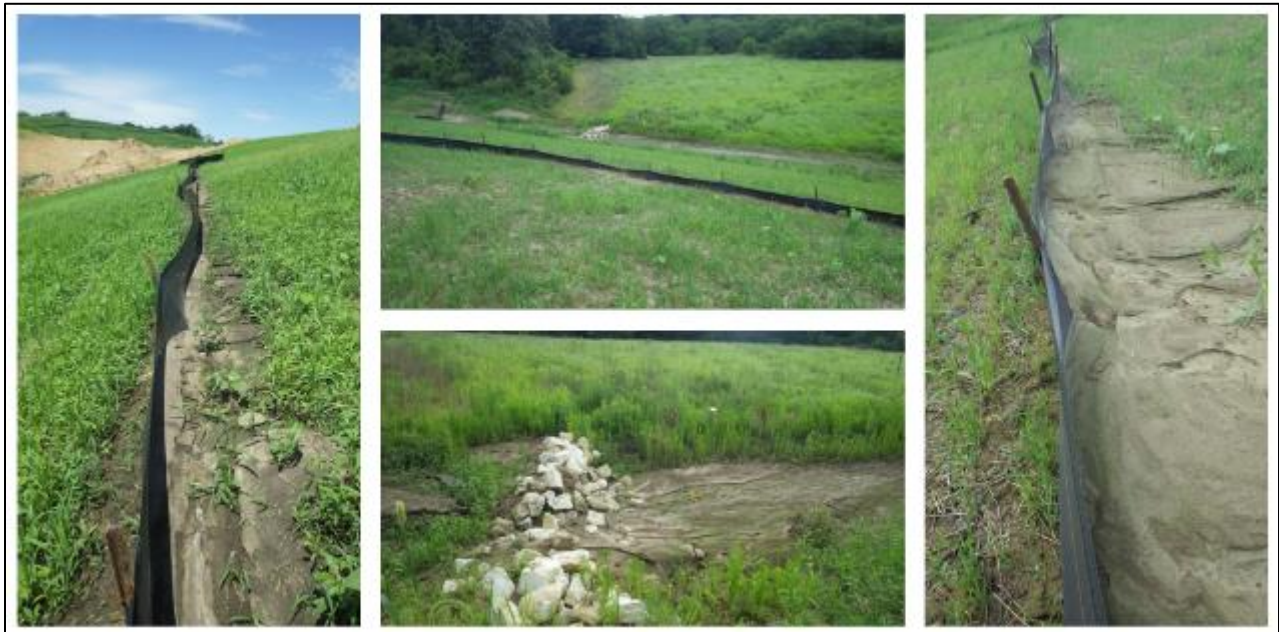
**Figure 4. Erosion and sediment control devices at Mediapolis Site 1, including silt fences and a check dam**

Overviews of the site locations and maps of both the Mediapolis and Oskaloosa sites are provided in Figure 2 and Figure 3, respectively. Figure 4 and Figure 5 show close-up views of some of the devices at Mediapolis Sites 1 and 2, respectively, while Figure 6 shows close-up views of some of the devices at the Oskaloosa site.

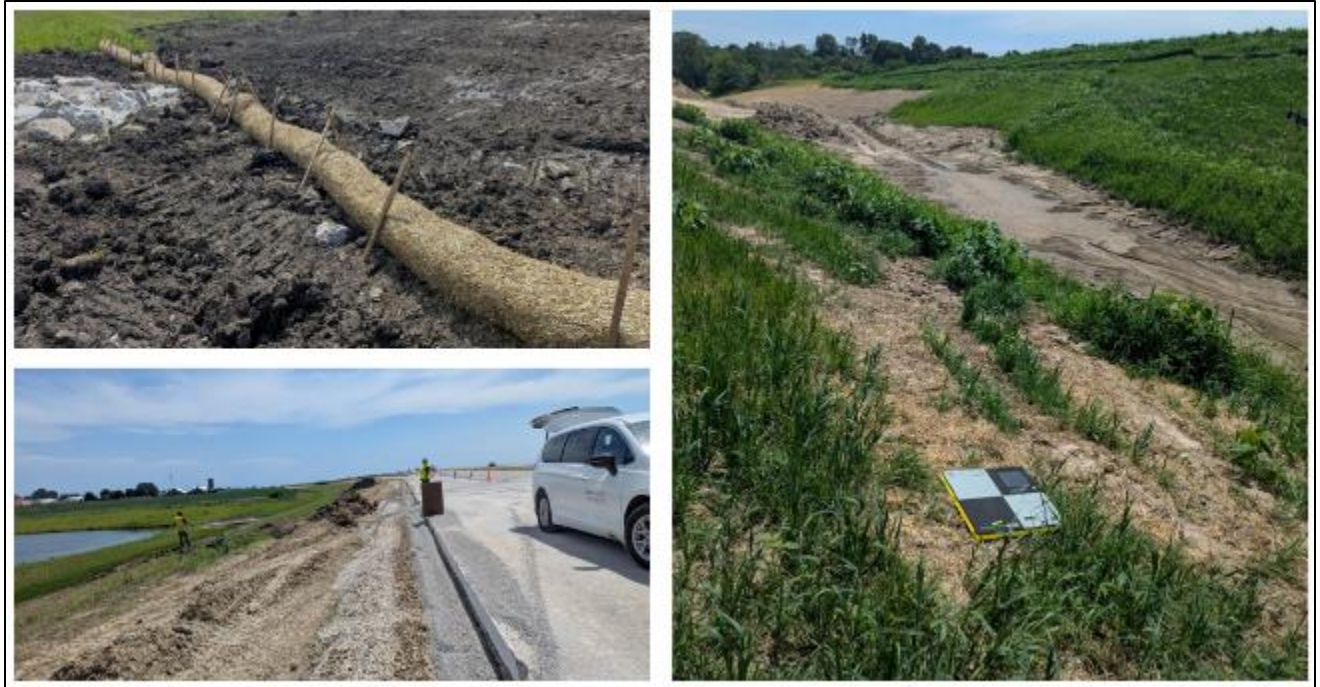
**Figure 5. Erosion and sediment control devices at Mediapolis Site 2, including wattles, a reseeded slope, and a check dam**

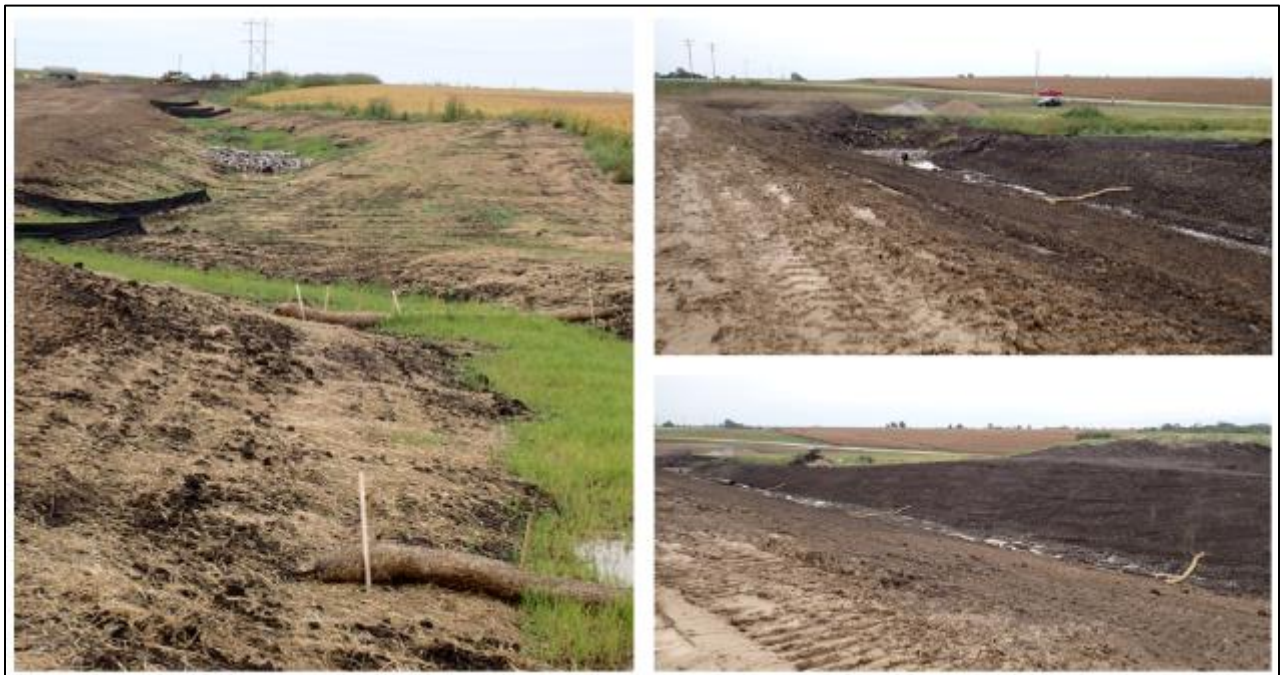
**Figure 6. Erosion and sediment control devices at the Oskaloosa site, including wattles**

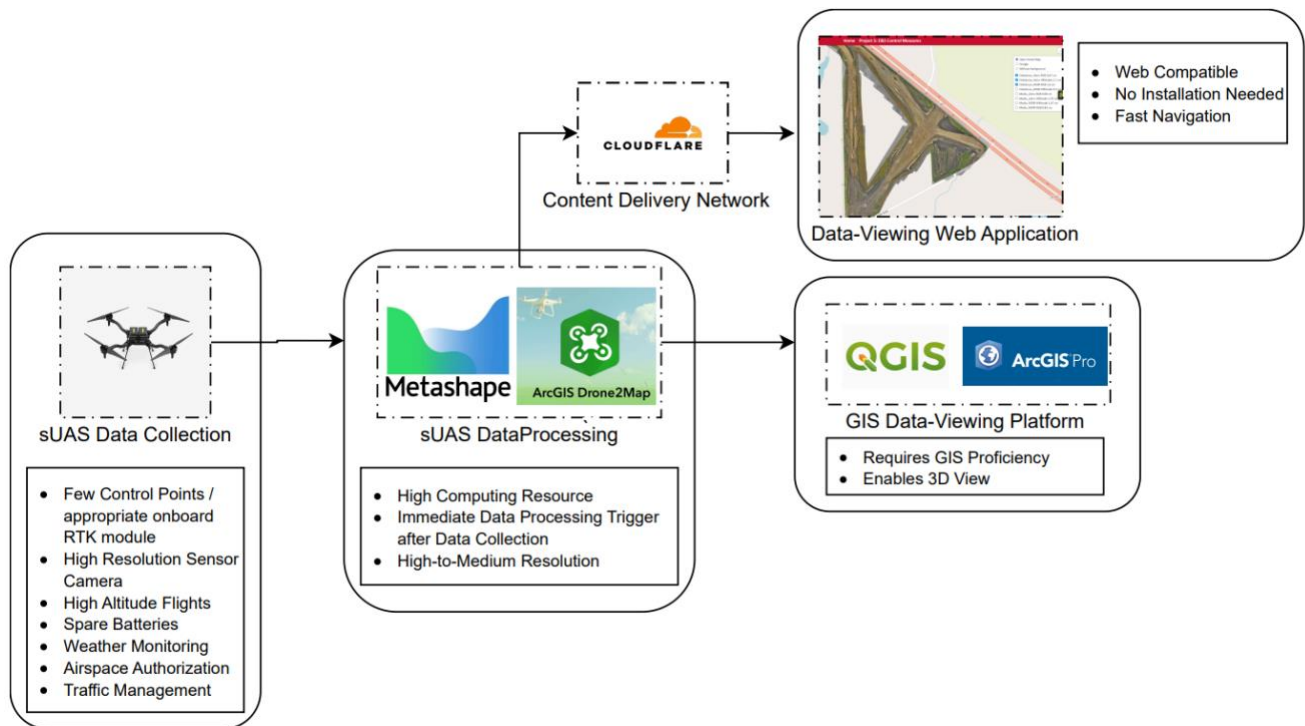
**Figure 7. Data pipeline from collection to visualization**

sUAS data collection and processing entail meticulous procedures that must be strictly adhered to for seamless operation and the delivery of desired results. Given that the Iowa DOT conducts weekly field inspections of ESCDs, it was imperative to produce not only a seamless data processing pipeline but also an expedited workflow that would deliver processed data within 24 to 48 hours. We therefore sought to identify the critical features that would support expedited and seamless sUAS operations, enabling the delivery of processed data at the right time for remote assessment and device condition monitoring. Figure 7 illustrates the prototype workflow for transitioning data from collection to visualization, and the subsequent sections in this chapter discuss the aspects of this workflow in detail.

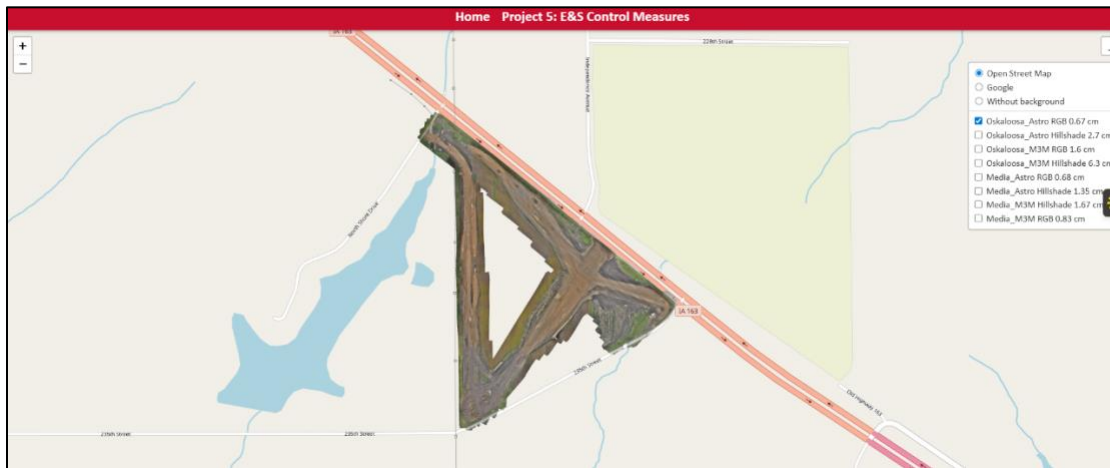
Rapid access to sUAS data is essential for ESCD monitoring and performance evaluation, particularly following precipitation events. To demonstrate the feasibility of timely data delivery, the research team developed a prototype online data sharing platform that hosts processed RGB orthophotos and DEM files. The web portal was built using the Leaflet application framework, which enables dynamic data retrieval from a public server. To improve performance and loading efficiency, the orthophotos were divided into smaller image tiles and hosted on a Cloudflare server, allowing the portal to seamlessly fetch and display the data. Members of the MTRI research team uploaded similar datasets to MTRI's existing server infrastructure, and all related drone data were also made available for viewing and access through the platform. Figure 8 and Figure 9 are screenshots from <https://prosperiastate.github.io/> and [https://apps2.mtri.org/iowa\\_dot\\_viewer/home](https://apps2.mtri.org/iowa_dot_viewer/home), respectively.

**Figure 8. Web-based data viewing platform (Iowa State University version)**

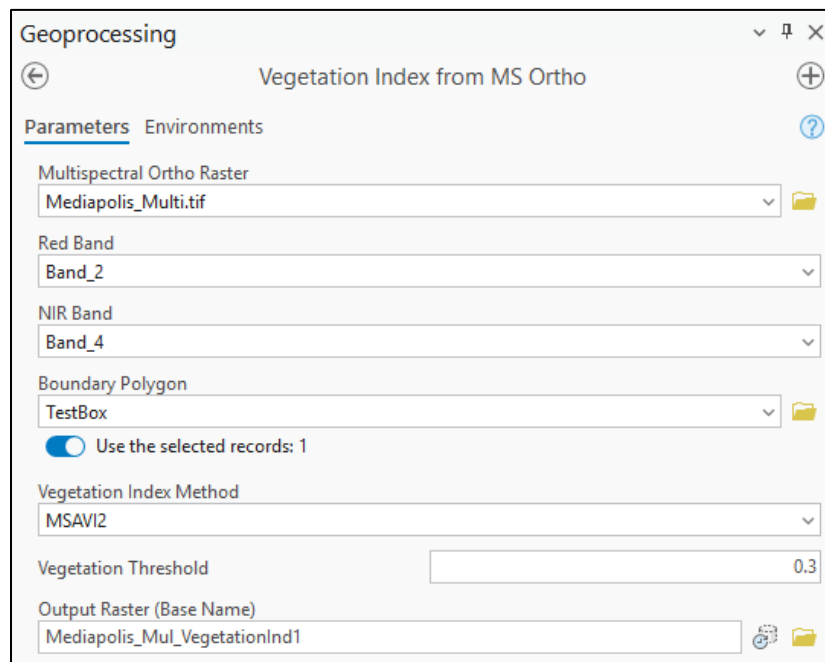
**Figure 10. ArcGIS Pro proof-of-concept toolbox for automatic vegetation index estimations**

We developed a proof-of-concept toolbox in ArcGIS Pro capable of extracting the required image bands from the raster files for the calculation of each pixel’s vegetation index, with users expected to know what each band number represents. A screenshot of the toolbox is shown in Figure 10, with bands 2 and 4 representing the red and near-infrared bands, respectively. Since the end product of analysis is to binarize each pixel value as either vegetation or non-vegetation, users are expected to provide a class threshold boundary (in the screenshot, a value of 0.3 has been provided), above which index pixels are classified as vegetation and below which pixels are classified as not vegetation. We also integrated the NDVI, SAVI, and MSAVI formulae into the code, allowing users to select one of the three expressions per analysis run.

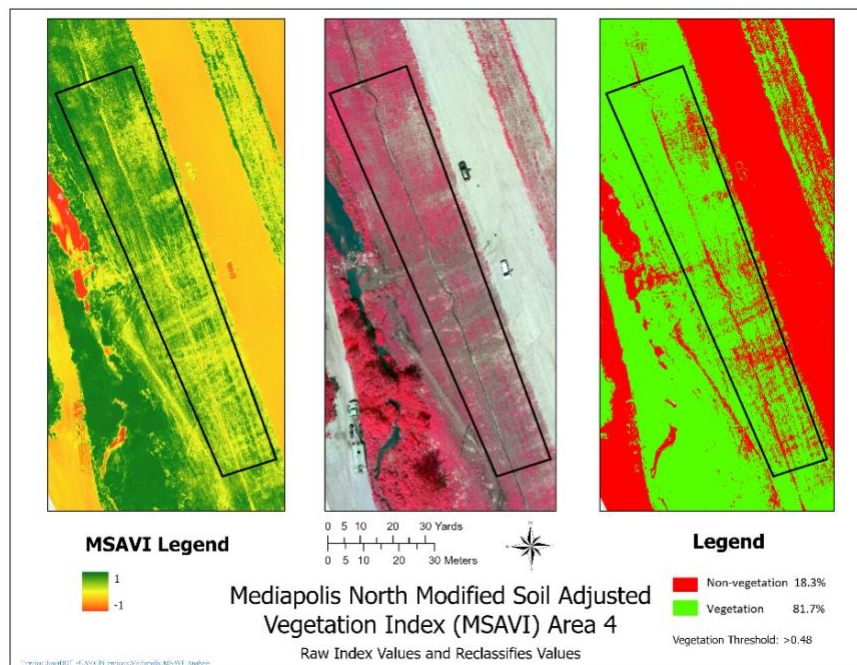
**Figure 11. Mediapolis Site 1 MSAVI results for demarcated area 1**

**Figure 12. Mediapolis Site 1 MSAVI results for demarcated area 2**

**Figure 13. Mediapolis Site 1 MSAVI results for demarcated area 3**

**Figure 14. Mediapolis Site 1 MSAVI results for demarcated area 4**

Since Mediapolis Site 1 had vegetation installed on the slopes for erosion and sediment control, we tested the automatic analysis workflow using processed multispectral ortho-imagery from that site. Figure 11, Figure 12, Figure 13, and Figure 14 show the results of the data analysis for the multispectral image shown in the middle of each figure, with the left image showing the MSAVI results ranging from -1 to +1 and the right image showing the pixels classified as vegetation or non-vegetation based on the chosen threshold. It should be noted that users should carefully choose vegetation thresholds to obtain accurate vegetation cover calculations, as

several factors such as grass health, season of data collection, sun angle, soil moisture content, soil background, and atmospheric conditions can influence the appropriate threshold value.

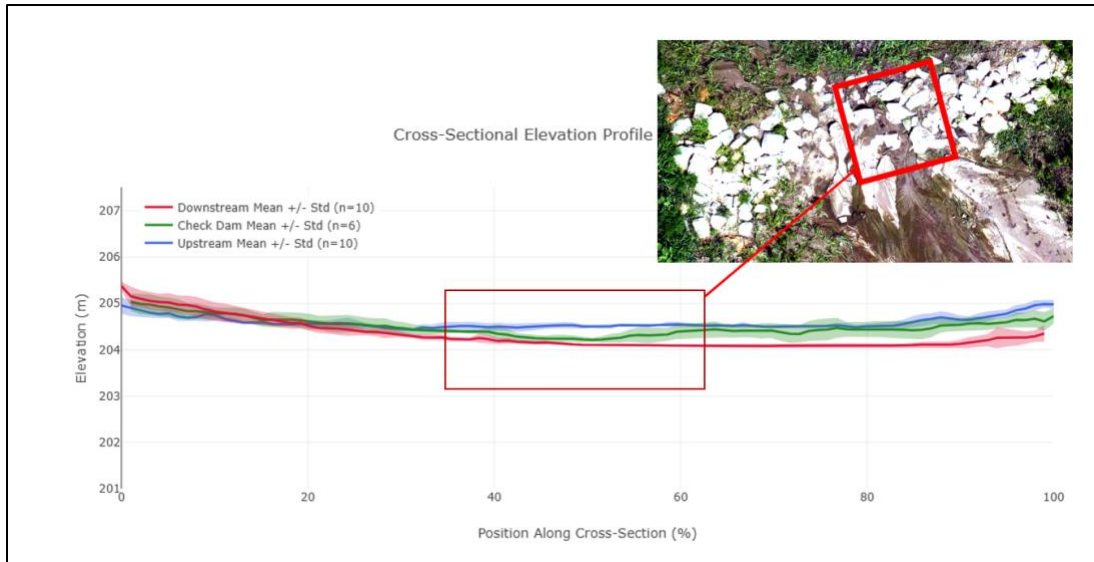
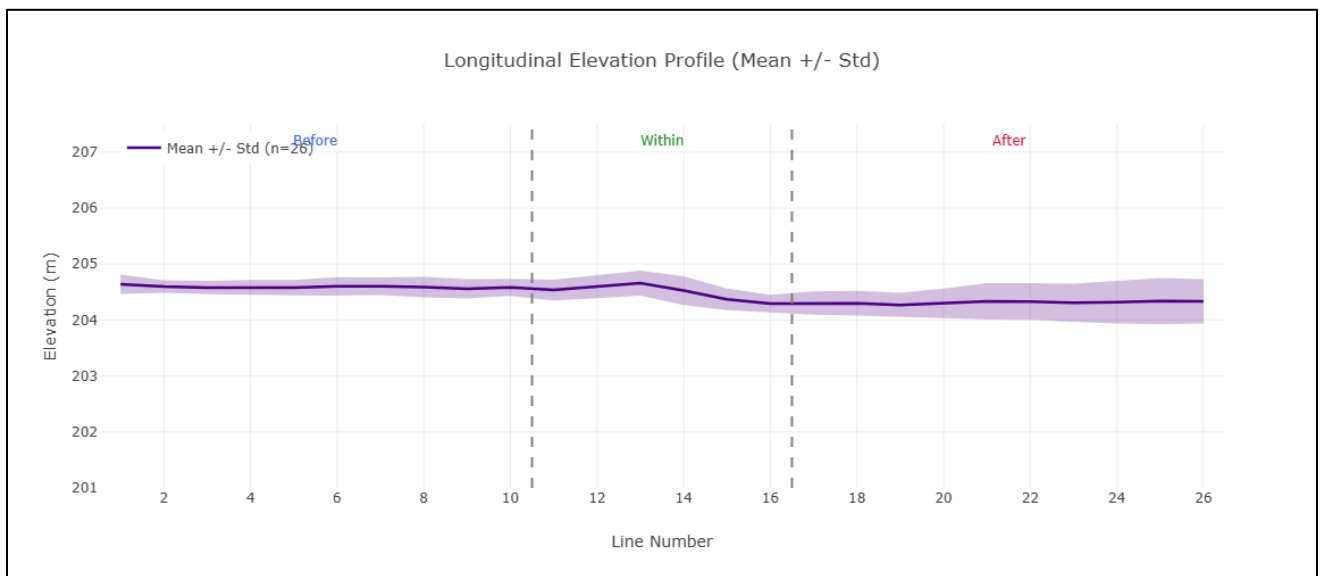
**Figure 17. Front elevation of a check dam, upstream and downstream**

**Figure 18. Side elevation of a check dam, upstream and downstream**

For the check dam at Mediapolis Site 1, shown in Figure 16, we processed the elevation plot and generated front and side elevations using the developed toolbox, as shown in Figure 17 and Figure 18, respectively. While the profile of a well-performing check dam would typically be above both the upstream and downstream sections, as shown in the bounded region of Figure 17, the check dam profile line in this case, represented in green, is below the upstream section and almost at the same level as the downstream section. Intuitively, this analysis provides a quantitative overview of sediment and vegetation overflows within the check dam region.

From these elevation plots, which show both mean and standard deviation, one can quantify the condition of the check dam and make informed decisions about maintenance and the dam's reliability for mitigating future runoff events. We selected other check dams at both the Oskaloosa and Mediapolis sites and added their profile results (Figure 19 and Figure 20).

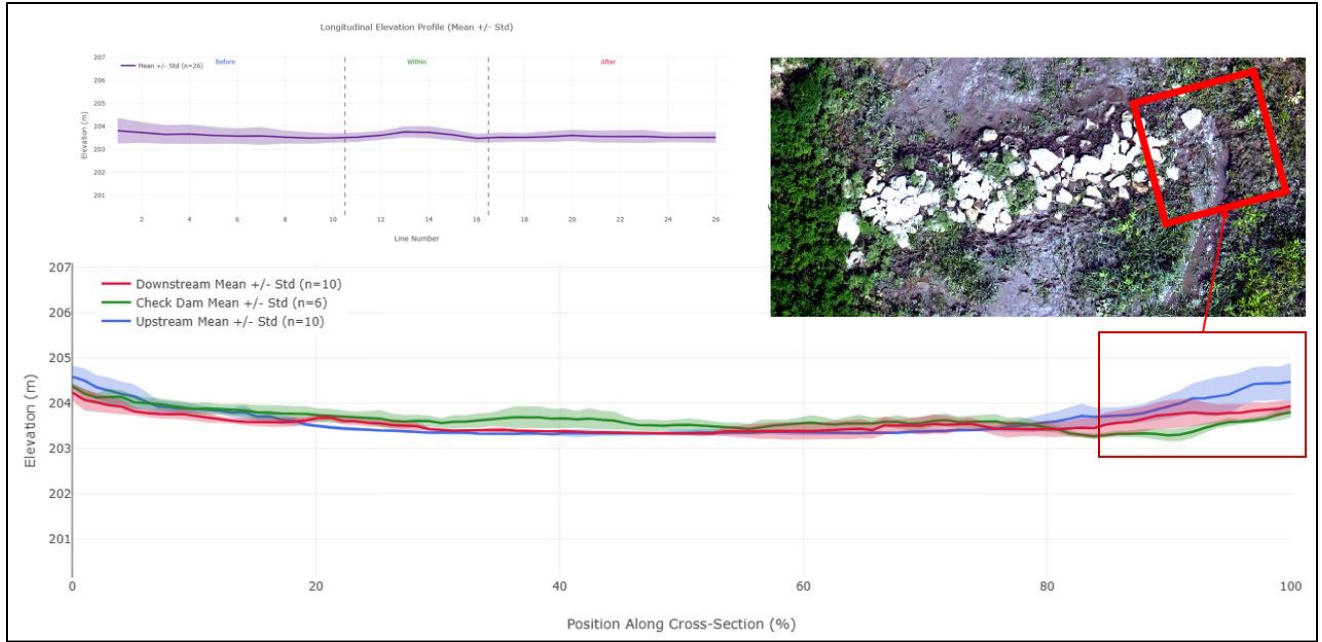
**Figure 19. Front and side elevations of a check dam at Mediapolis Site 1, upstream and downstream**

**Figure 20. Front and side elevations of a check dam at the Oskaloosa site, upstream and downstream**

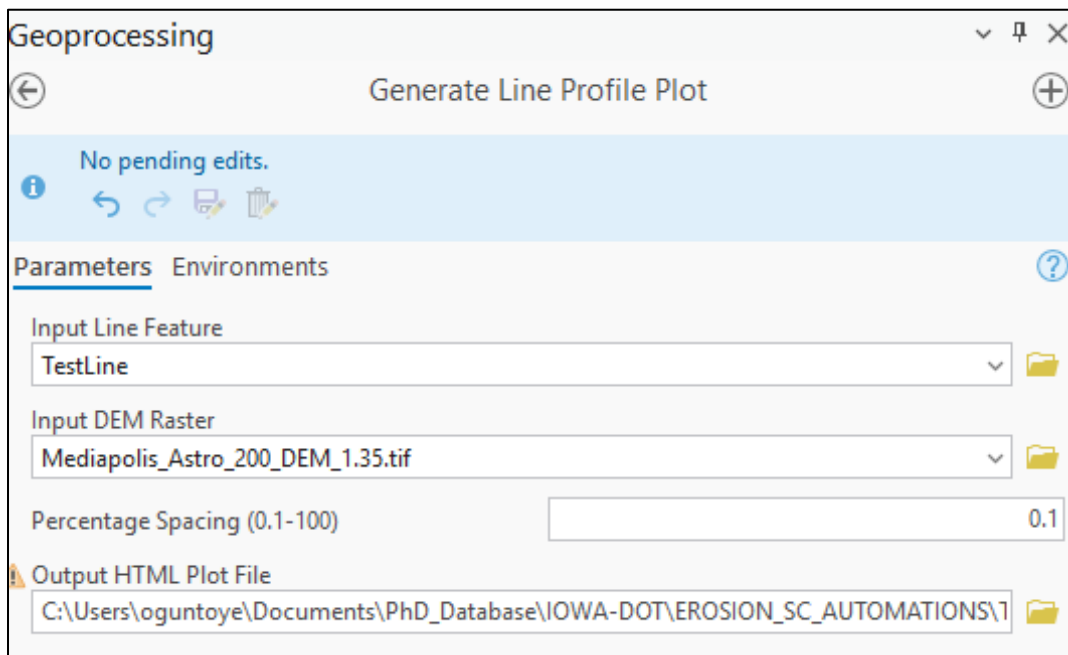
**Figure 22. Screenshot of ArcGIS Pro proof-of-concept toolbox for profile plotting of silt fence areas**

We developed an automated profiling toolbox prototype in ArcGIS Pro that requires users to provide a line feature (an orthogonal line crossing the silt fence) and a DEM raster file to sample and plot elevation points along the line feature. Figure 22 shows a screenshot of the toolbox.

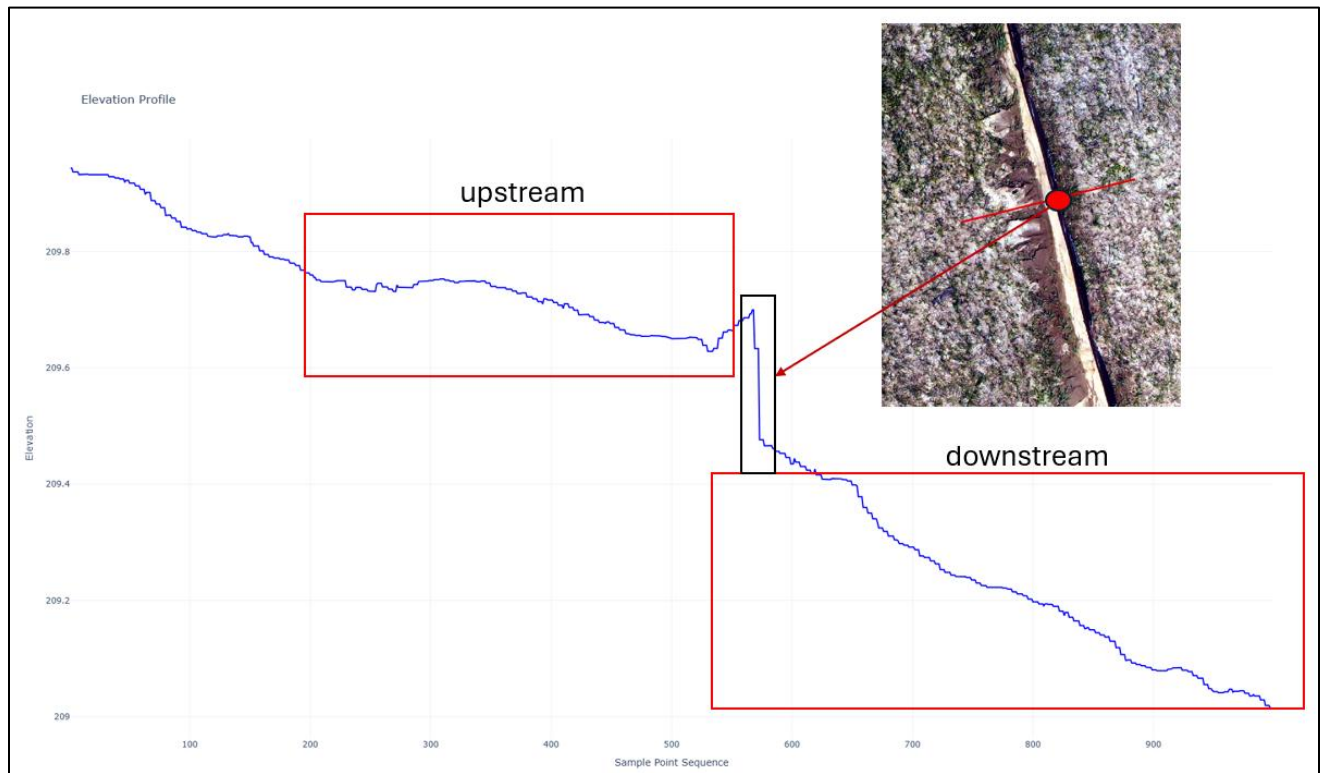
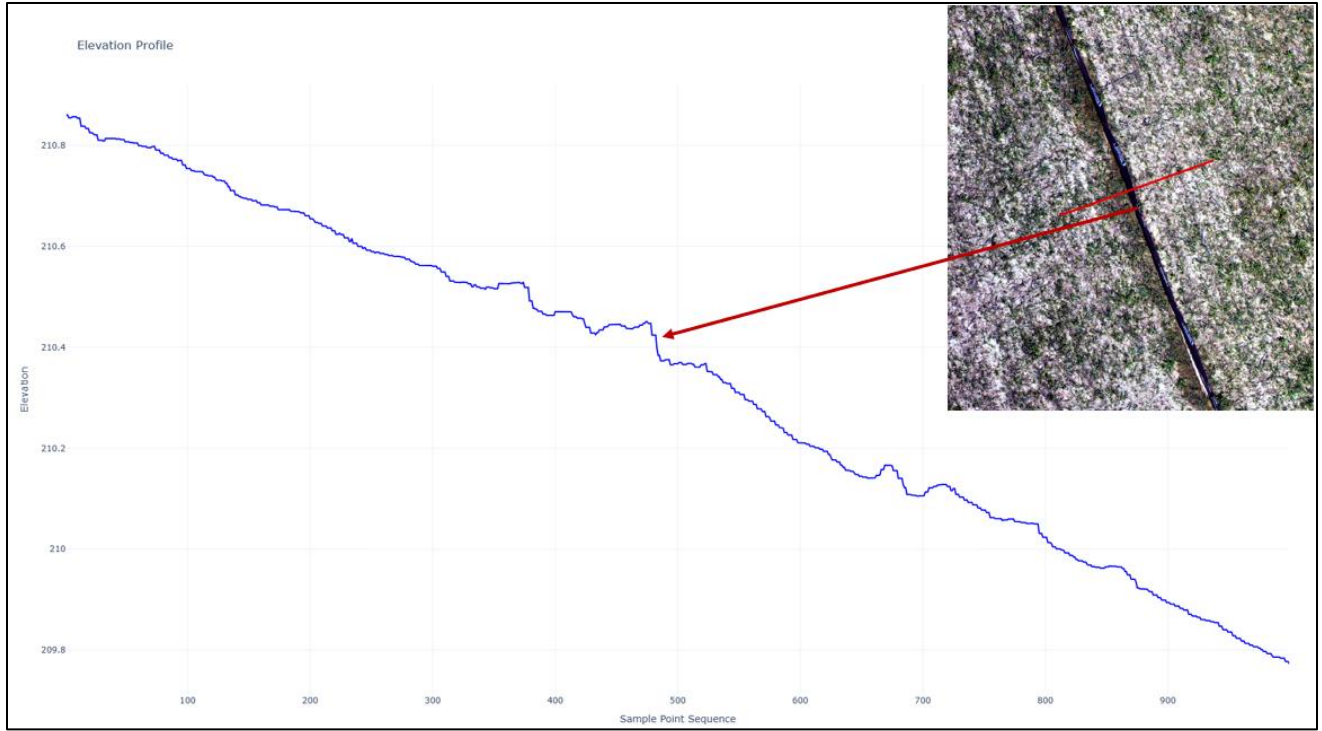
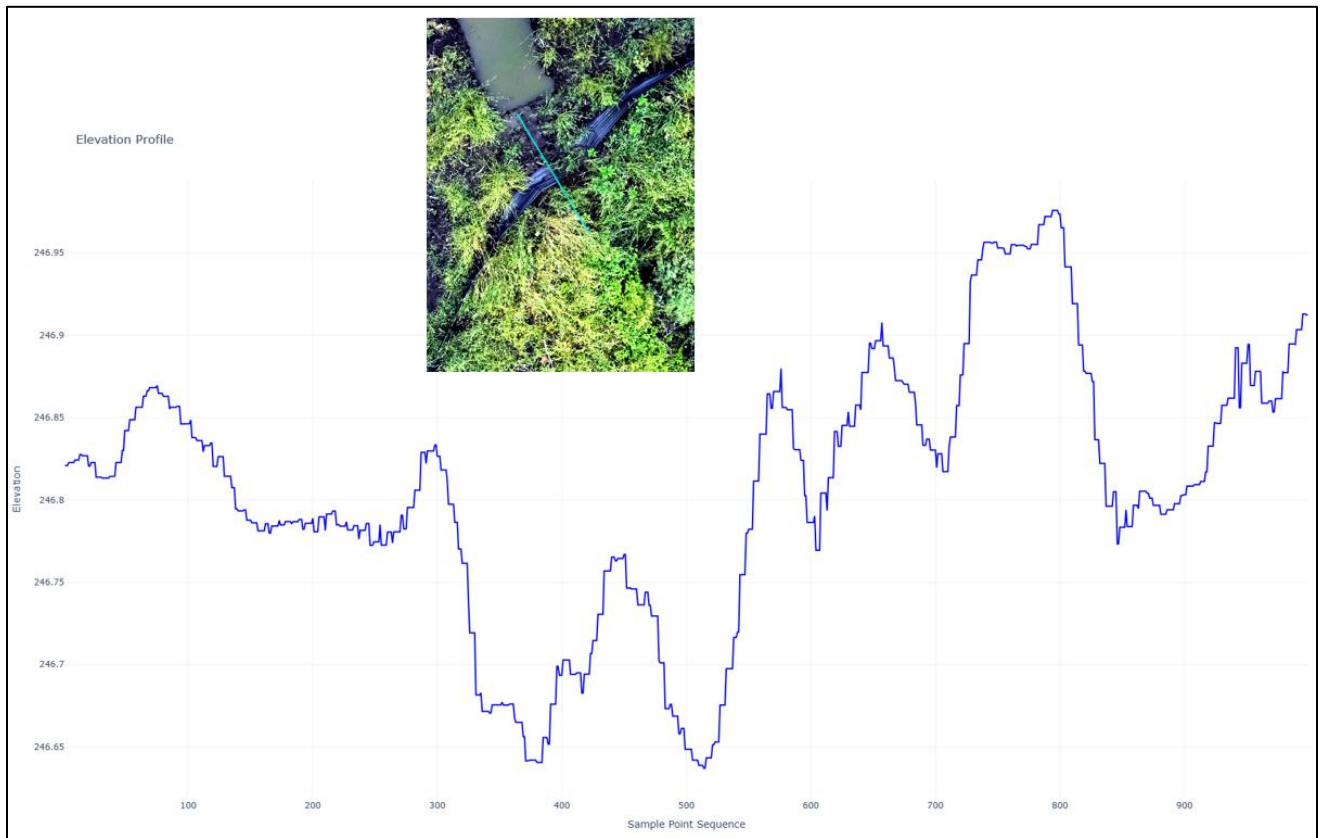
**Figure 23. Plotted profile of a silt fence with accumulated sediment in the upstream section**

**Figure 24. Plotted profile of a silt fence with no visible sediment in the upstream section**

**Figure 25. Plotted profile of a damaged silt fence**

We performed profile analyses on selected silt fences, with the results shown in Figure 23, Figure 24, and Figure 25.

As stated earlier, the drastic drop shown in Figure 23 is indicative of sediment pressure on the silt fence, while the continuous slope profile shown in Figure 24 reflects a consistent profile with no visible concentrated sediment. The jagged profile in Figure 25 suggests possible abnormalities in or damage to the silt fence.

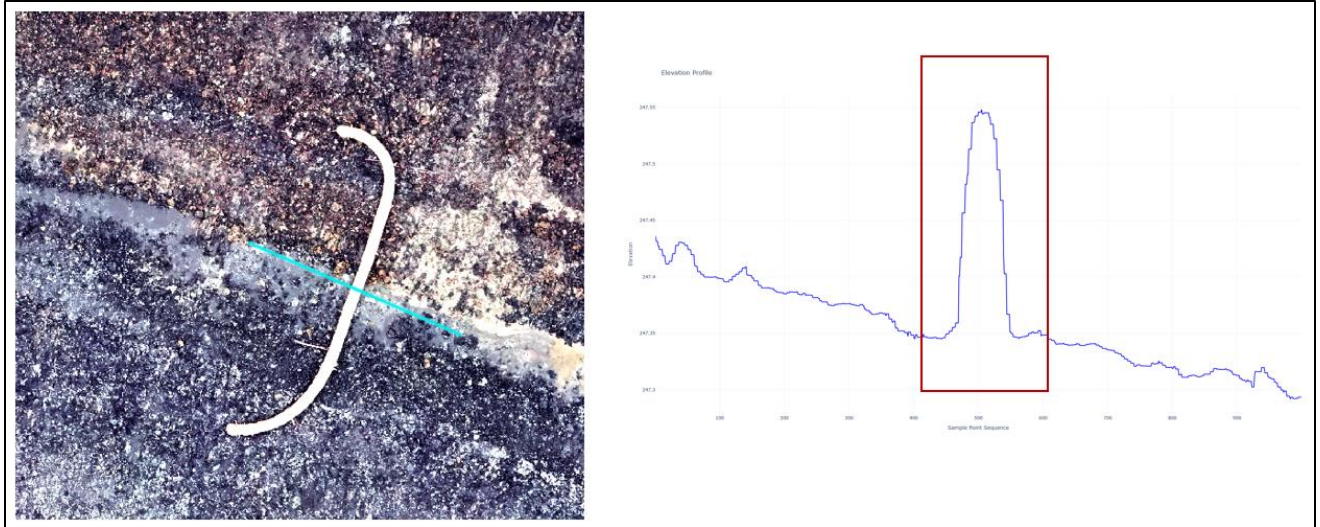
**Figure 29. Wattle profile plot generated using ArcGIS Pro proof-of-concept toolbox**

Profile analysis quantifies the available headroom on the upstream side of a wattle and compares the top-level elevations of the downstream and upstream sections, from which one can determine whether sediment is overwhelming the wattle device. The proof-of-concept toolbox for conducting profile analyses of silt fences is applicable for wattles as well. Figure 29 illustrates how a wattle's profile can be plotted using the developed toolbox. Quantifying the level of sediment on the upstream and downstream sides of the wattle can help inform maintenance actions. For example, a profile plot showing upstream/downstream top elevations flush with that of the wattle would imply that the wattle needs to be replaced or that sediment needs to be excavated to accommodate more sediment from future precipitation runoff.

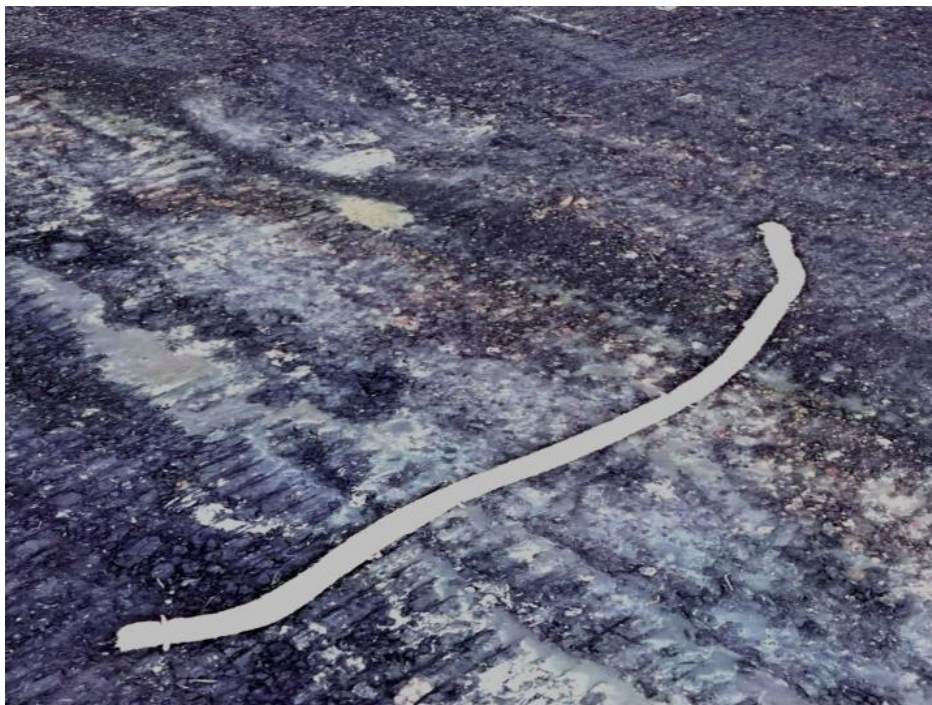
**Figure 30. 3D view showing a close-up examination of a wattle**

The second assessment method involves 3D viewing, a technique described in the previous section in relation to silt fences. A 3D global scene can similarly be a valuable tool for the remote examination of wattles. Panning and zooming close to a wattle, as shown in Figure 30, can indicate how much sediment has accumulated, the cleanliness of the wattle, and possibly the extent to which the wattle has been soaked in sediment over time.

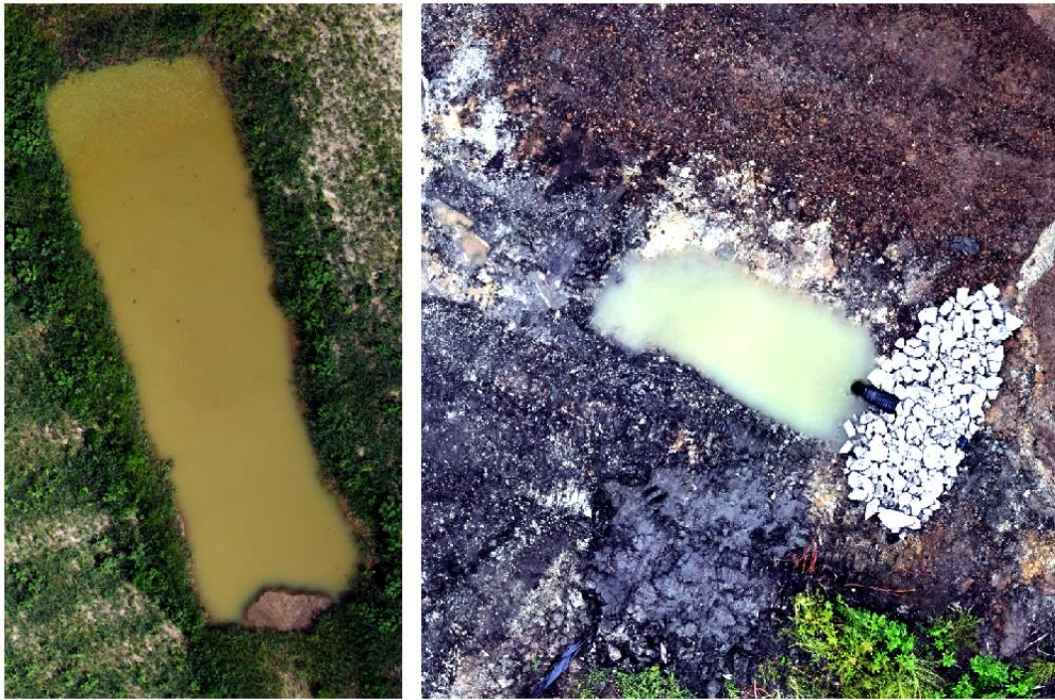
**Figure 31. 2D orthophotos showing stormwater basins from Mediapolis Site 1**

Stormwater basins are excavated areas designed to collect runoff and release it at a controlled rate, allowing suspended sediment to settle when sufficient detention time is provided. While monitoring the coloration, flooding, and fill level of small basins is achievable through manual foot-on-ground inspection, applying similar inspection techniques to wider basins is challenging. However, adequate data for assessing basins can be obtained from 2D orthophotos, which can indicate flooding conditions and other critical features required for an overall assessment of a basin's conditions. Mediapolis Site 1 featured a few stormwater basins; 2D orthophotos of these devices are provided in Figure 31.
