Improving the Foundation Layers for Concrete Pavements

Field Assessment of Jointed Portland Cement Concrete Pavement with Premature Distresses – Iowa US 34 Field Study

February 2016

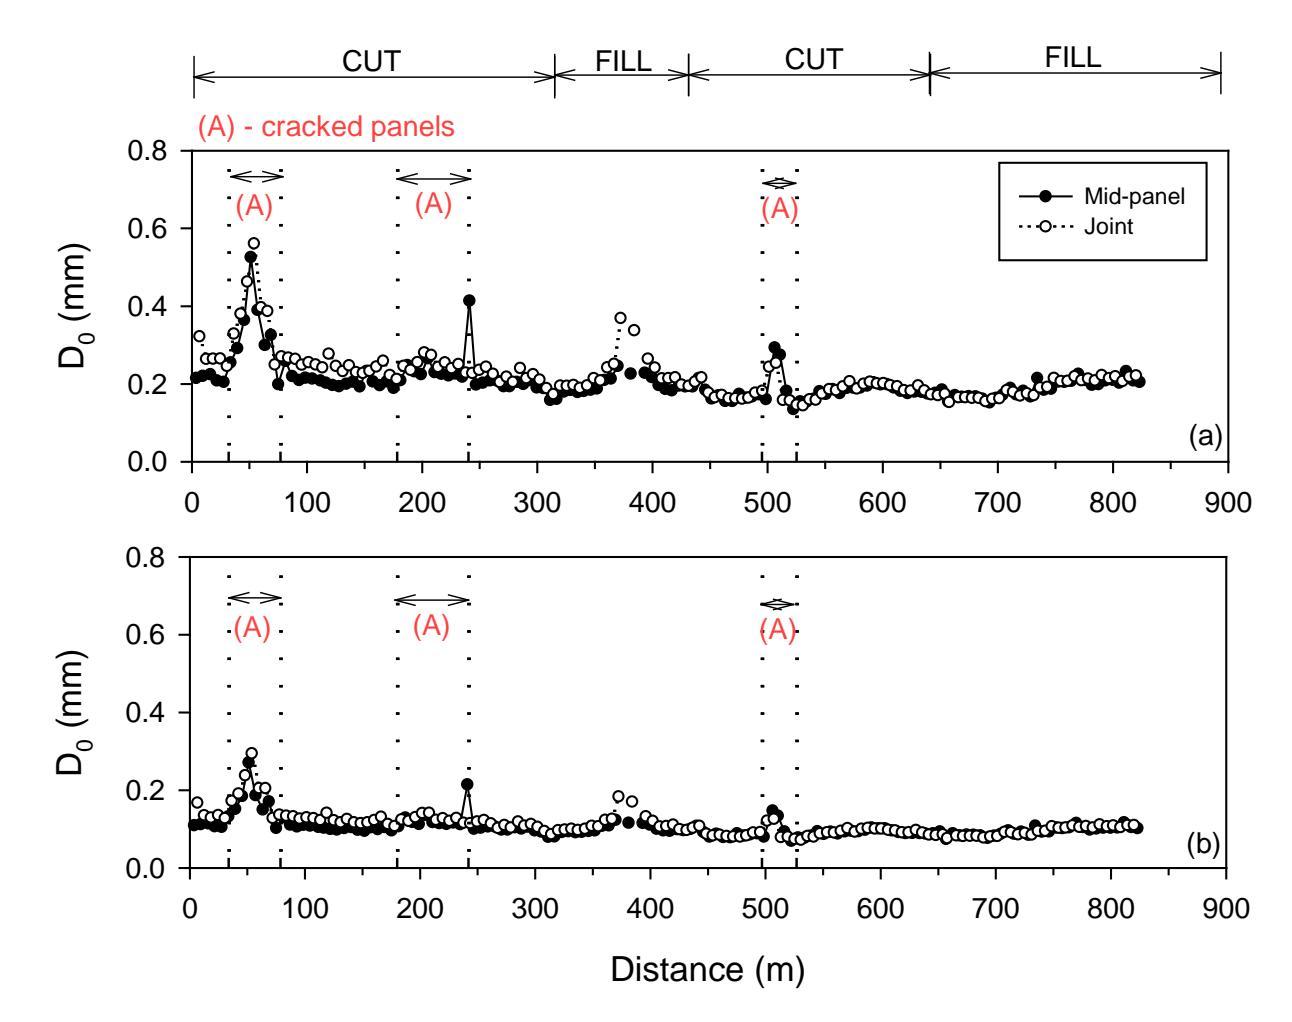
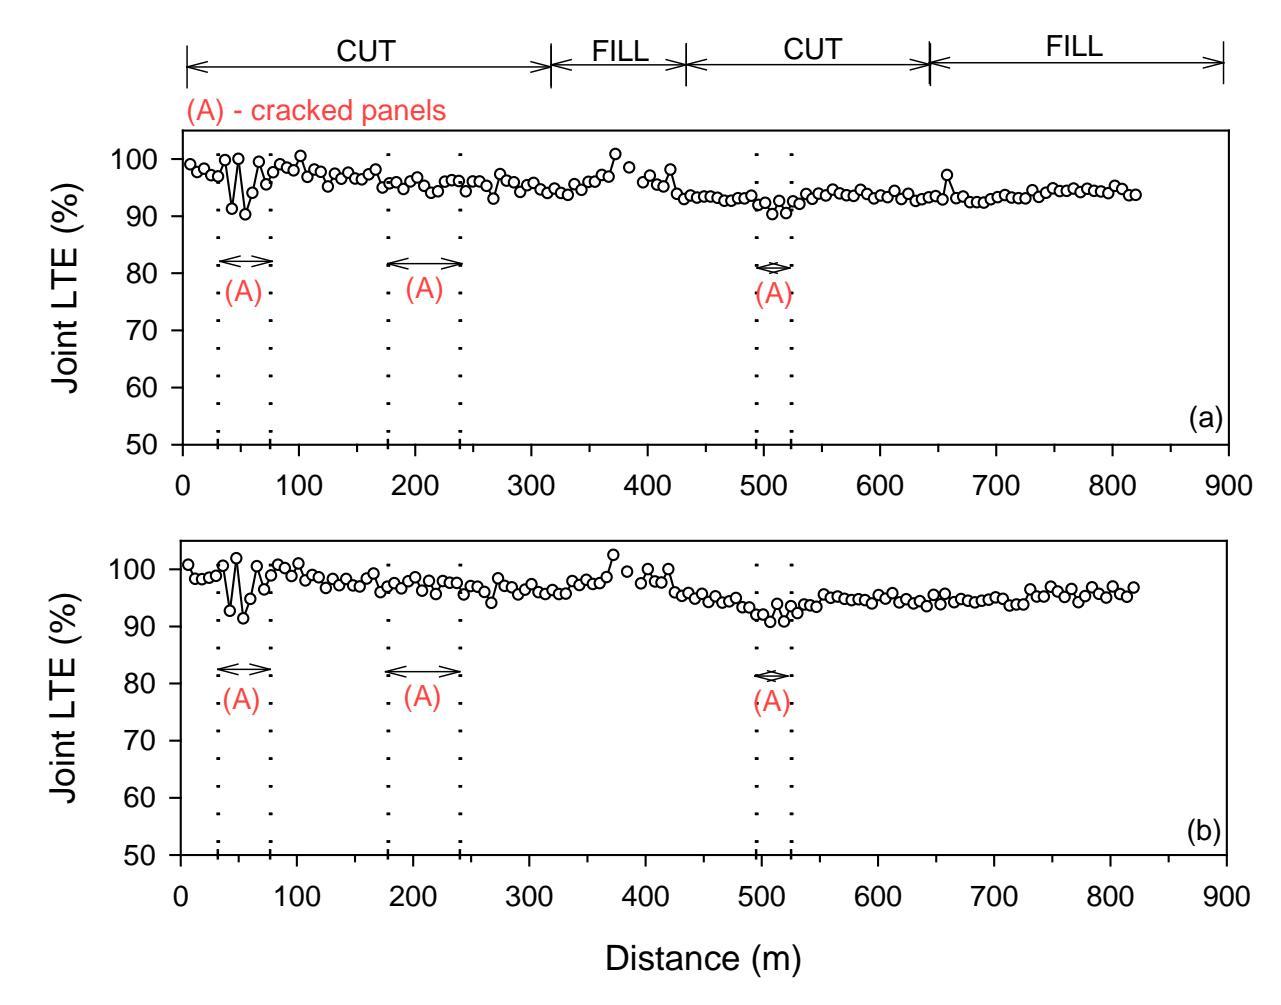
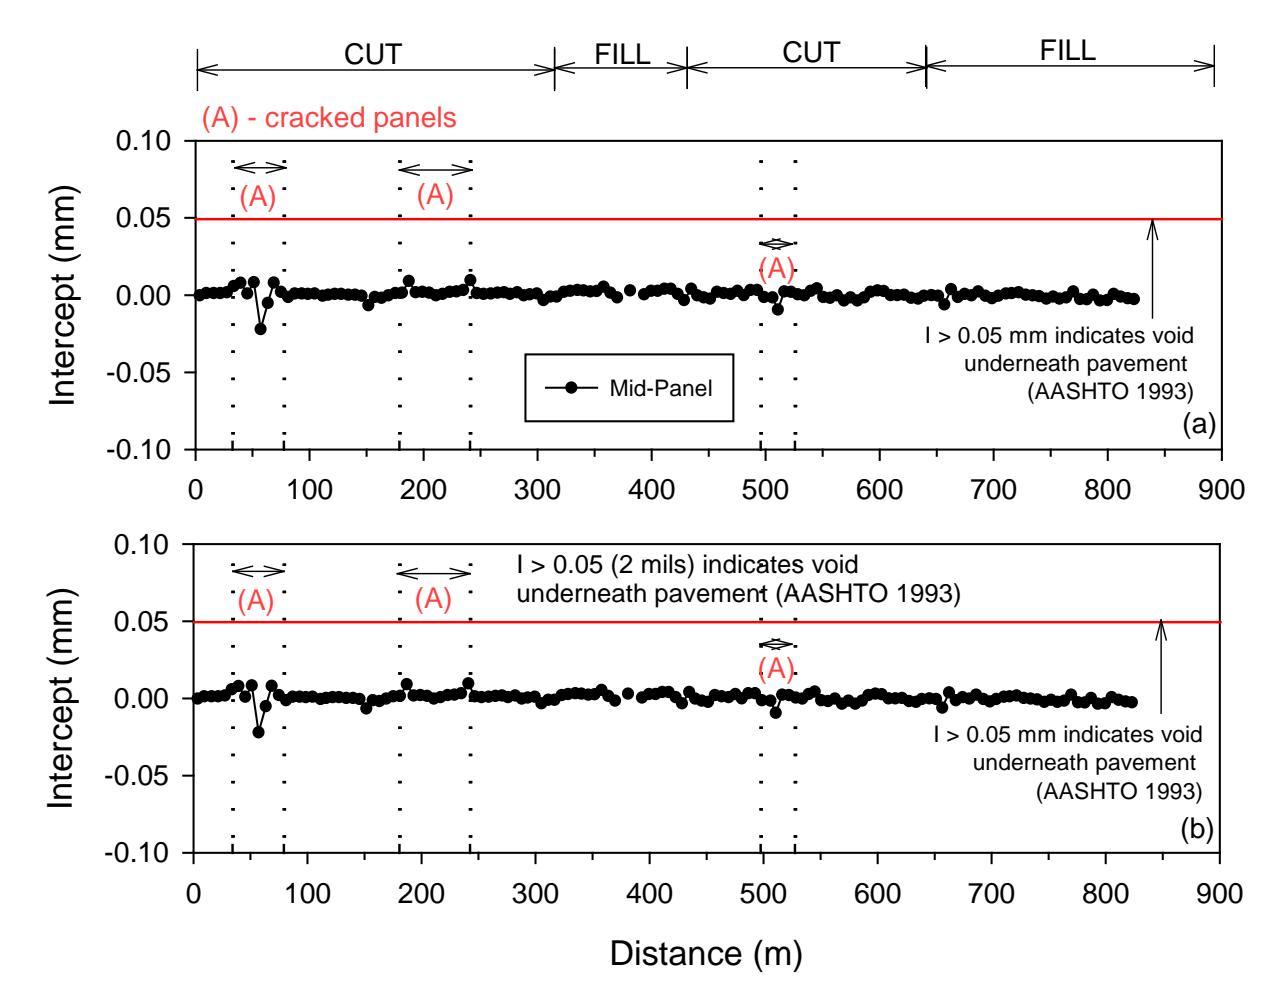
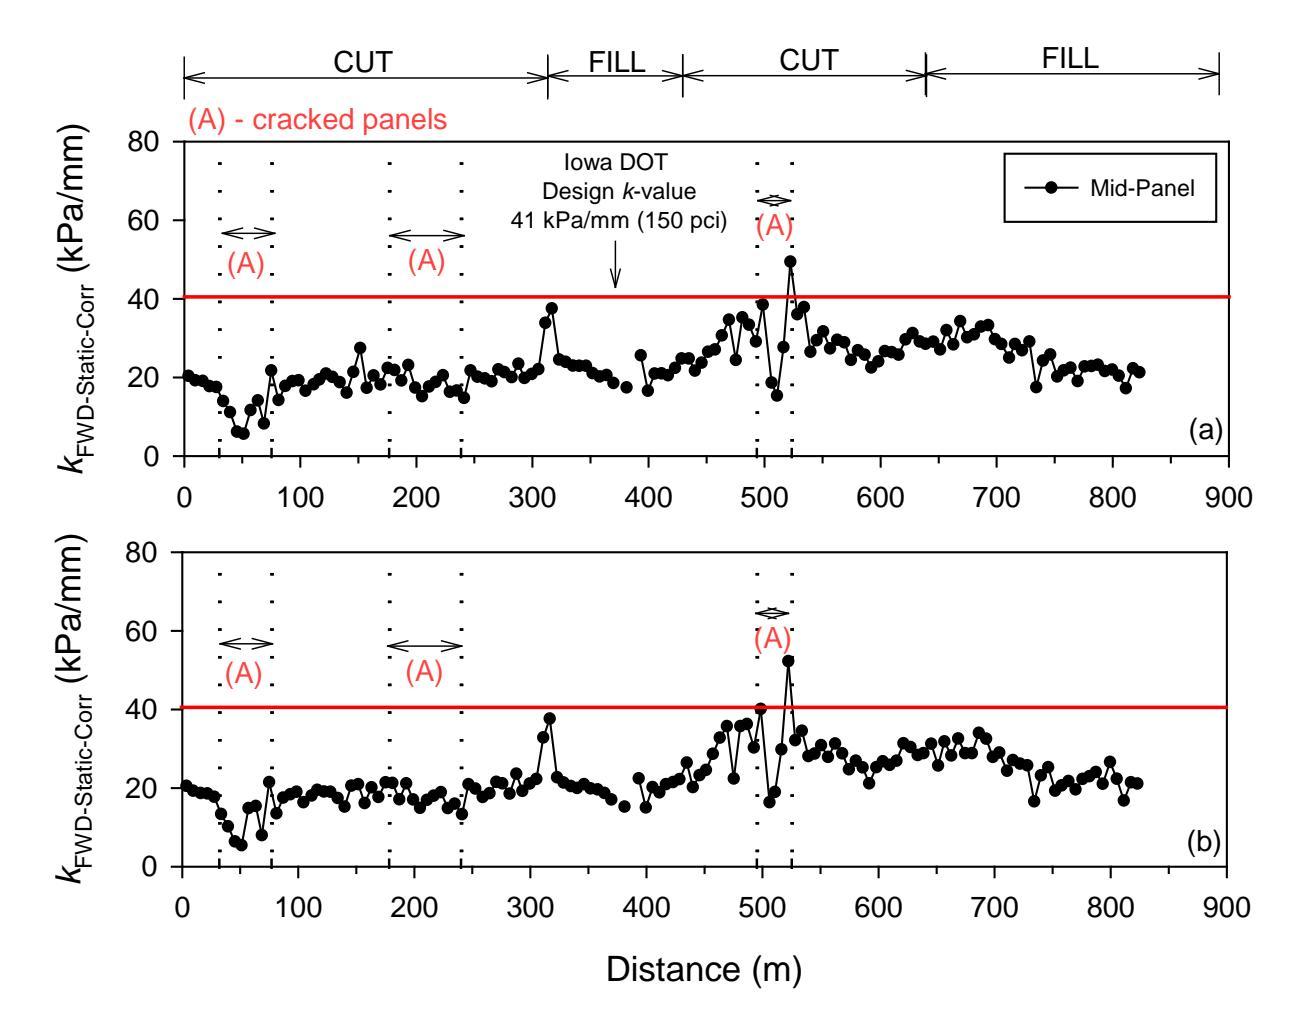
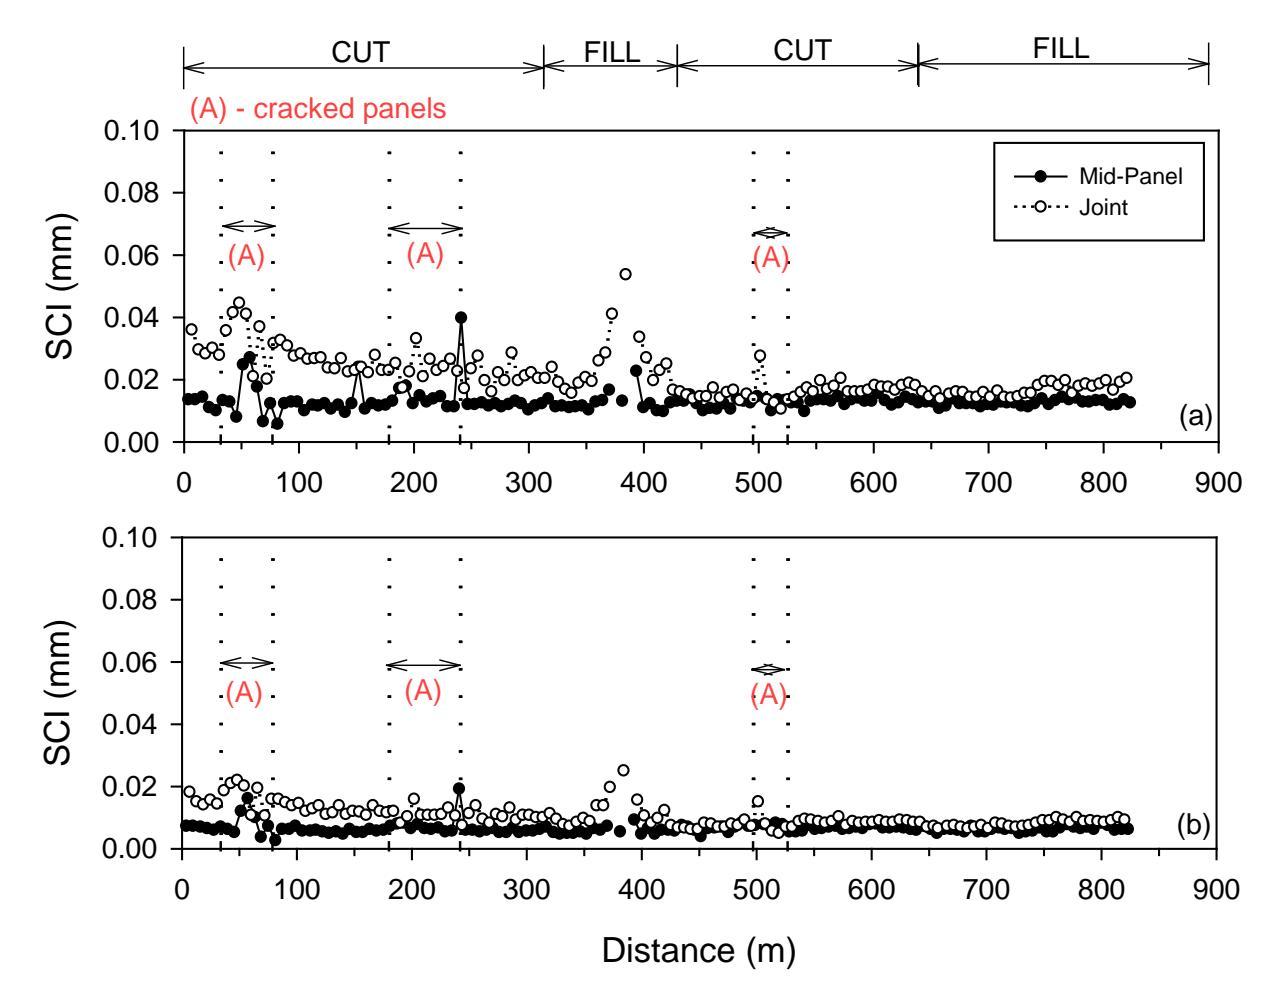
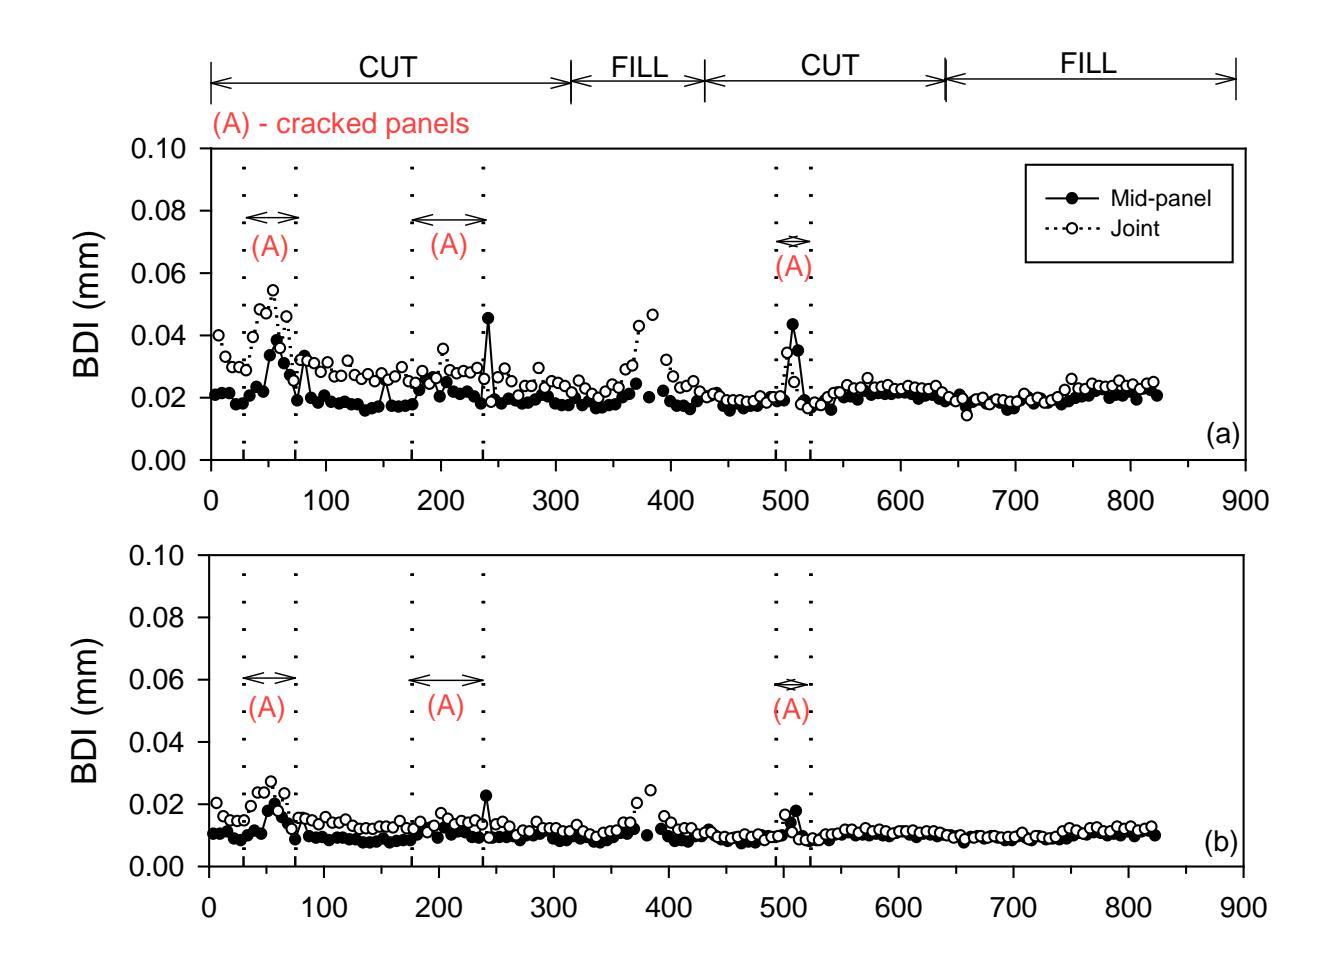
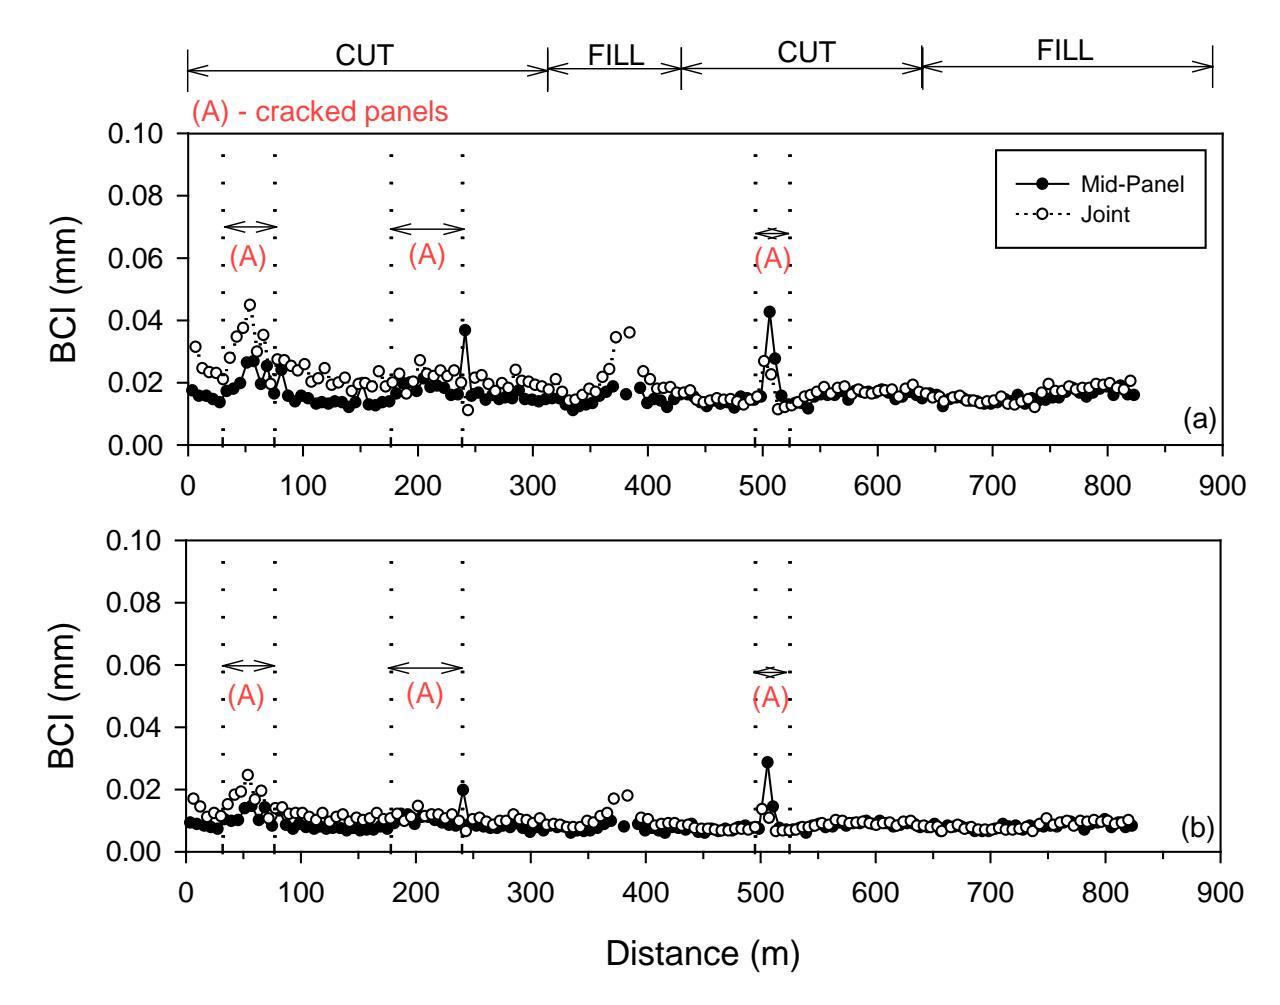
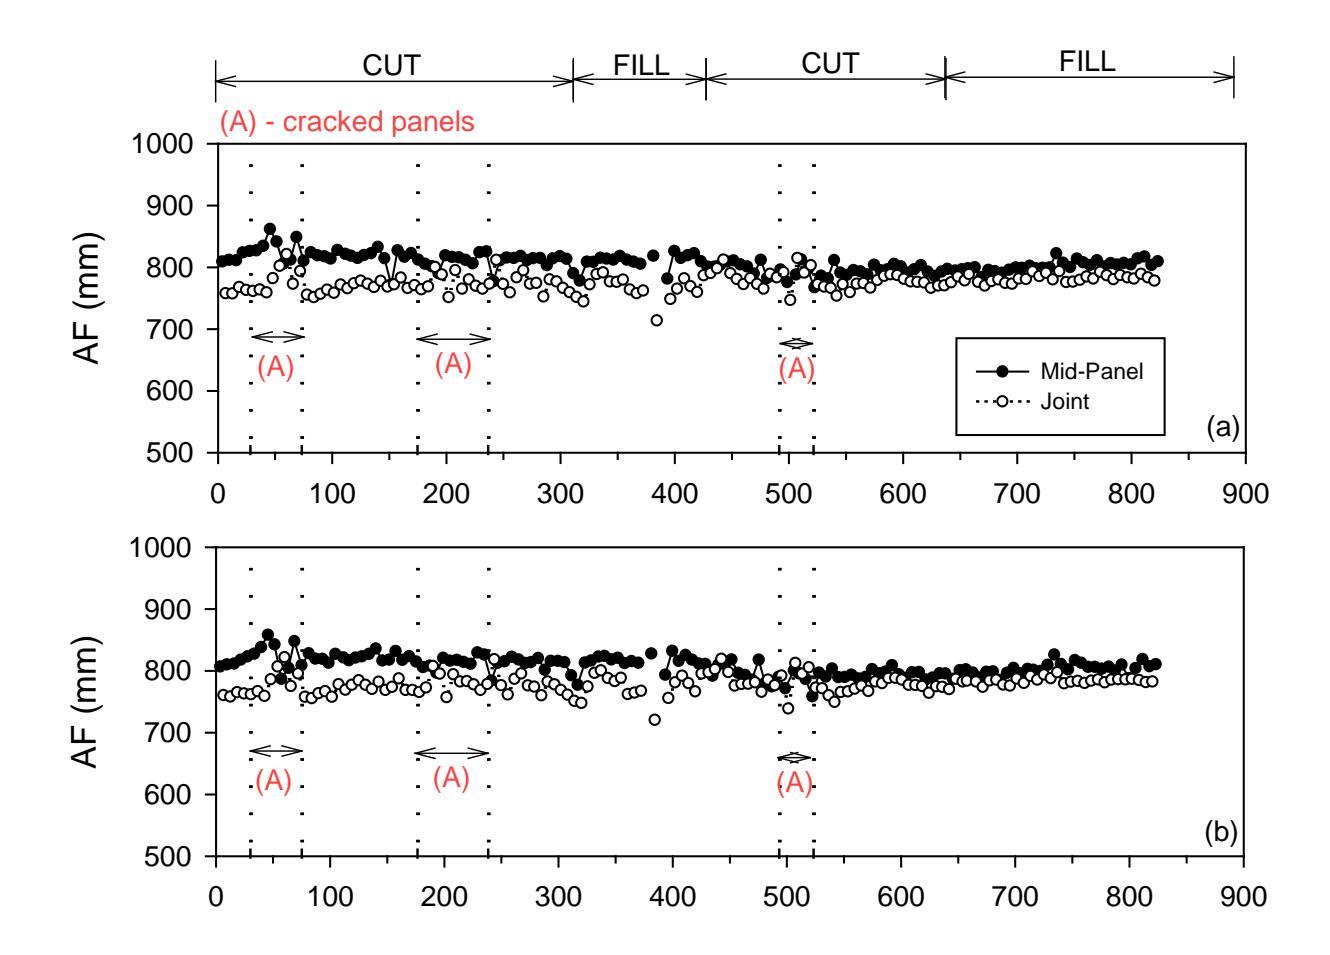
FWD test results measurements obtained near joints and mid-panel are presented in Figure 15 to Figure 22. The figures identify zones of cracked panels and cut or fill. All of the cracked panels are located in the cut areas.

Figure 15. FWD D₀ versus distance with applied loads of (a) 80 kN (18,000 lb) and (b) 40 kN (9,000 lb) [Distance 0 = Sta 350+50]

Figure 16. Joint LTE from FWD tests versus distance with applied loads of (a) 80 kN (18,000 lb) and (b) 40 kN (9,000 lb) [Distance 0 = Sta 350+50]

Figure 17. I-value versus distance with applied loads of (a) 80 kN (18,000 lb) and (b) 40 kN (9,000 lb) [Distance 0 = Sta 350+50]

Figure 18. kFWD-Static-Corr versus distance with applied loads of (a) 80 kN (18,000 lb) and (b) 40 kN (9,000 lb) [Distance 0 = Sta 350+50]

Figure 19. SCI versus distance with applied loads of (a) 80 kN (18,000 lb) and (b) 40 kN (9,000 lb) [Distance 0 = Sta 350+50]

Figure 20. BDI versus distance with applied loads of (a) 80 kN (18,000 lb) and (b) 40 kN (9,000 lb) [Distance 0 = Sta 350+50]

Figure 21. BCI versus distance with applied loads of (a) 80 kN (18,000 lb) and (b) 40 kN (9,000 lb) [Distance 0 = Sta 350+50]

Figure 22. AF versus distance with applied loads of (a) 80 kN (18,000 lb) and (b) 40 kN (9,000 lb) [Distance 0 = Sta 350+50]

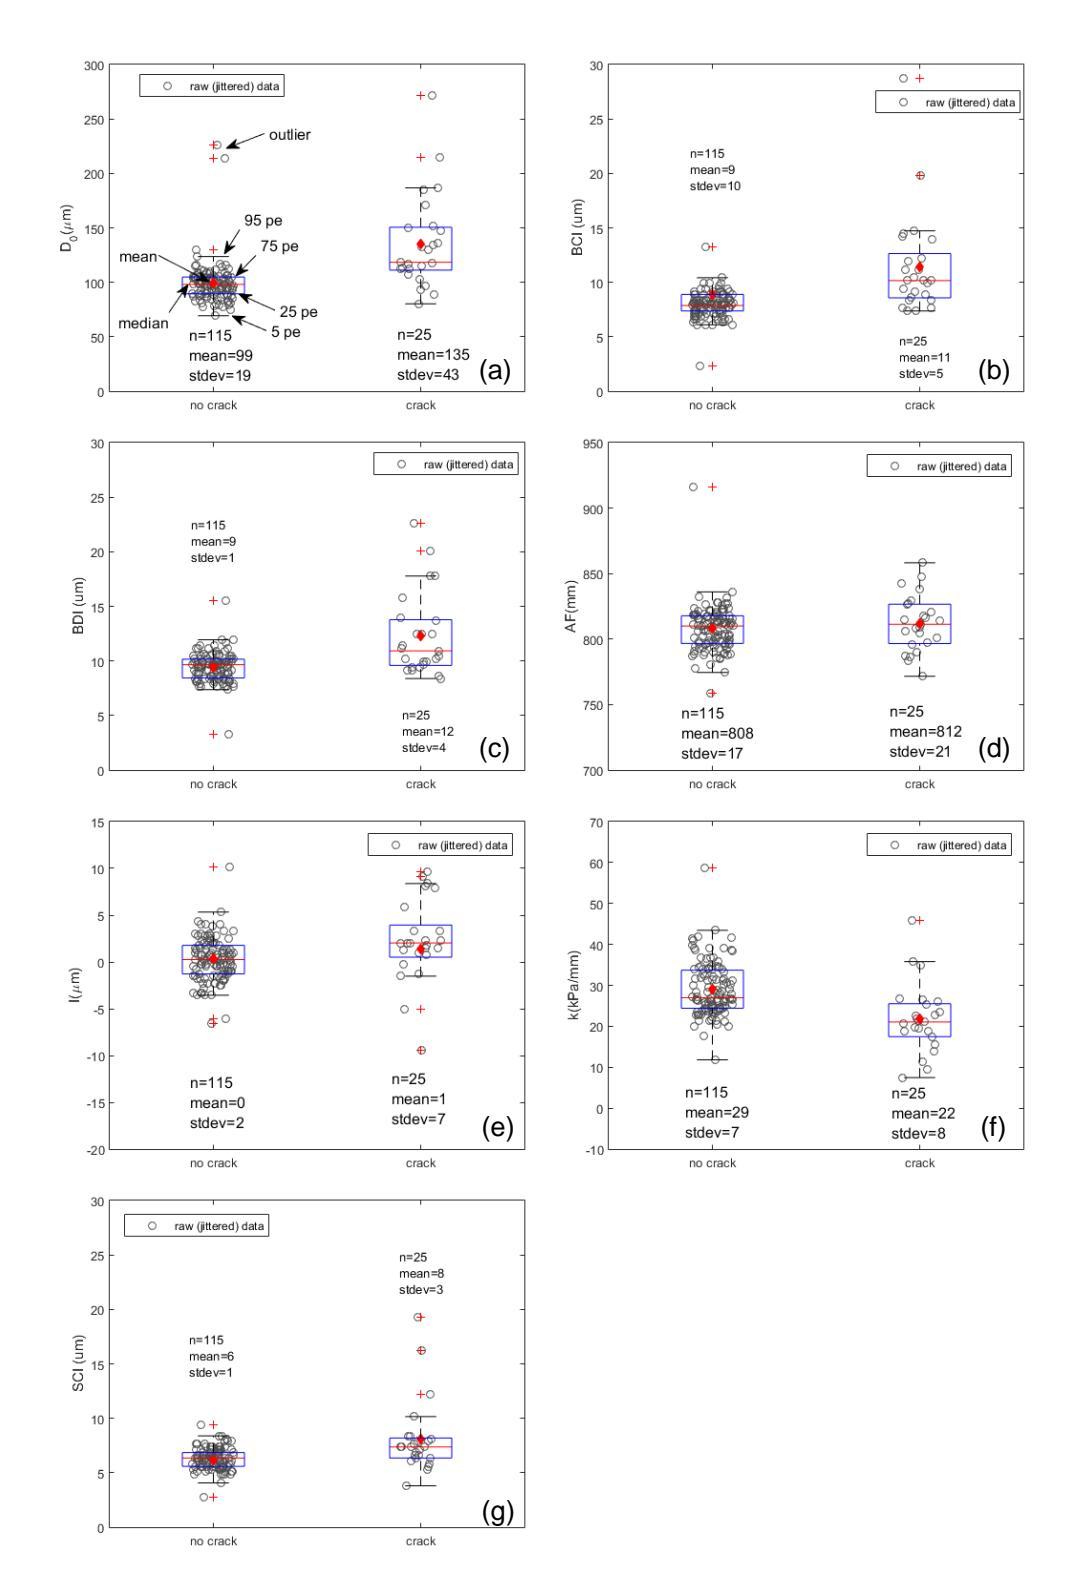
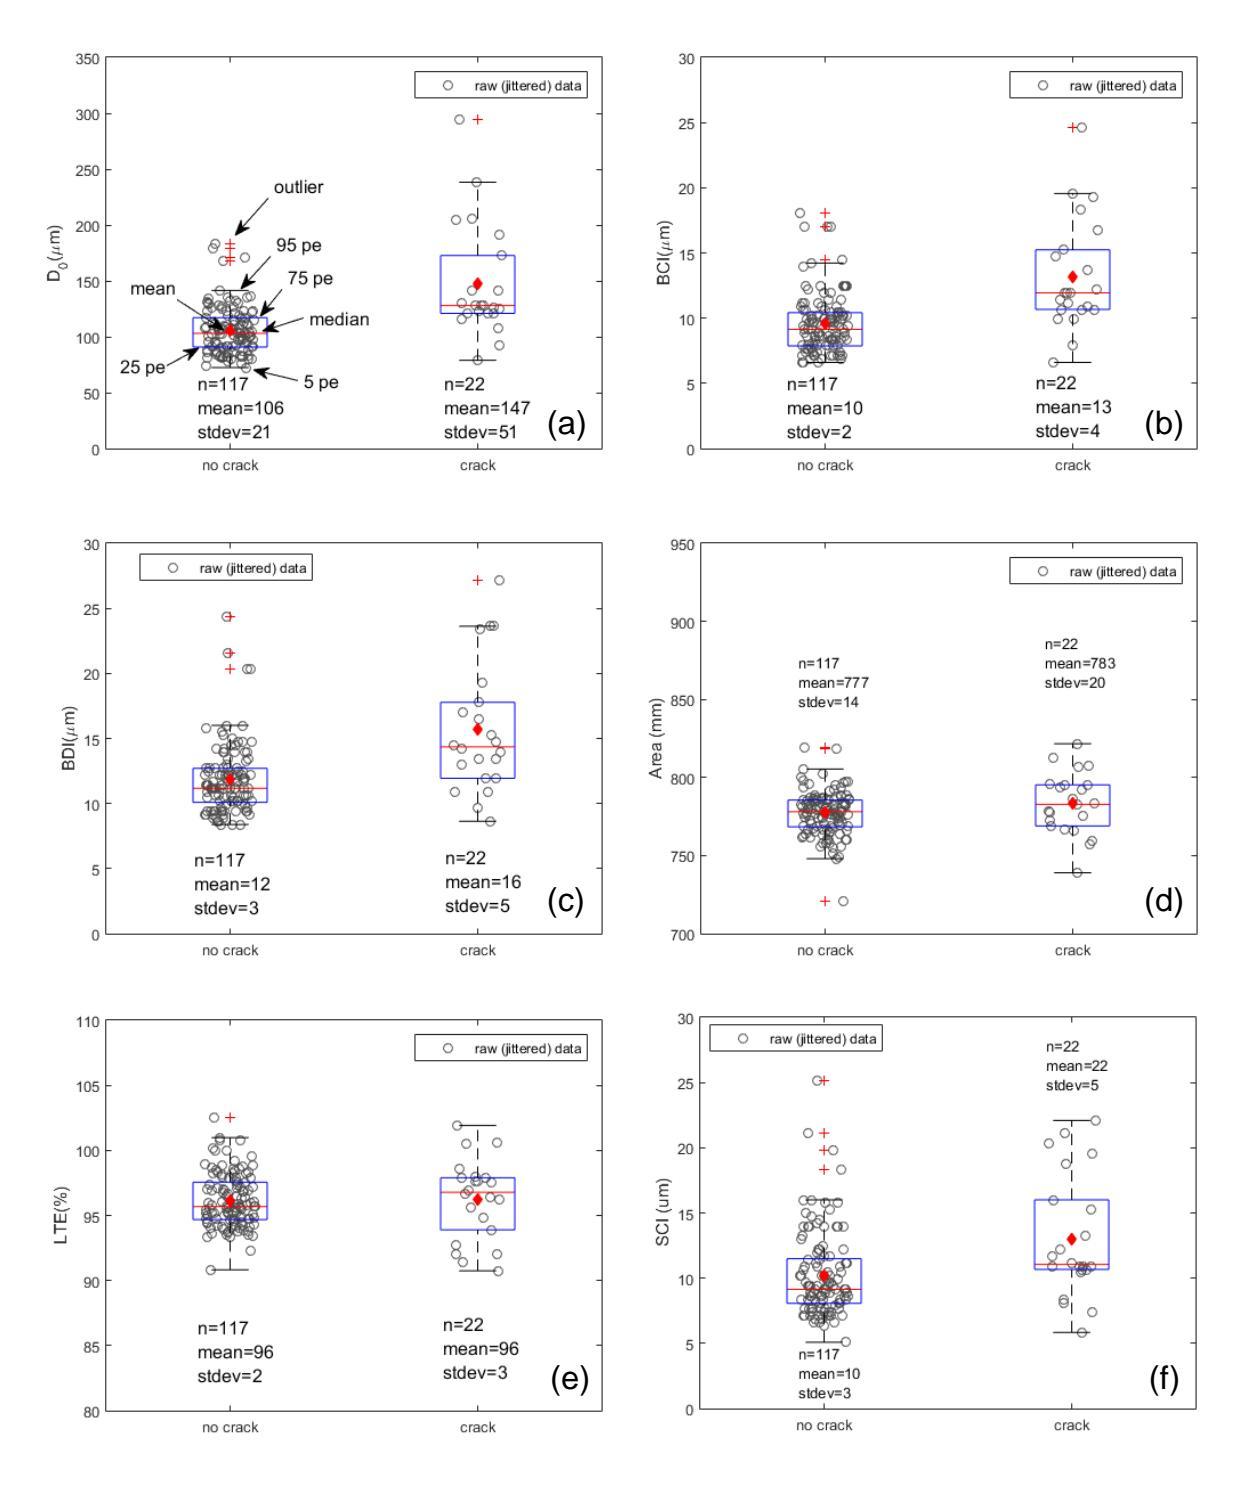
Box plots showing FWD test measurements obtained on panels with and without cracks are shown along with number of measurements (n), mean, and standard deviation statistics in Figure 23 and Figure 24 for tests conducted near mid-panel and joint, respectively. Summaries of t-test analysis results that compare measurement values obtained on panels with and without cracks are provided in Table 1 for tests conducted near mid-panel and Table 2 for tests near joint.

- The D₀, *k*_{FWD-Static-Corr}, SCI, BDI, and BCI values showed statistically significant differences between cracked and uncracked panels, with results on uncracked panels representing better support conditions than on cracked panels.
- The *k*_{FWD-Static-Corr} values were on average about 1.3 times lower under cracked panels than under uncracked panels. The COV of the *k* values were higher under cracked panels (38%) than under the uncracked panels (23%).
- There was no statistically significant difference in the I values between the cracked and uncracked panels. The I values were all very low ($\leq 1 \mu m$). I > 5 μm is typically considered a trigger value suggesting void beneath the pavement.
- The joint LTE at all panels was relatively high (> 91%) and there was no statistically significant difference between the cracked and the uncracked panels.

Figure 23. Box plots of FWD deflection basin parameters near mid-panel comparing panels with and without cracks: (a) D₀, (b) BCI, (c) BDI, (d) AF, (e) I-value, (f) *k*_{FWD-Static-Corr}, and (g) SCI

Figure 24. Box plots of FWD deflection basin parameters near joint comparing panels with and without cracks: (a) D₀, (b) BCI, (c) BDI, (d) AF, (e) joint LTE, and (f) SCI

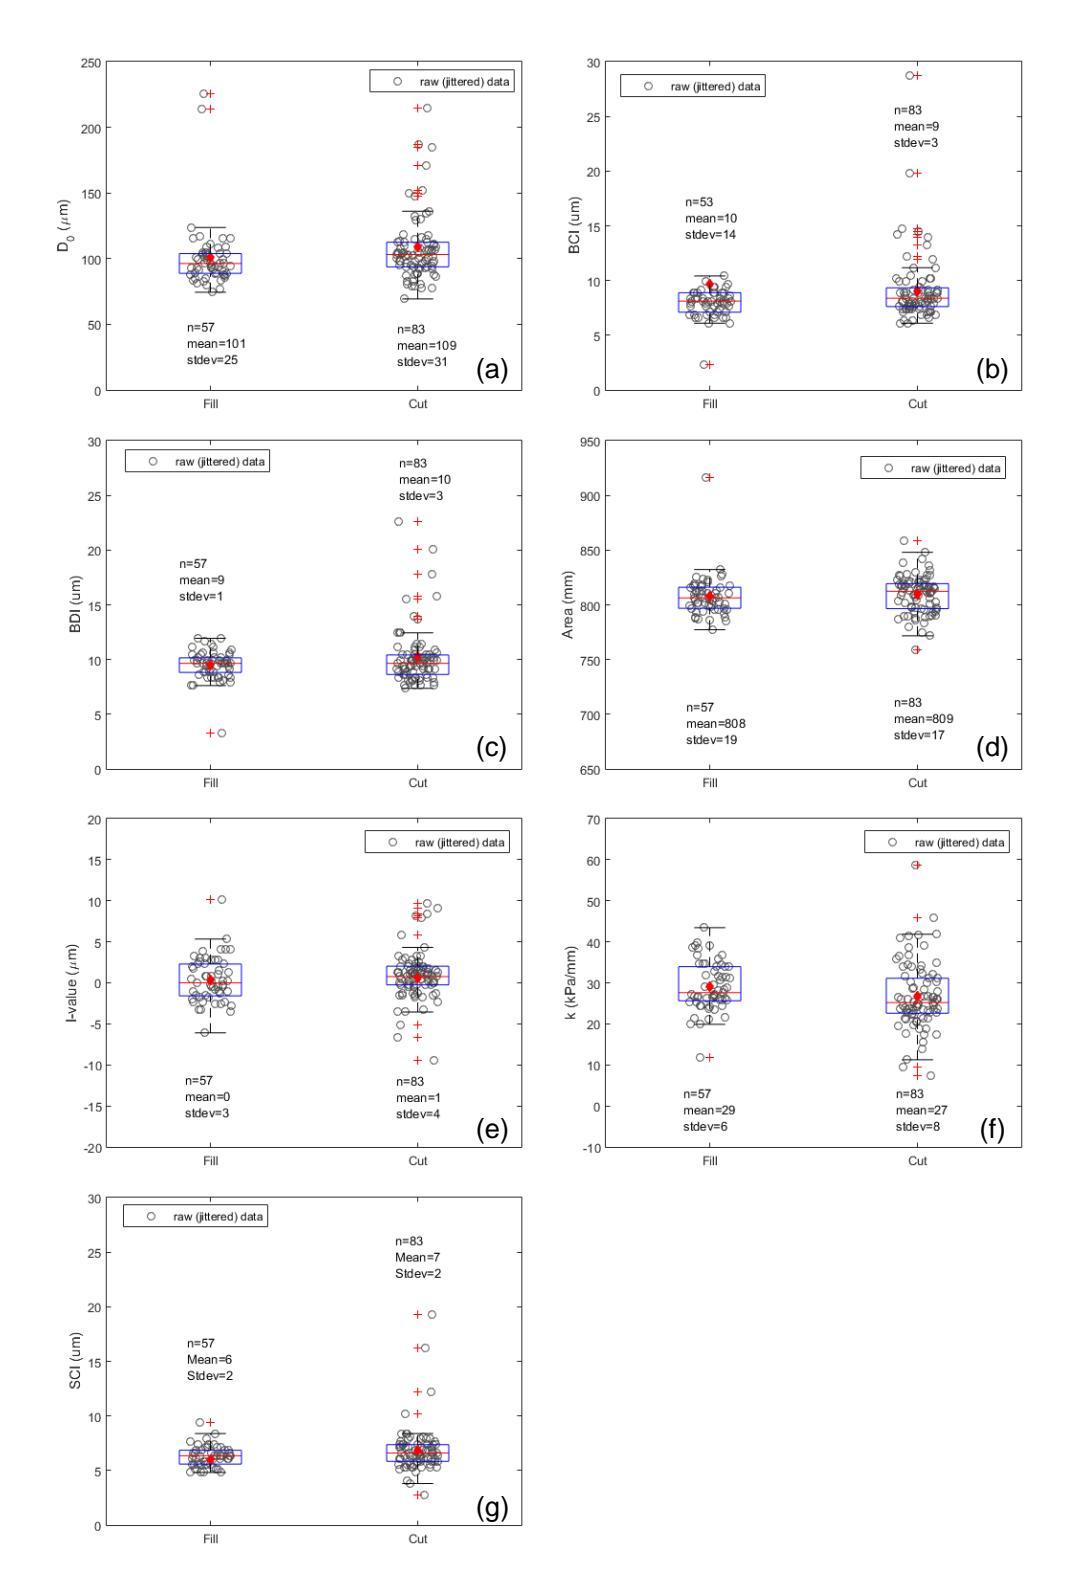
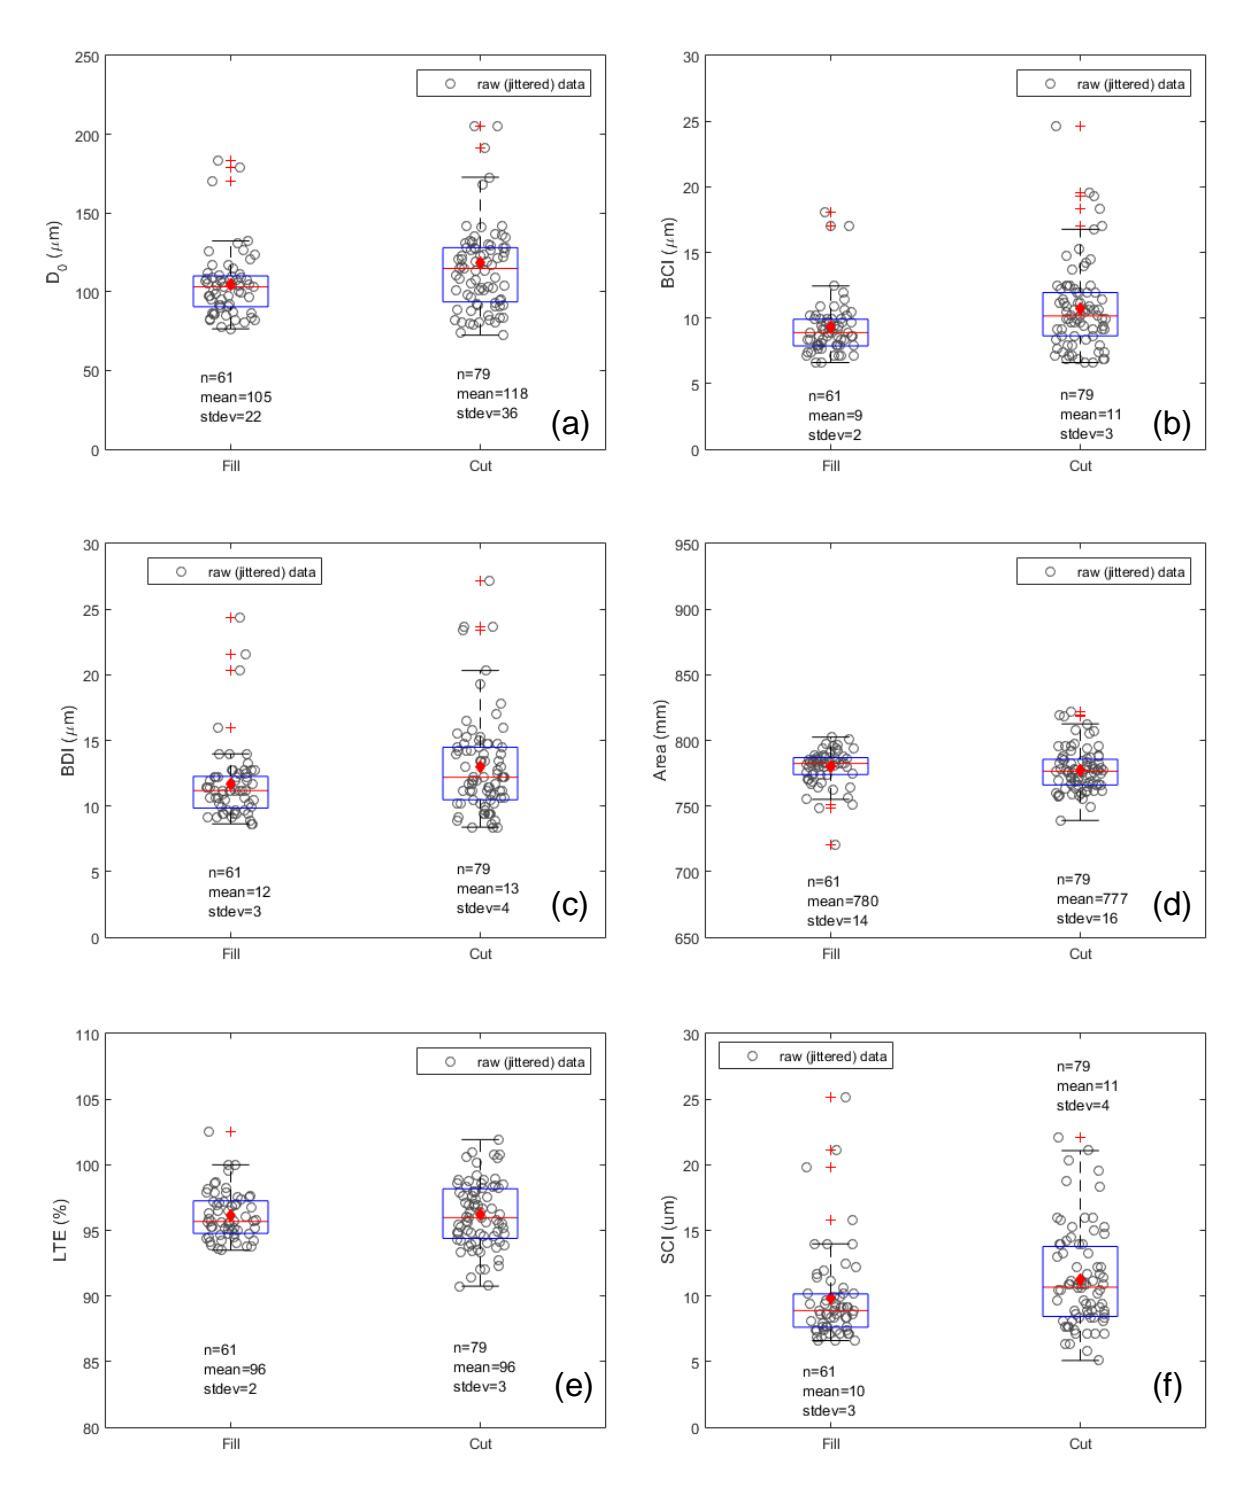
Box plots showing FWD test measurements obtained in cut and fill areas are shown along with number of measurements (n), mean, and standard deviation statistics in Figure 25 and Figure 26 for tests conducted near mid-panel and joint, respectively. Summary of t-test analysis results comparing measuremet values obtained on panels in cut and fill areas as provided in Table 3 and Table 4, respectively.

- The D₀, *k*_{FWD-Static-Corr}, SCI, BDI, and BCI values showed statistically significant differences between cut and fill areas, with results in fill areas showing better support conditions than in cut areas. As indicated earlier, all cracked panels were located in the cut areas.
- The *k*_{FWD-Static-Corr} values were on average about 1.1 times lower in cut areas than in fill areas. The COV of the *k* values were higher in the cut areas (31%) than in the fill areas (21%).
- There was no statistically significant difference in the I values cut and fill areas. The I values were all very low ($\leq 1 \mu m$).
- The joint LTE at all panels was relatively high (> 91%) and there was no statistically significant difference between tests conducted in cut and fill areas.

Figure 25. Box plots of FWD deflection basin parameters near mid-panel comparing panels located in fill and cut areas: (a) D₀, (b) BCI, (c) BDI, (d) AF, (e) I-value, (f) *k*_{FWD-Static-Corr}, and (g) SCI

Figure 26. Box plots of FWD deflection basin parameters near joint comparing panels located in cut and fill areas: (a) D₀, (b) BCI, (c) BDI, (d) AF, (e) joint LTE, and (f) SCI
